TYPE 2 - ASBESTOS SURVEY REPORT

Conducted at: - Community Hall
 Station Road
 Teynham
 Kent

Date: 23rd March 2007

Survey Reference: AS/0757-T2/SP

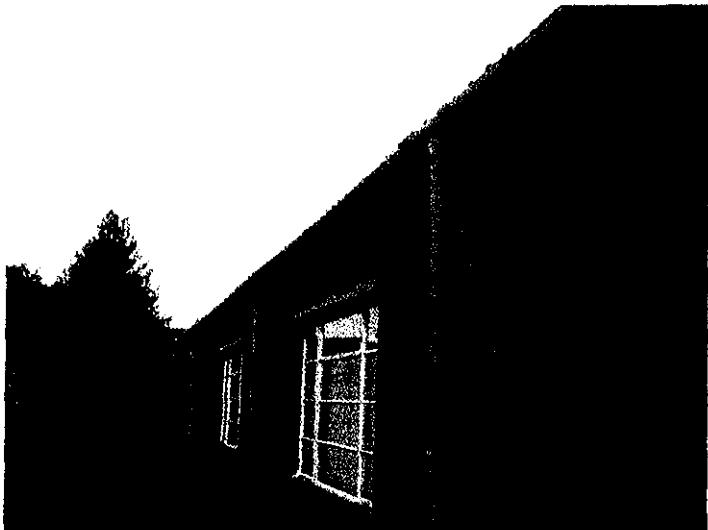
PHOTO 07

| Location / Room | Material Sampled | Sample / Photo No: | Approx Extent | Product Type | Condition / Damage | Surface Treatment | Asbestos Type | Personnel Accessibility | Risk Score Category | Considered Action Required |
|---|---|---|---|---|---|---|---|---|---|---|
| Roof | Rain Water Goods | P 07 S 07 | 75m | 1 | 1 | 1 | 1 | Moderate | 4 Category D | Label & Manage |

External

Rain Water Goods

Sample No. 07

Chrysotile

Asbestos Cement

| CLIENT SAMPLE No. | SCOPES SAMPLE | Sample Location | Fibre Type Detected |
|---|---|---|---|
| SO 757-T2 07 | 7 | EXTERNAL ROOF-RAIN WATER GOODS | CHrysotile |

Asbestos cement should be removed intact and carefully without damage. Personal protective equipment should be worn by operatives.

Considered Recommendation: **Label & Manage**
