Your survey report

Teynham Community Hall, 89 Station Road,
Teynham, Kent, United Kingdom, ME9 9DU

Teynham Parish Council

19/03/2026

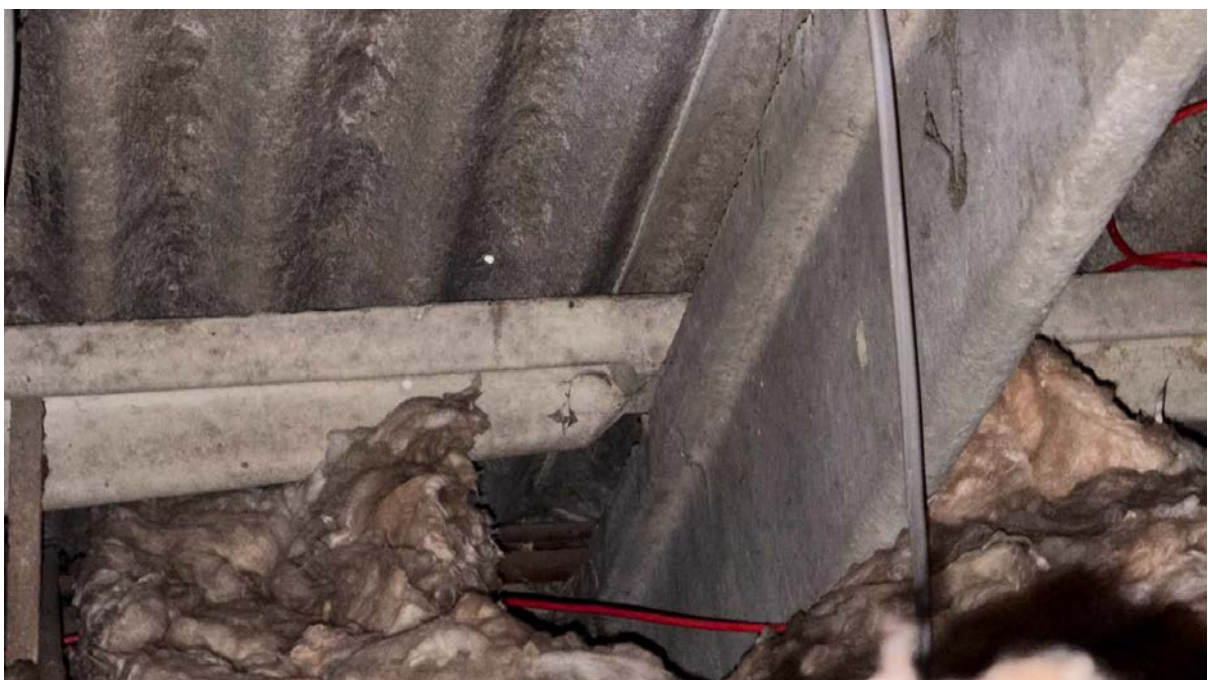
When inspecting the loft space where the heating system is stored, areas of daylight could be noted through the roof panels (facing out to the flat roof area). Some staining was noted across various ceiling tiles in the main hall suggesting past leaks.

Daylight through roof panels.

It is clear that over the coming few years, sections of patch repairs will be required where holes form in the asbestos panels. This can usually be overlay sections of GRP plates or metal sheets.

You should however be expecting to carry out full replacement of the main roof in the next 10 years due to expected further wear to fixings.

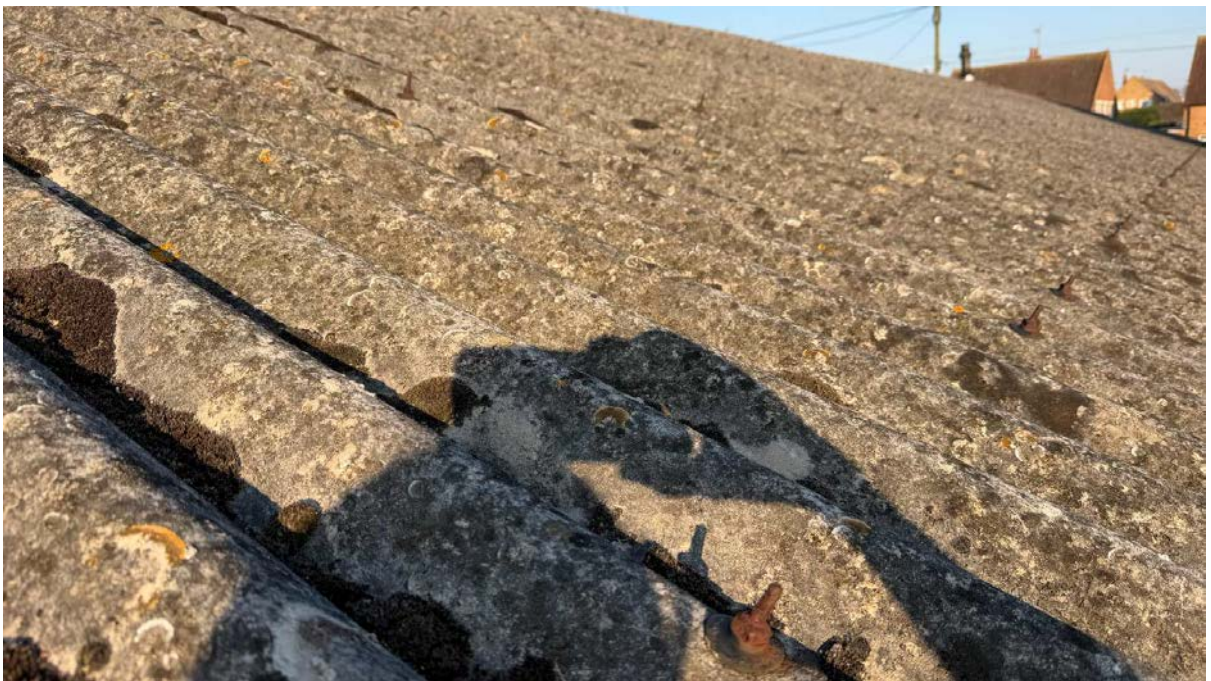
Daylight through roof panels.

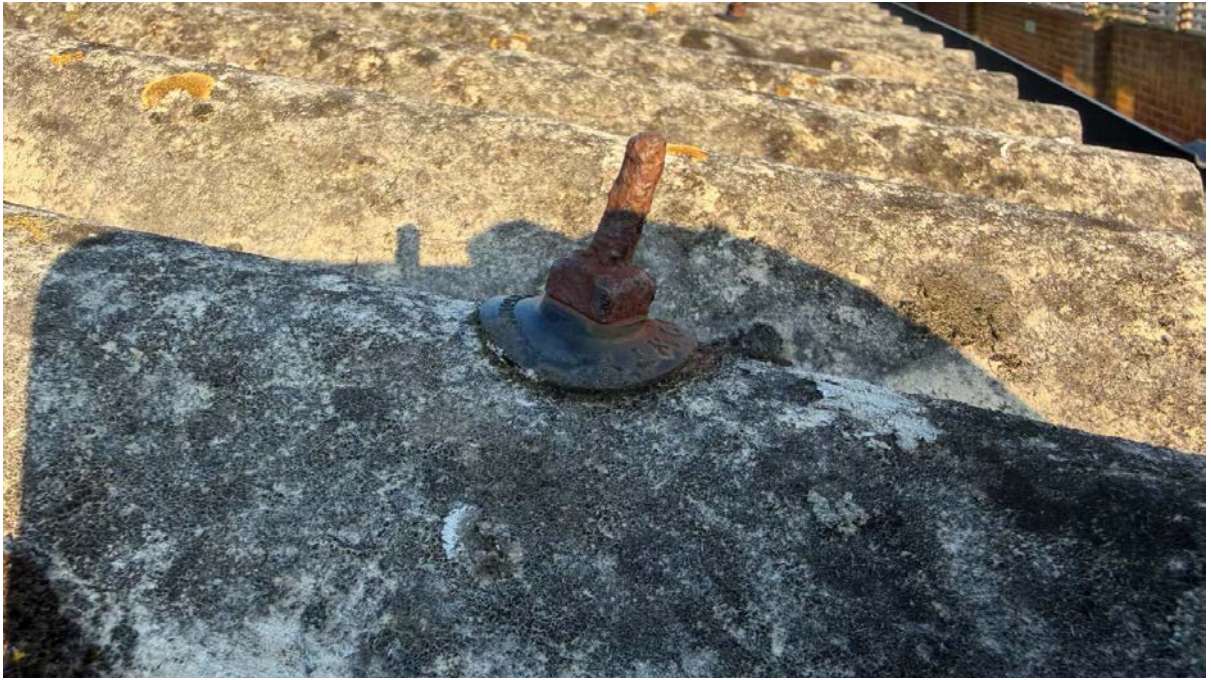
There were some areas between the main roof and flat roof surface where section of asbestos panels have dropped away from the main roof. There were some fixings noted to the roof panels which are very worn/rusted. This is usually the common place for water ingress to occur over time.

Worn fixings.

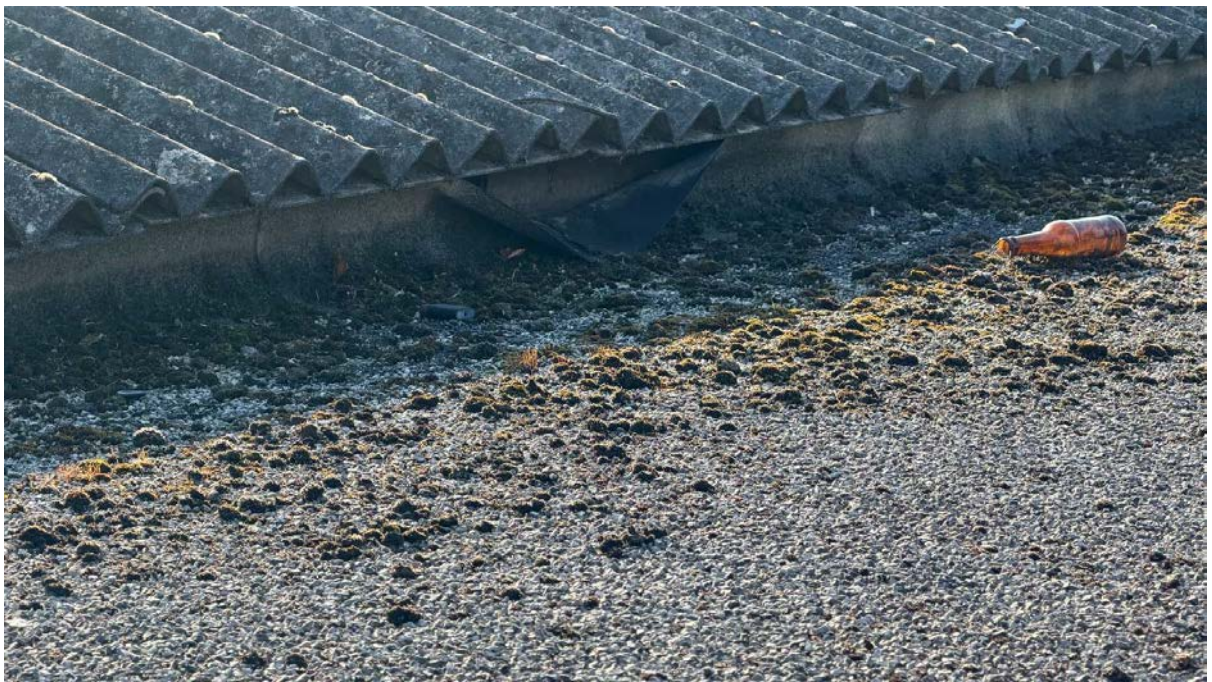
To the flat roof section, one area to the upstand was noted to have dropped (can be seen from the front of the building where the flat roof meets the asbestos panels). This will likely be causing water ingress issues and should be pushed back into place, bonded and sealed. This should be carried out ideally before the next winter period, but as soon as possible if recommended. Other than this area, the overall condition of the roof felt looked to be in good condition and should last for the next 15 years or so.

Area of slipped roof felt.

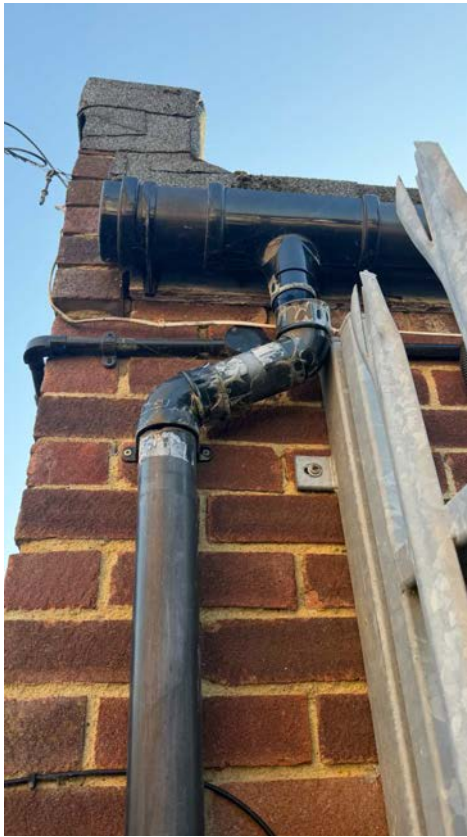
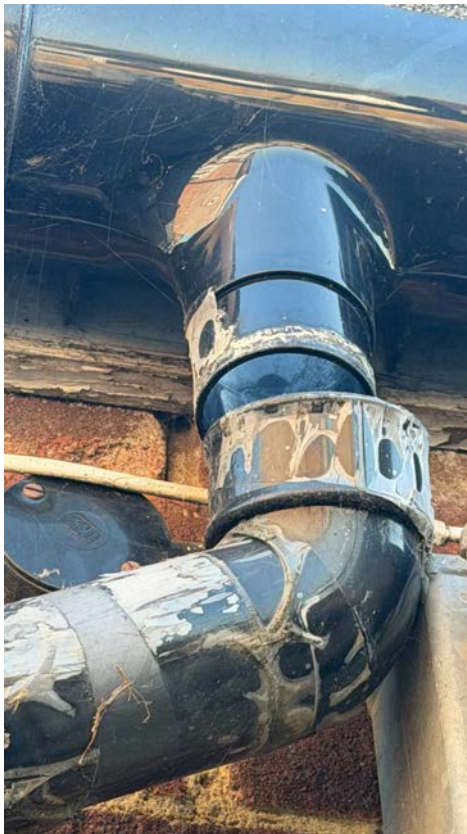
The property has PVC gutters and downpipes installed. No loose or missing areas of guttering were noted overall. There is an area to the front of the property where a downpipe has disconnected from the gutter outlet. This should be fixed back in place and supported so it does not drop again.

Dropped downpipe.

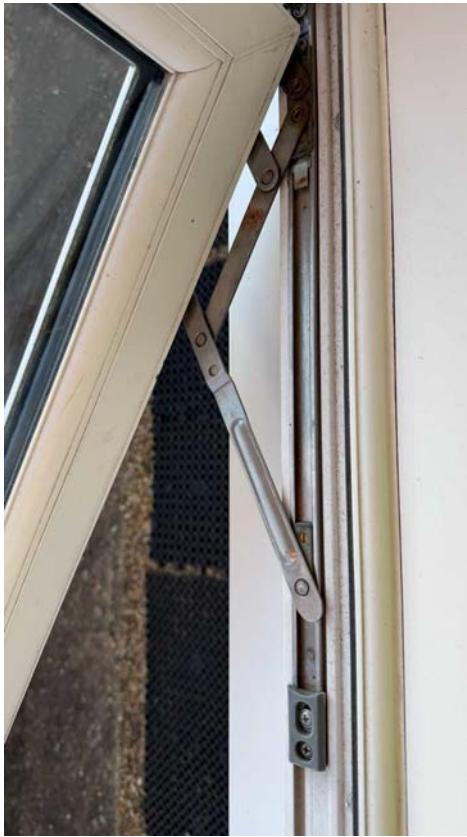
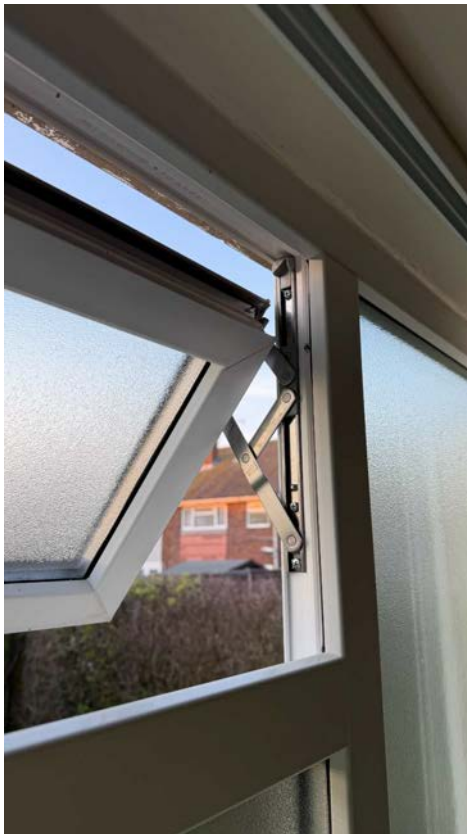
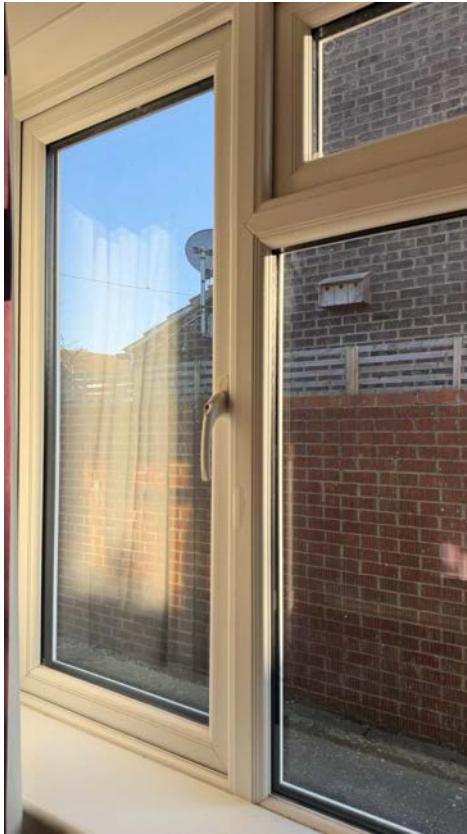
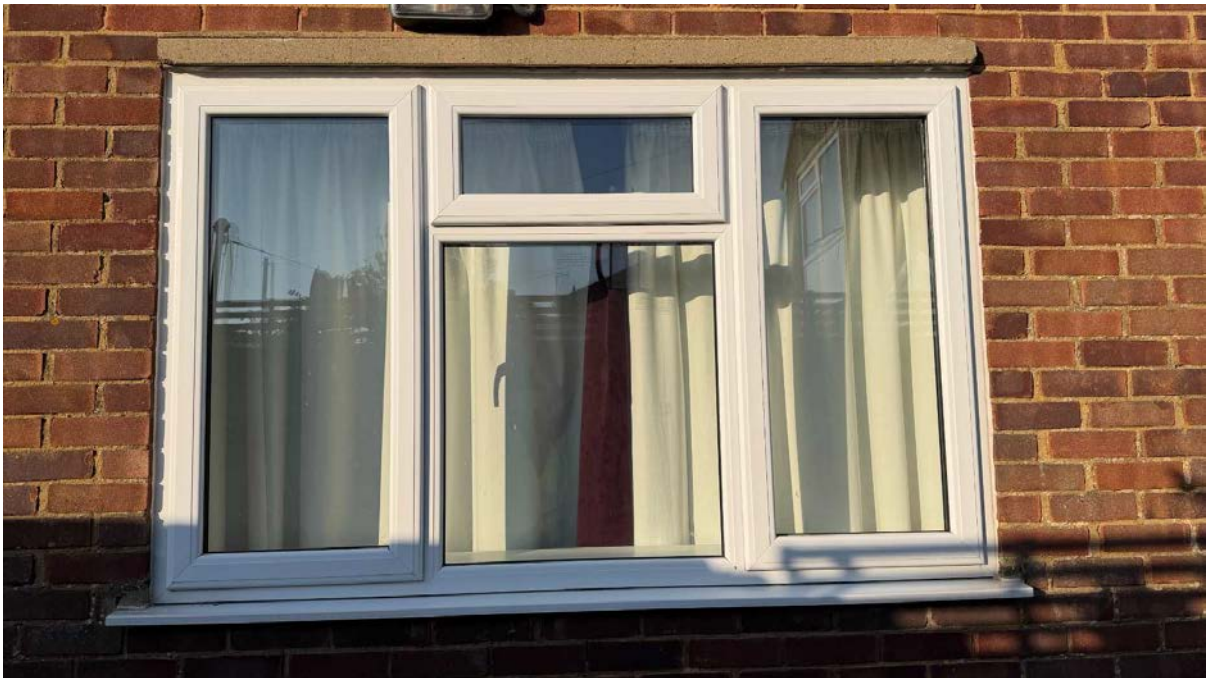
D5 Windows

Unfortunately, it does appear the window lintels have been installed incorrectly. It is usually expected for lintels to span past the window opening on each side of at least 150mm. The lintels appear to be resting on top of the window frames. So far, this does not appear to have caused any structural issues as the windows were still opening and no dropped brickwork or concerning cracks were noted.

The UPVC windows have a lifespan of around 15-25 years. When new windows are installed, new lintels should be installed which will of course increase the cost of the future works. I would recommend that the lintels and brickwork be monitored over the coming years. If concerning cracks or bowing start to appear, then the lintel would have failed and you could have them replaced as and when this occurs. Glass cracking would also point towards lintel failure as the increased load will cause stress on the glass.

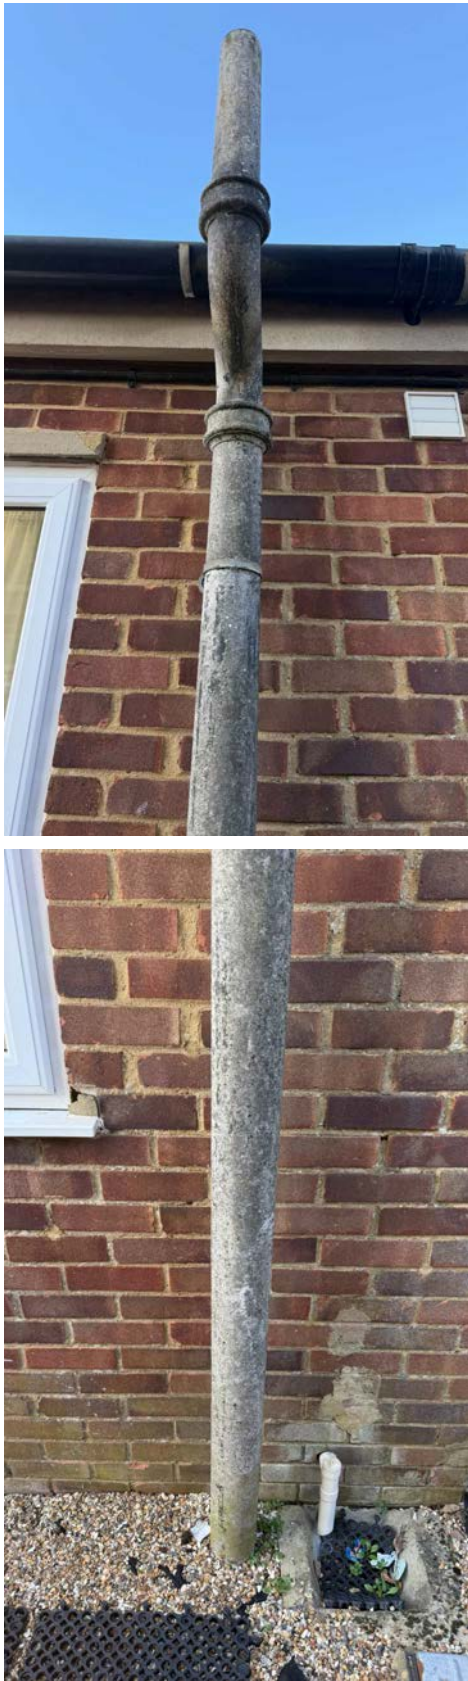
There is an asbestos soil pipe at the side of the property. Providing this remains undisturbed and not damaged, then this will not present any health risks.

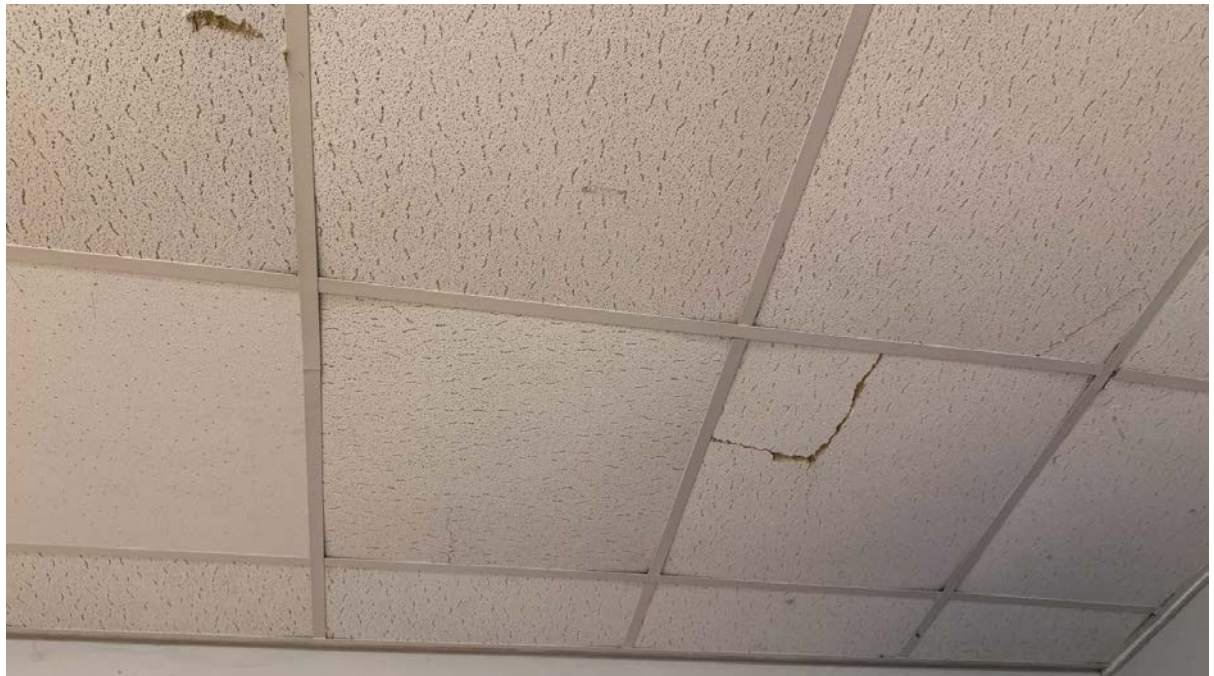
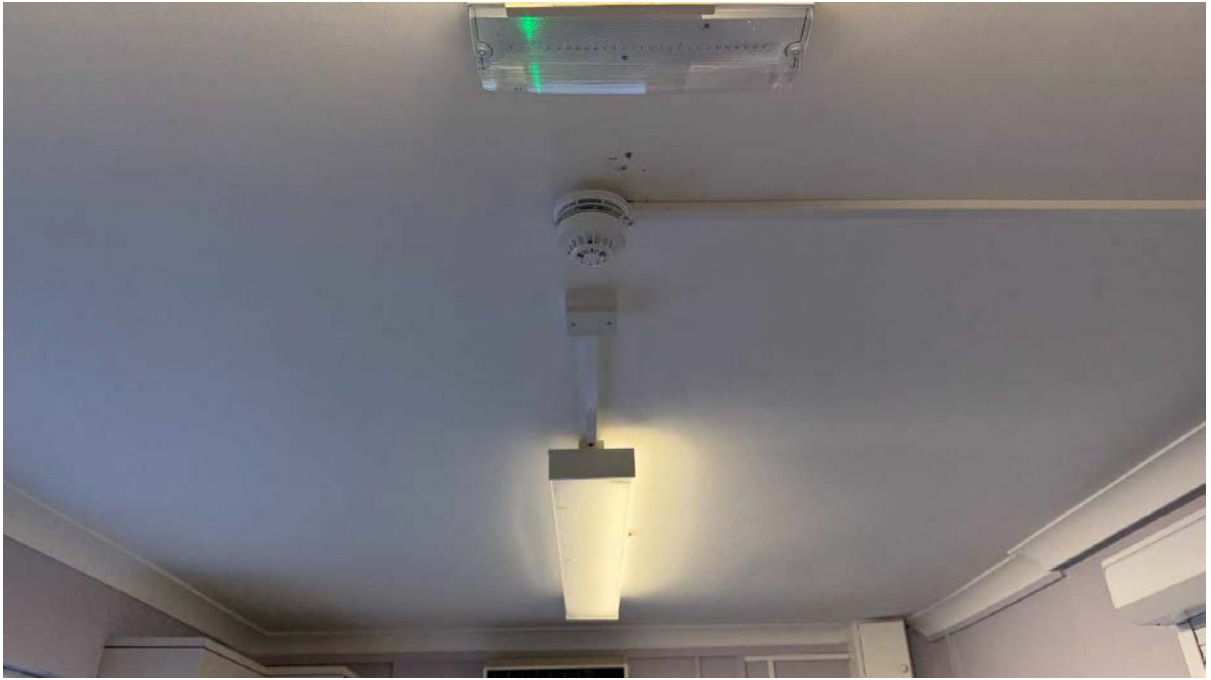
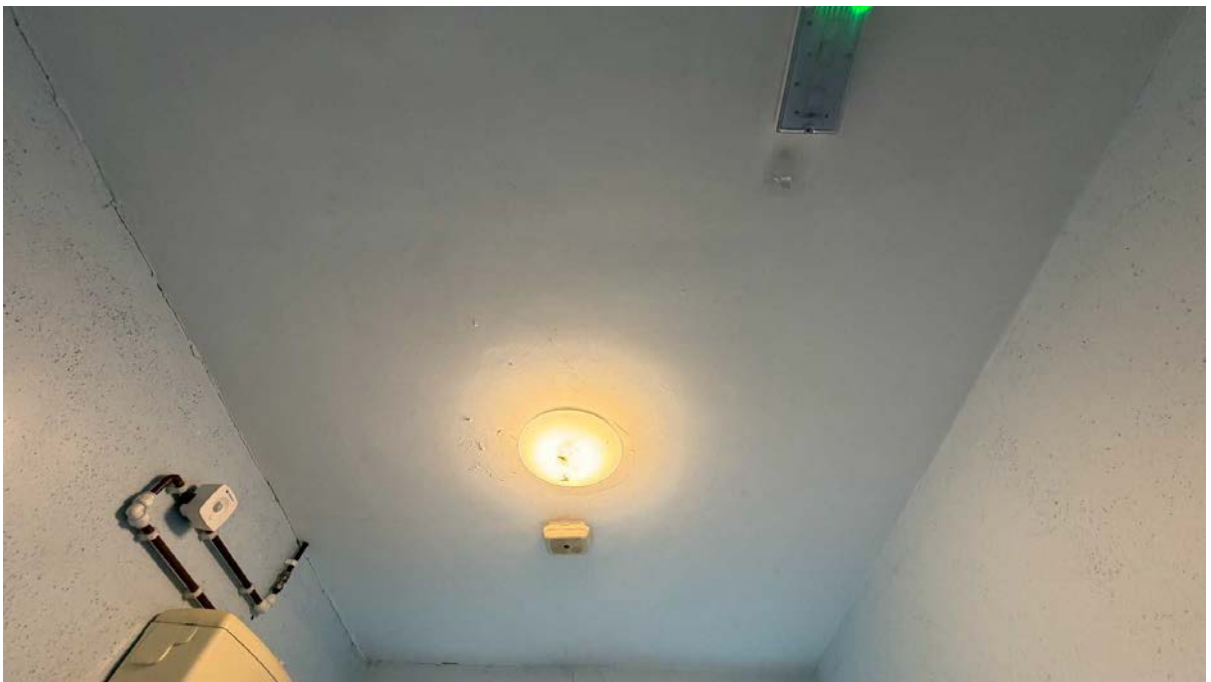
Through the main hall, there are ceiling tiles installed. A number of damaged tiles were found as well as some stained from past water leaks. In the next few years, there will be various tiles requiring replacement.

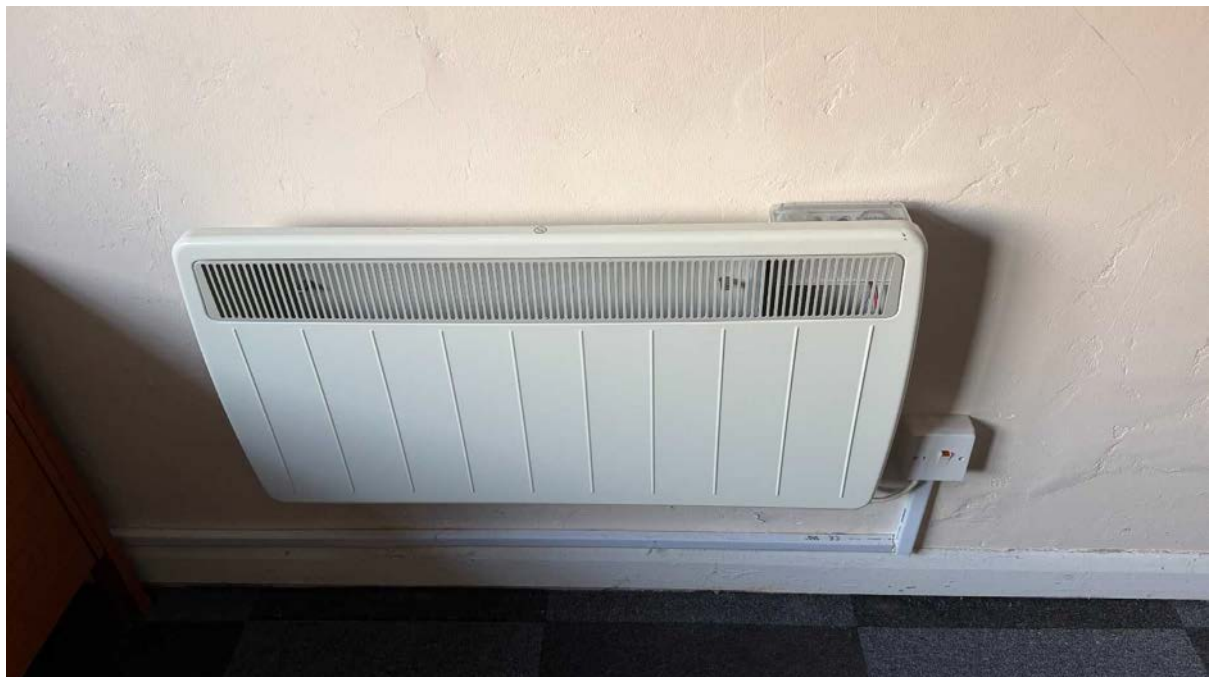
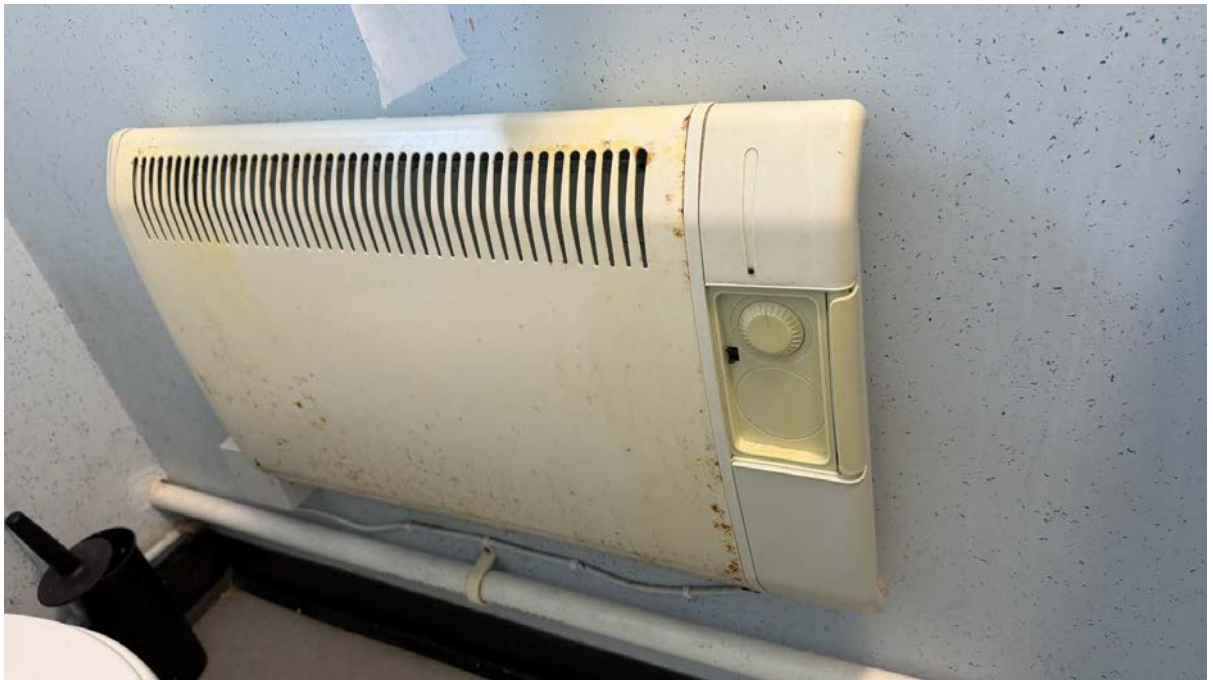
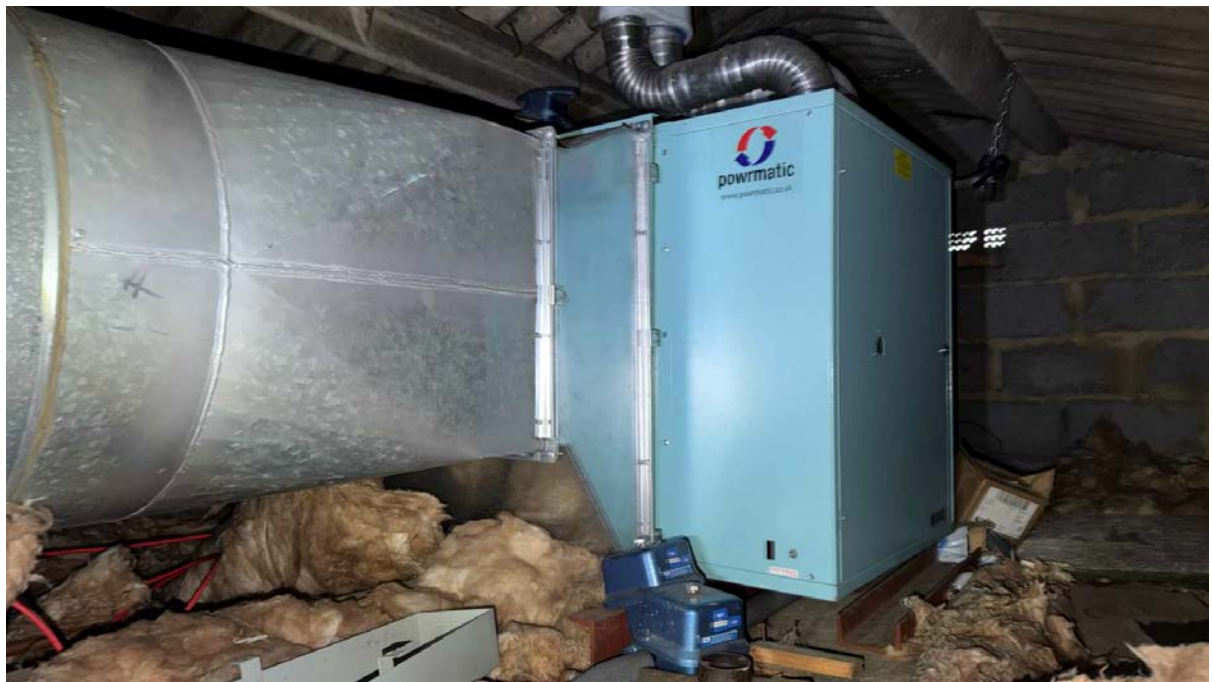
Heating to the property is provided by a Powrmatic warm-air unit located within the roof void. It is understood to currently not be operating due to considerations being given to replacement.

There are also electric wall heaters installed to bathrooms and the rear office area. The bathroom heaters were noted to be very old
