Your survey report

Teynham Community Hall, 89 Station Road,
Teynham, Kent, United Kingdom, ME9 9DU

Teynham Parish Council

19/03/2026

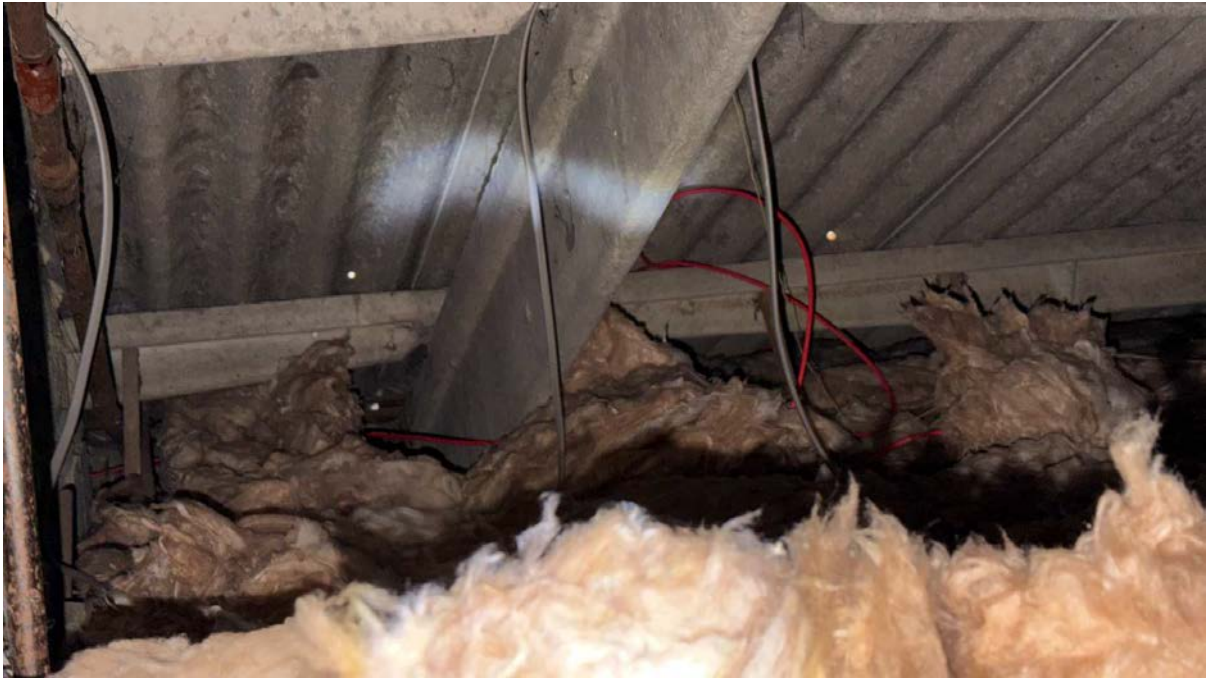
Daylight through roof panels.

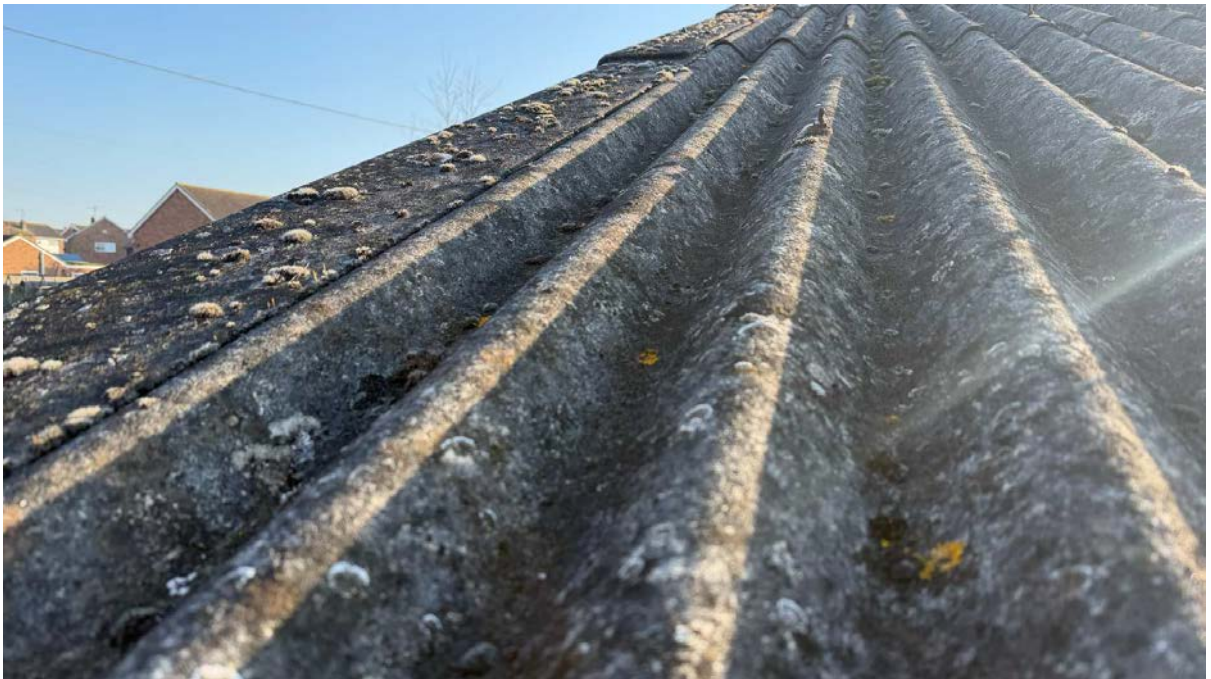
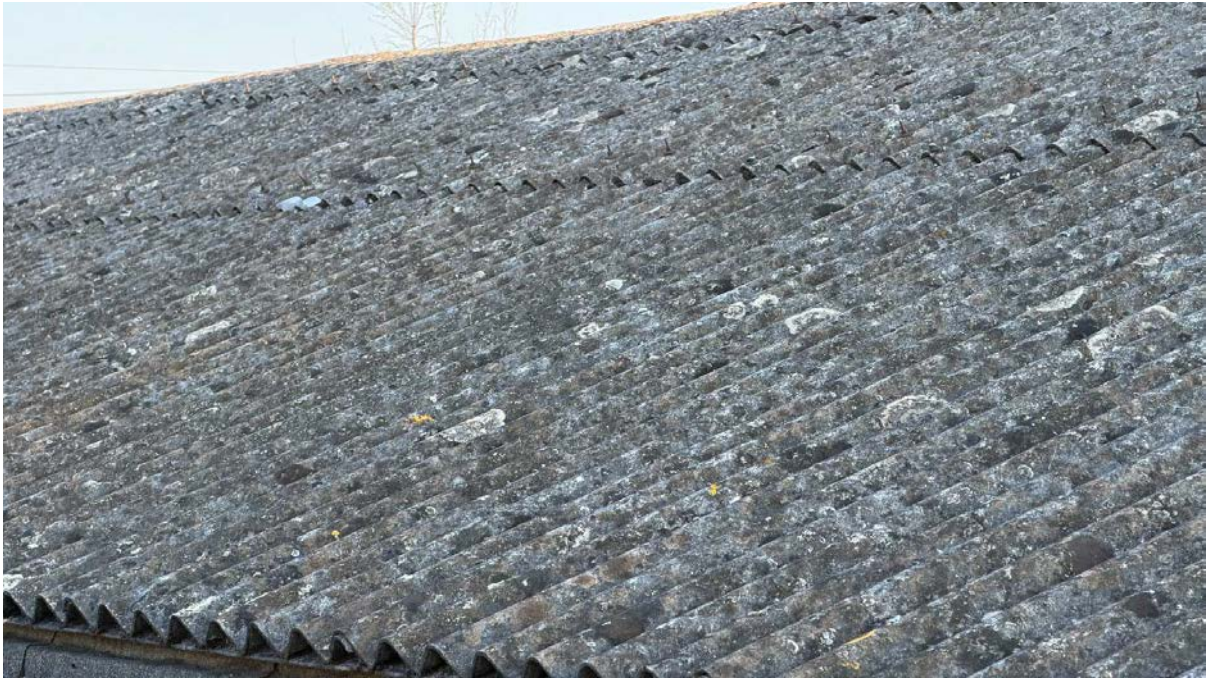
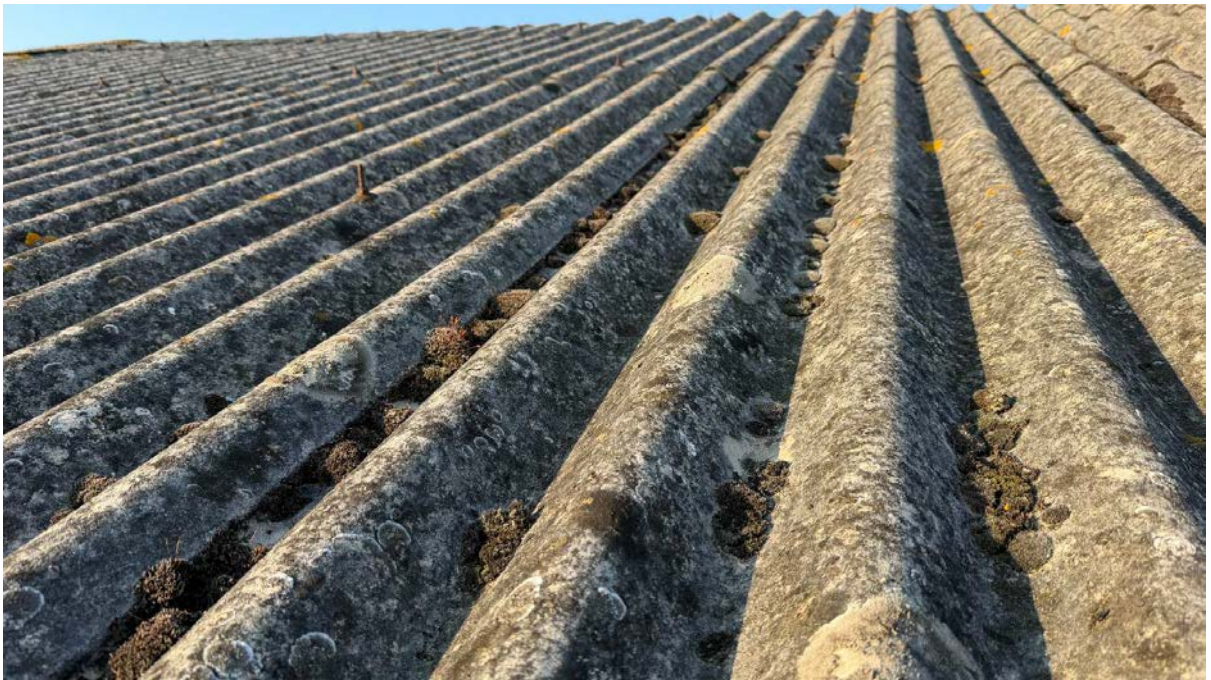
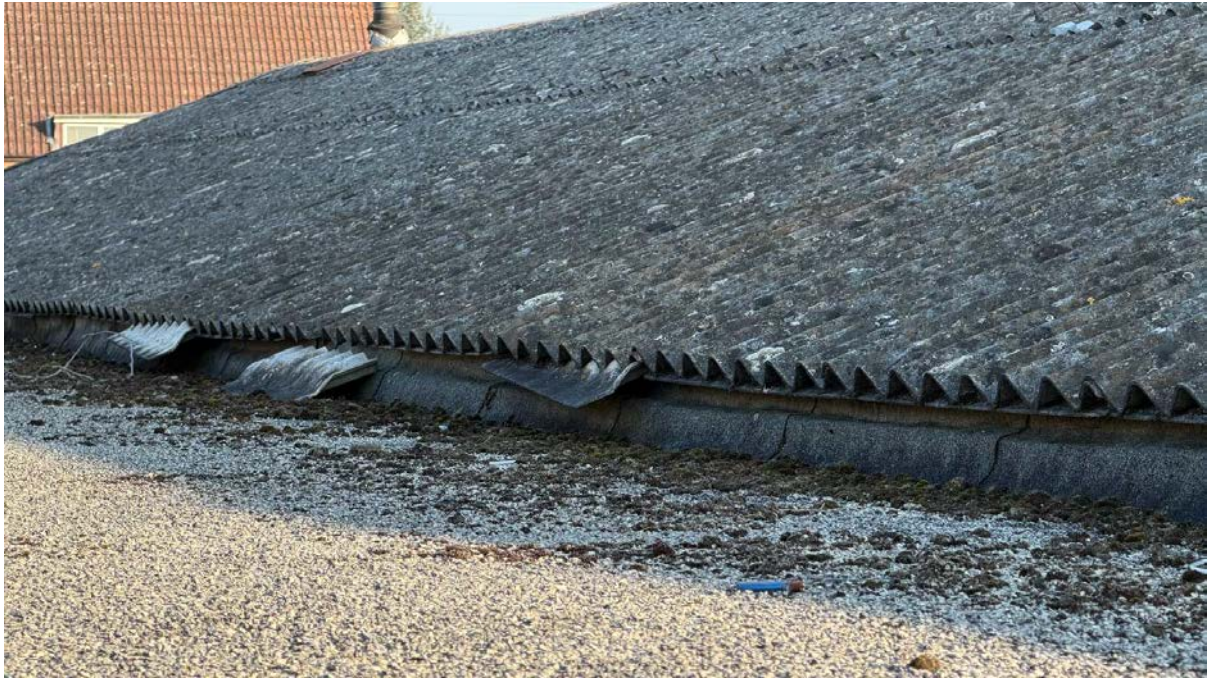
Worn fixings.

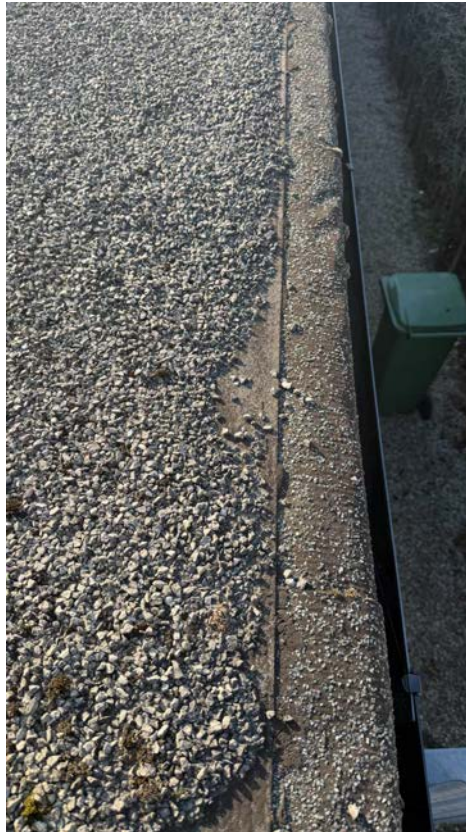
Area of slipped roof felt.

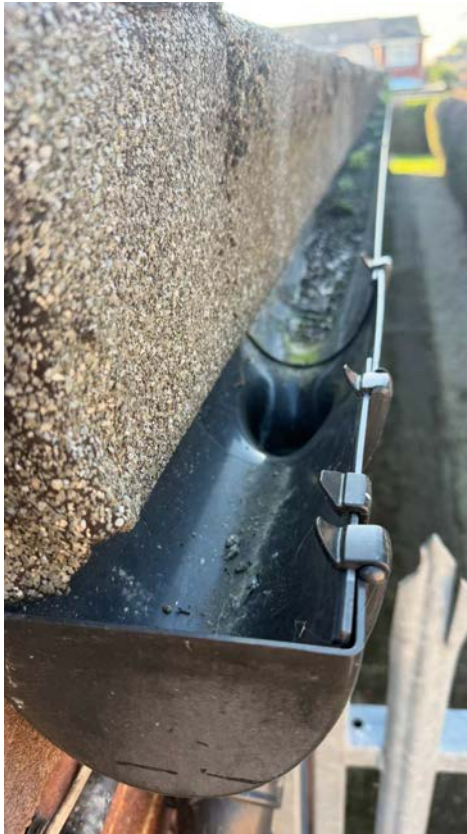
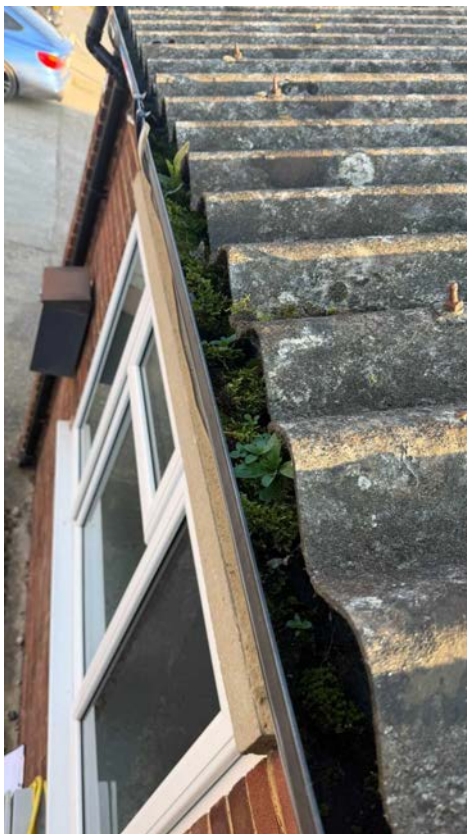
Dropped downpipe.

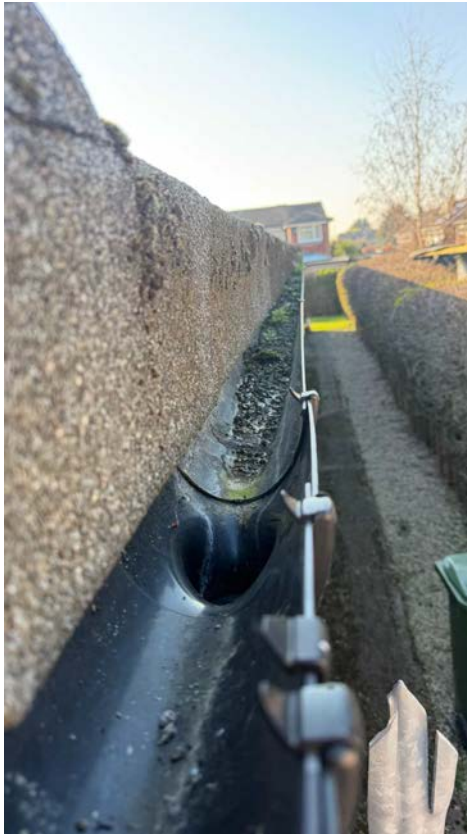
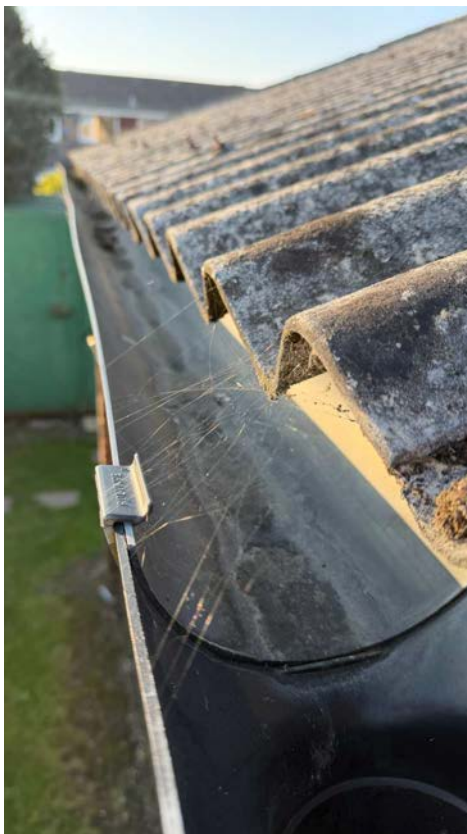
Blocked gutters.

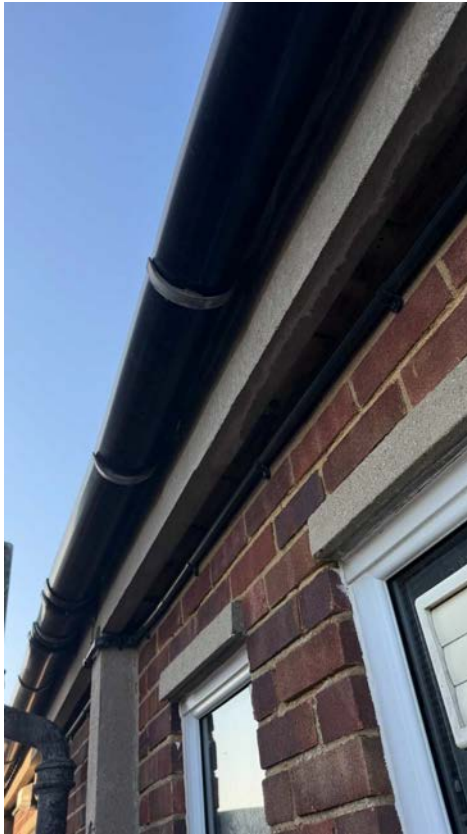
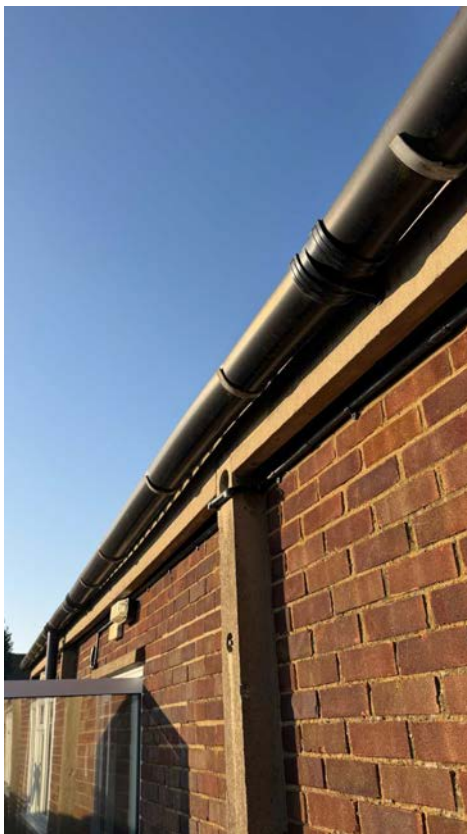
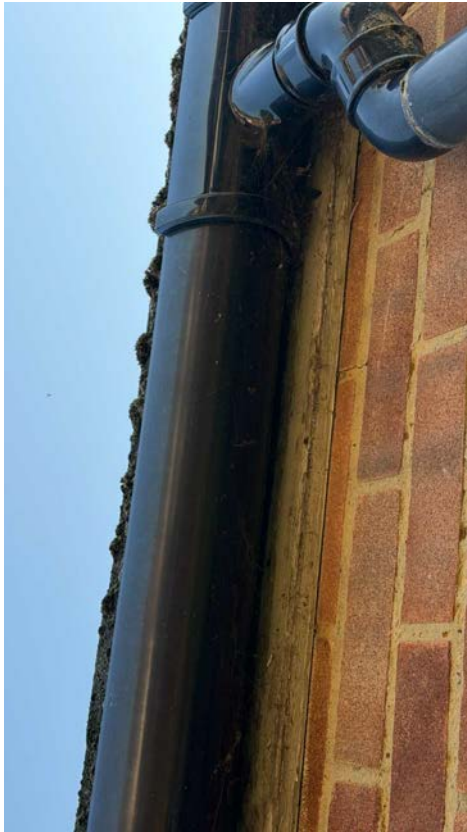
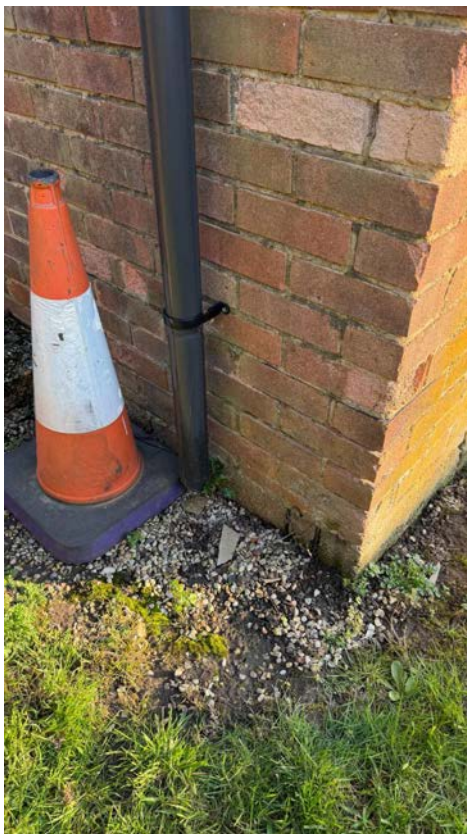
Element no.	Element name	Comments (if applicable)
D3	Rainwater pipes and gutters	Downpipe disconnected from gutter, will cause water overflows onto brickwork. Blockages noted.

Downpipe exit out onto earth around main walls.

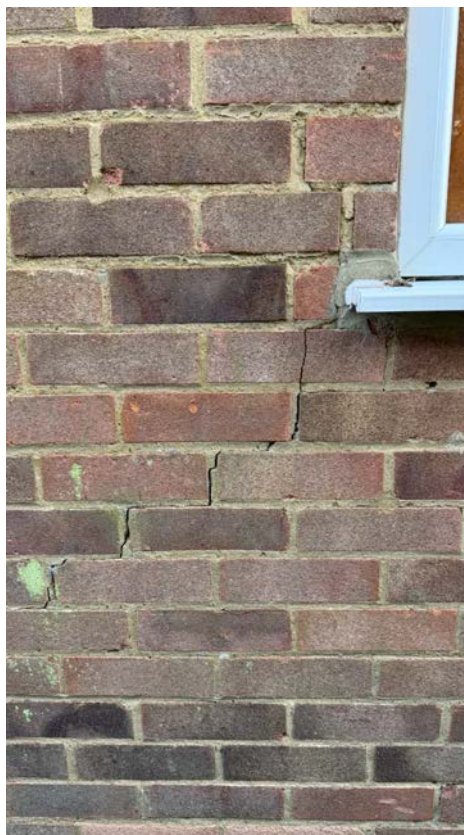
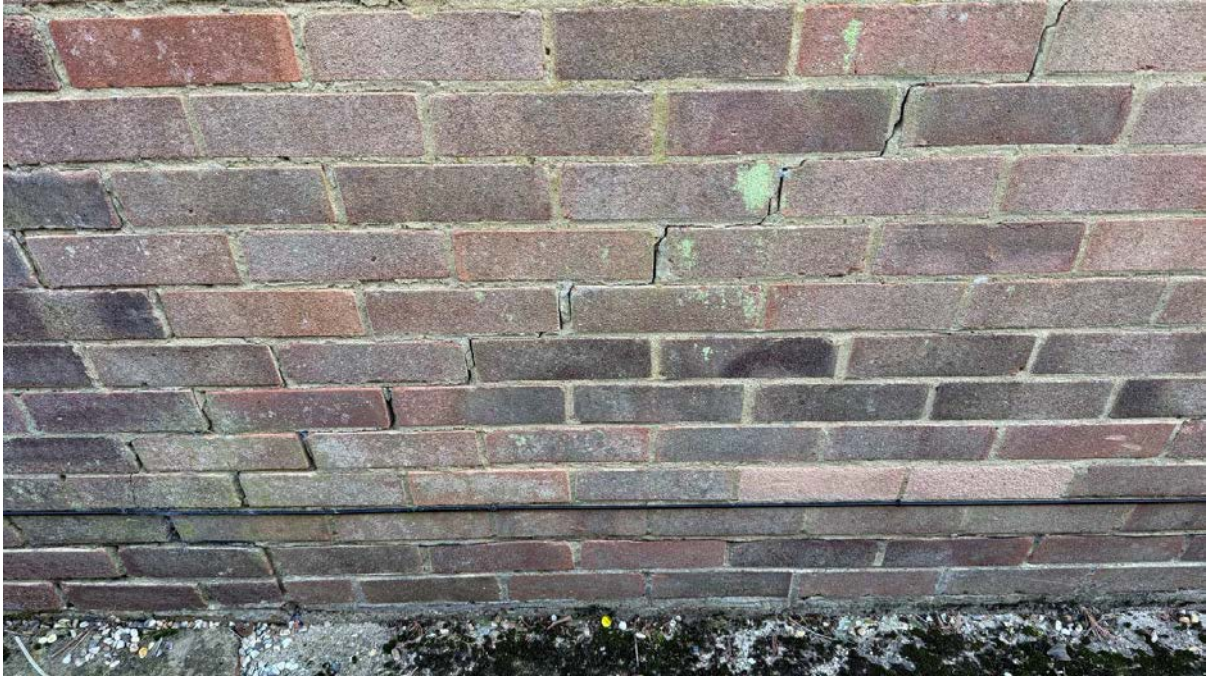
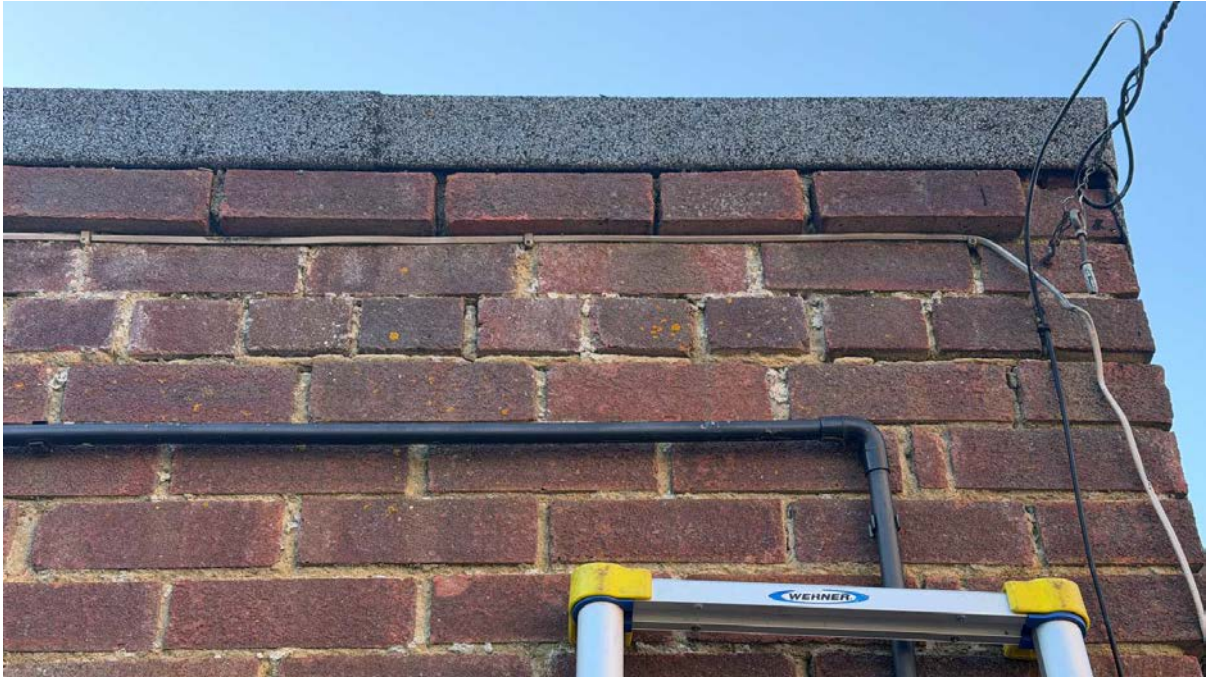
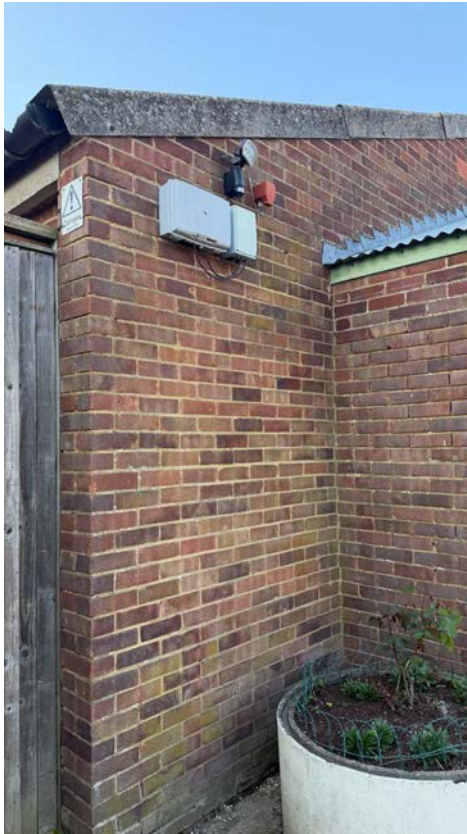
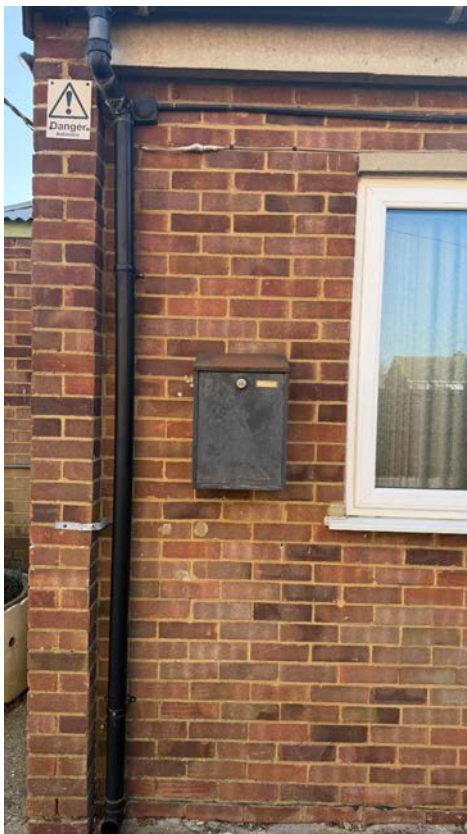
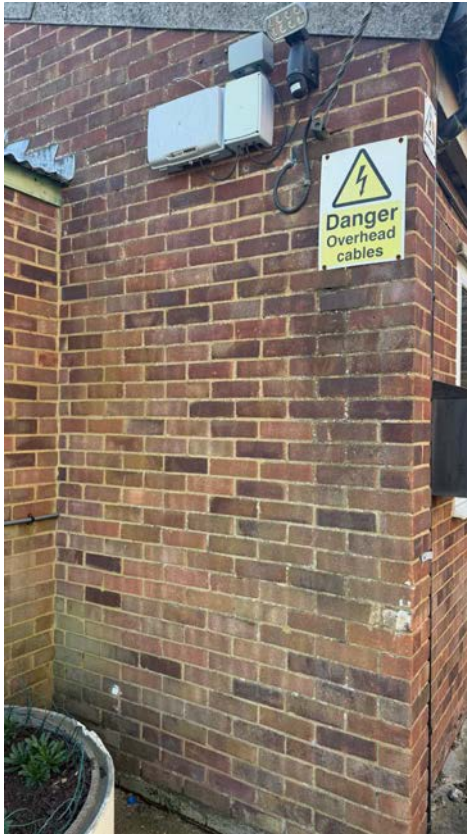
D4 Main walls

The external walls were inspected for any major recent structural cracking of which no issues of this nature were noted. To the right side of the property, near a store room window, there was some step cracking from a window sill down to ground level. This did not appear to be recent and has not opened up more than 5mm. It is recommended that the cracking be monitored over the next few years to ensure no further movement occurs. If this does happen, further investigation will be required.

There are some small areas of localised repointing likely to be required in the next few years as some weathering was noted. These were above the front/side door (below where the flat roof is located). An area near the lintel should also be repointing to stop any issues with moisture ingress.

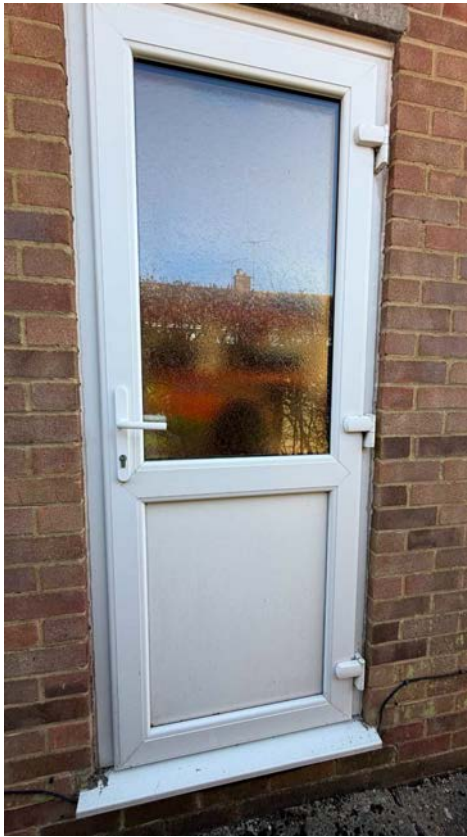
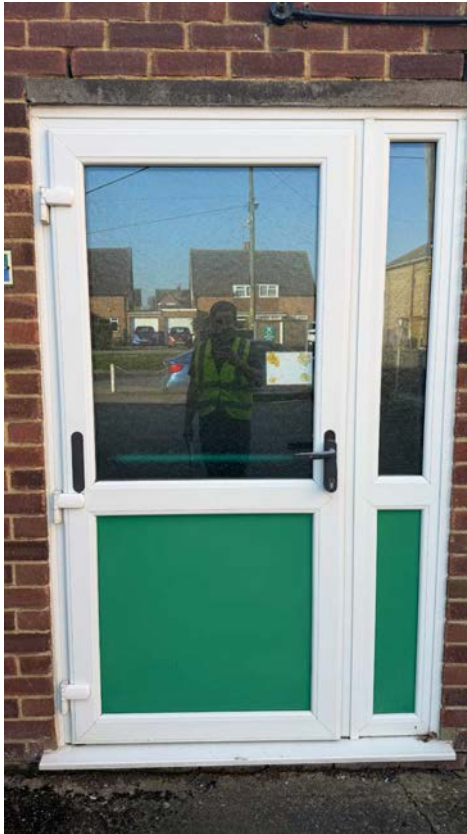
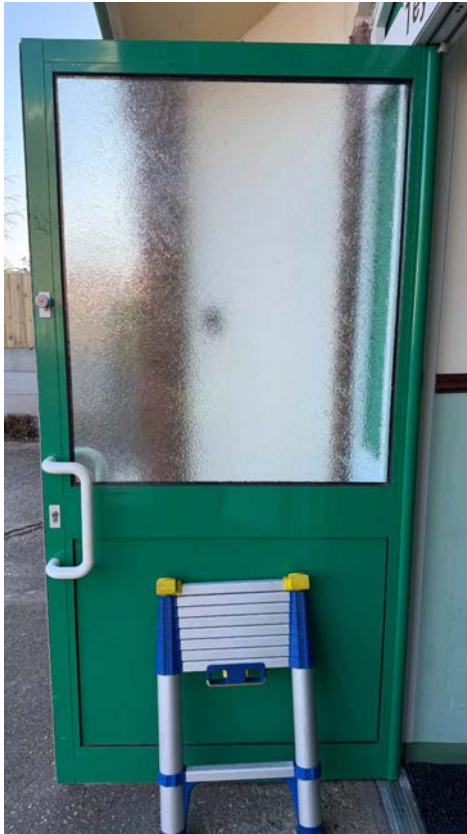
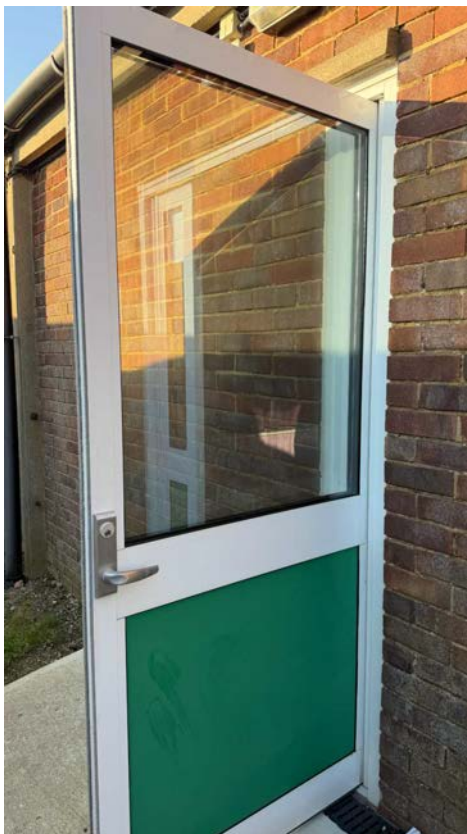
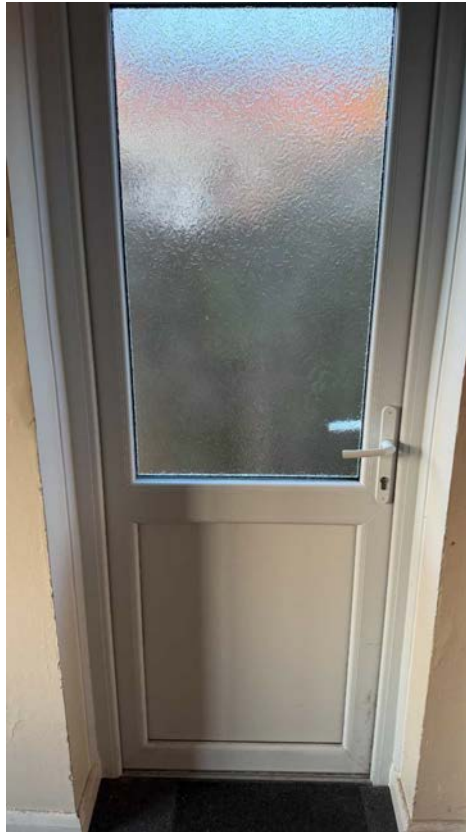
D6 Outside doors (including patio doors)

The property has four external doors; two doors to the front and two side doors. Each door was accessible and found to be operating properly. The surfaces were generally in good condition, (increased expected wear to the main front door due to high usage). Overall, no replacement doors will be required, for at least the next 10 years.

Please note the comments on the lintels to the windows will also apply to the doors as the same issues were found (although less likely due to the narrower width of door openings compared to window openings).

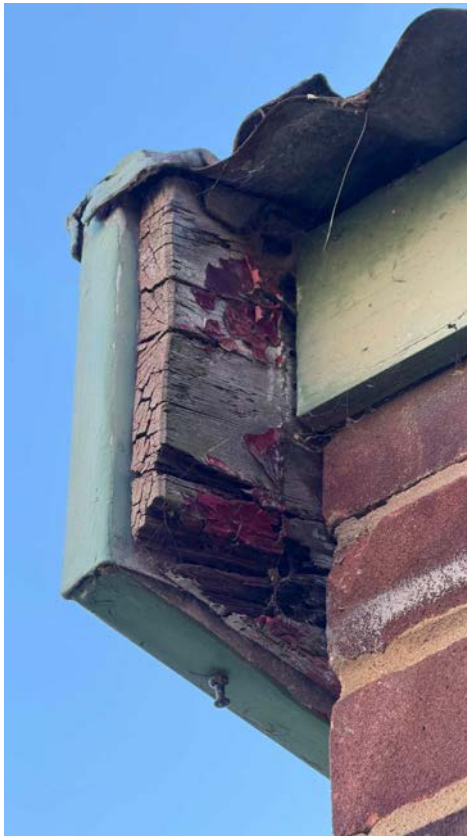
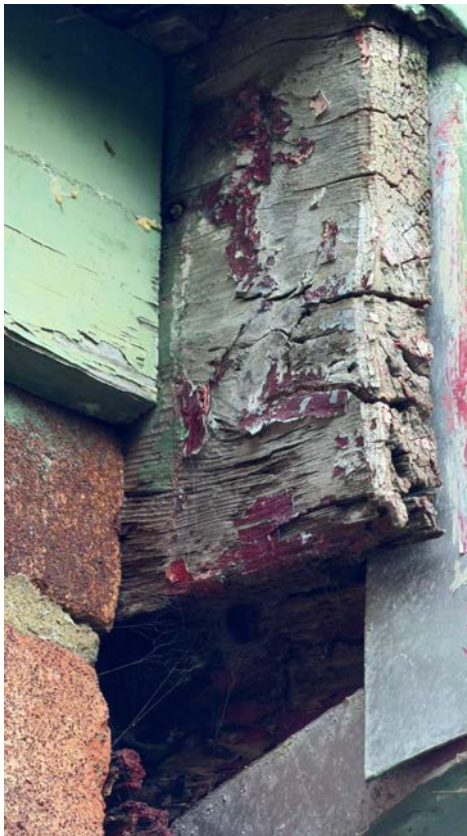
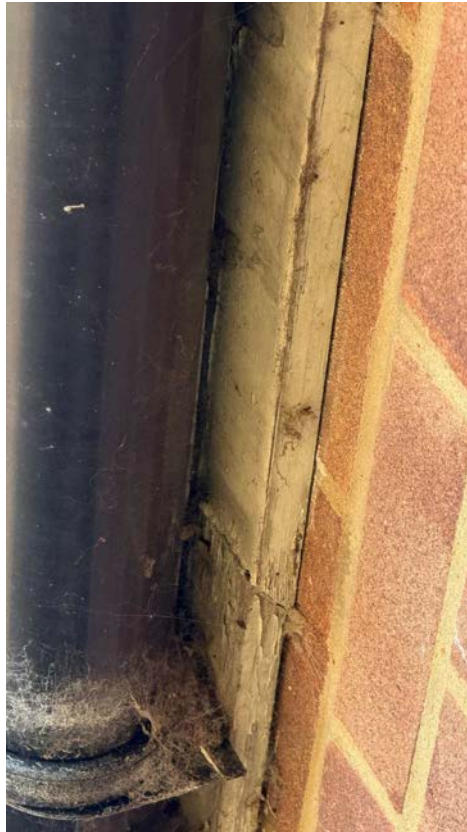
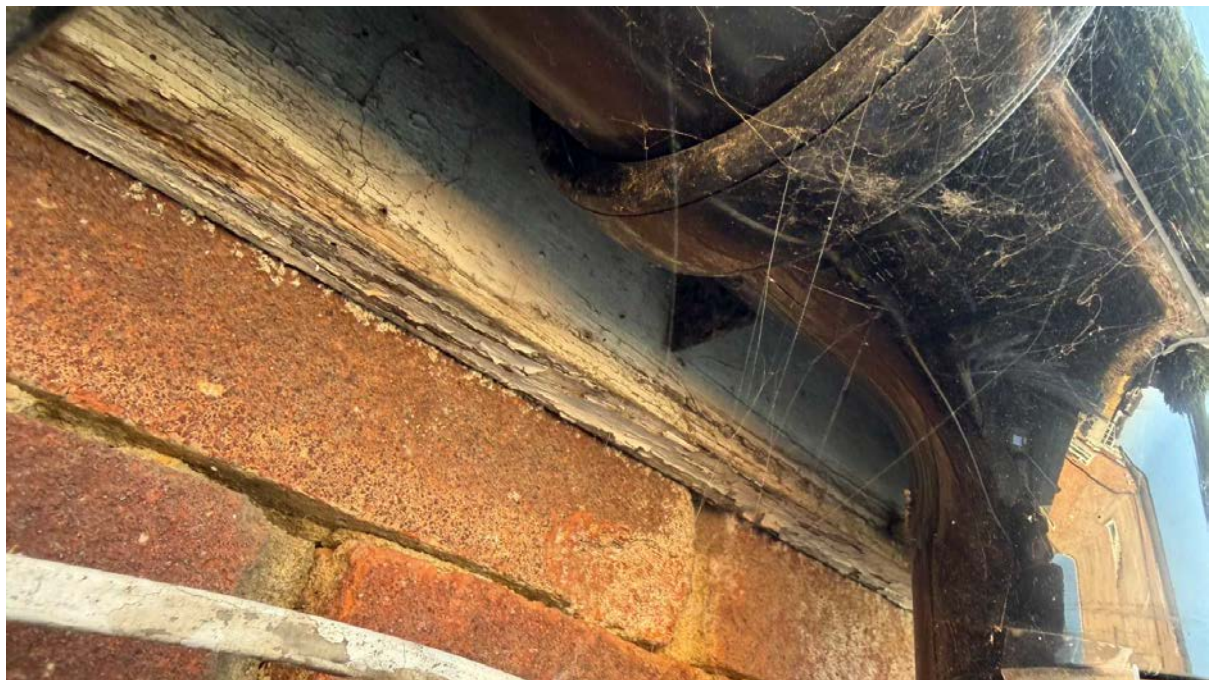
The property has timber fascia boards behind the main guttering to the main building, and then also some original timber boards are still in place behind the entrance roof panelling. The fascia's to the main building were weathered and worn. These will likely require sanding and redecoration in the next few years.

The boarding behind the entrance roof panels will likely fail in the next 5 years or so leading to loosening fixings to the surfaces. If this occurs, then the roof coverings would need removing so that the original timber areas can be replaced.

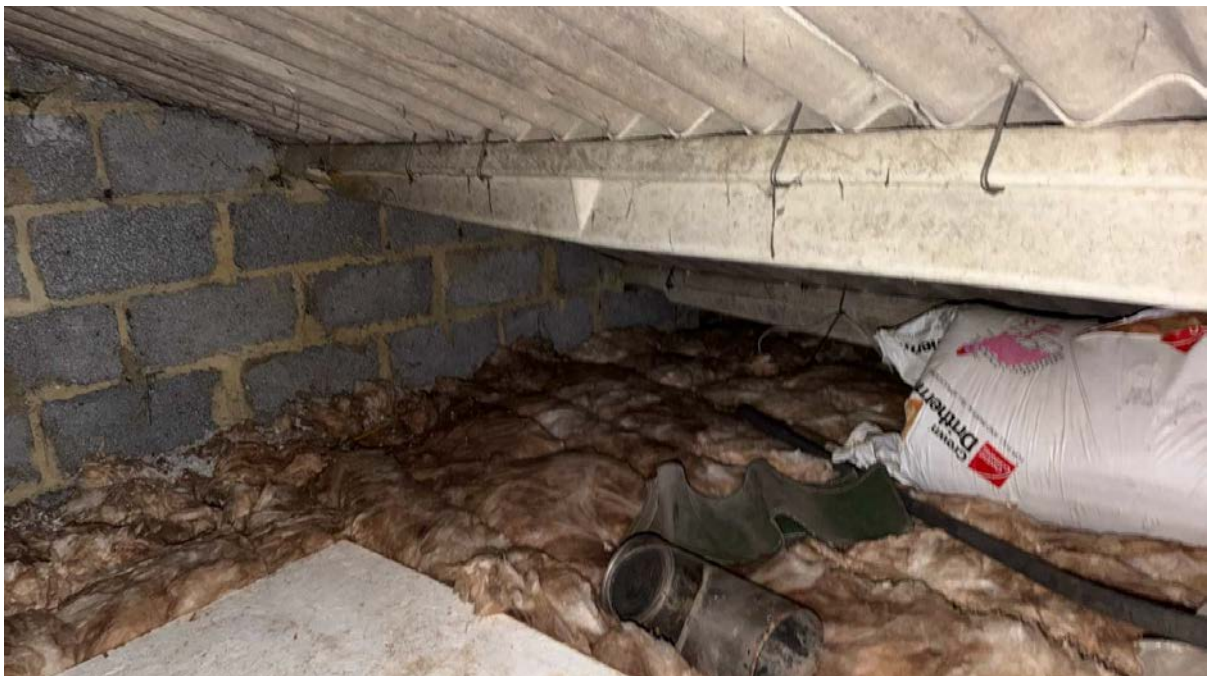
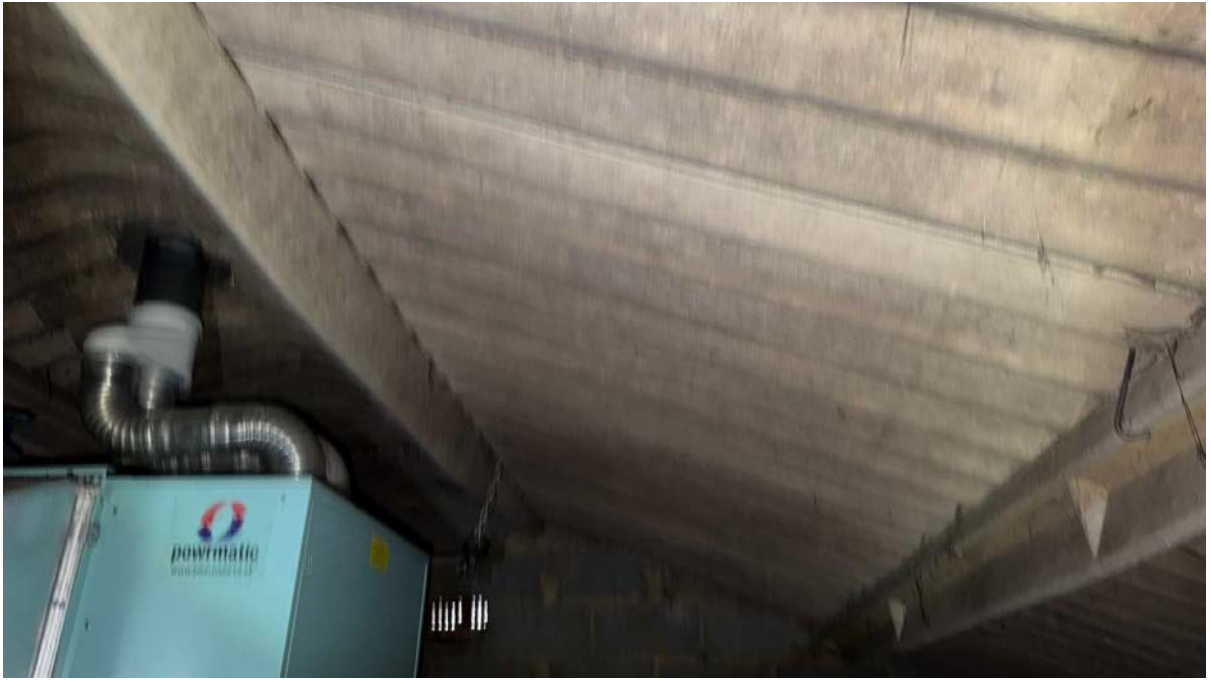
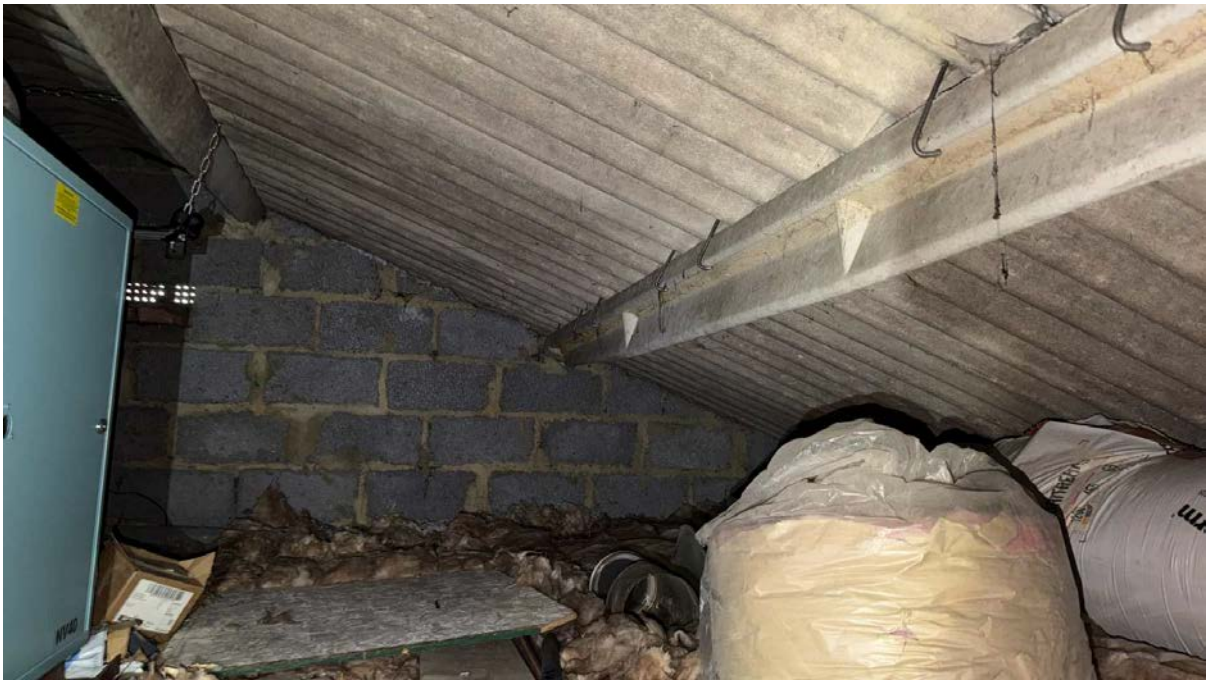
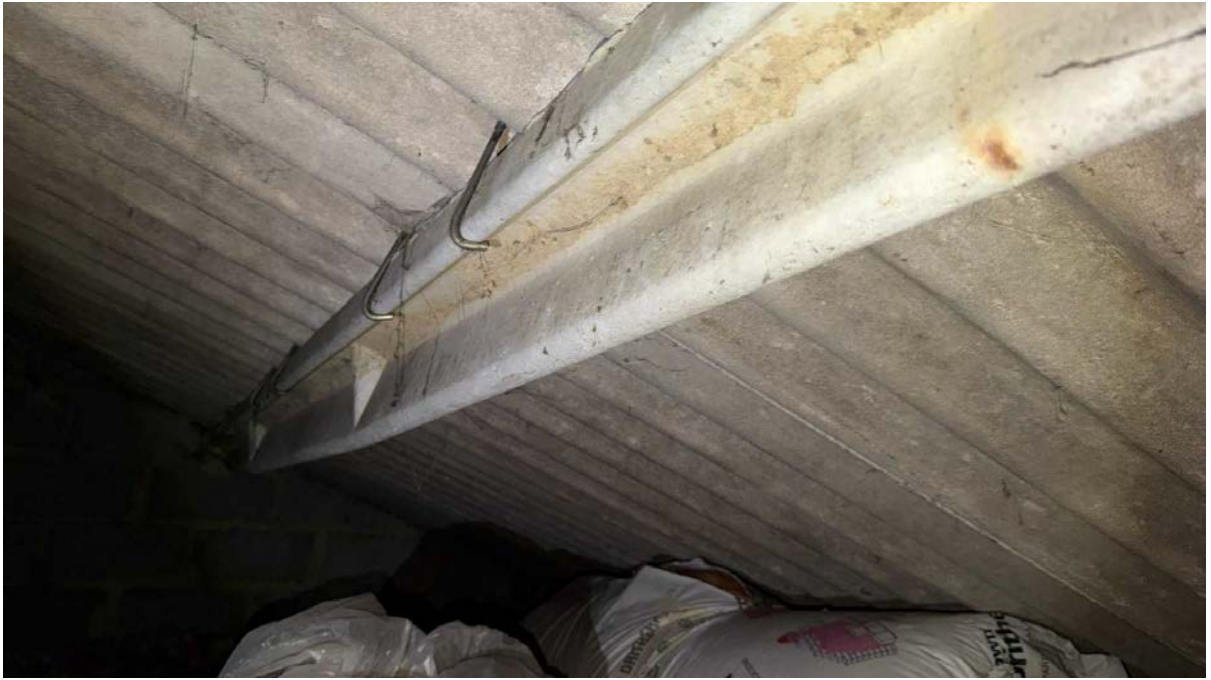
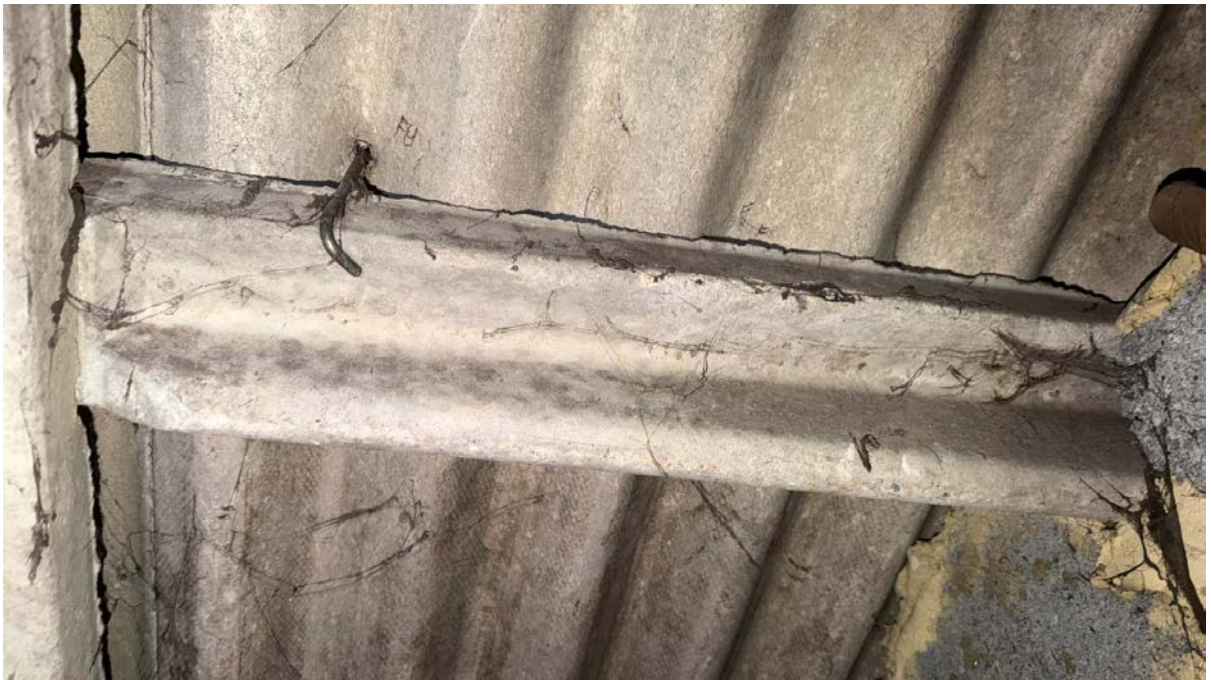
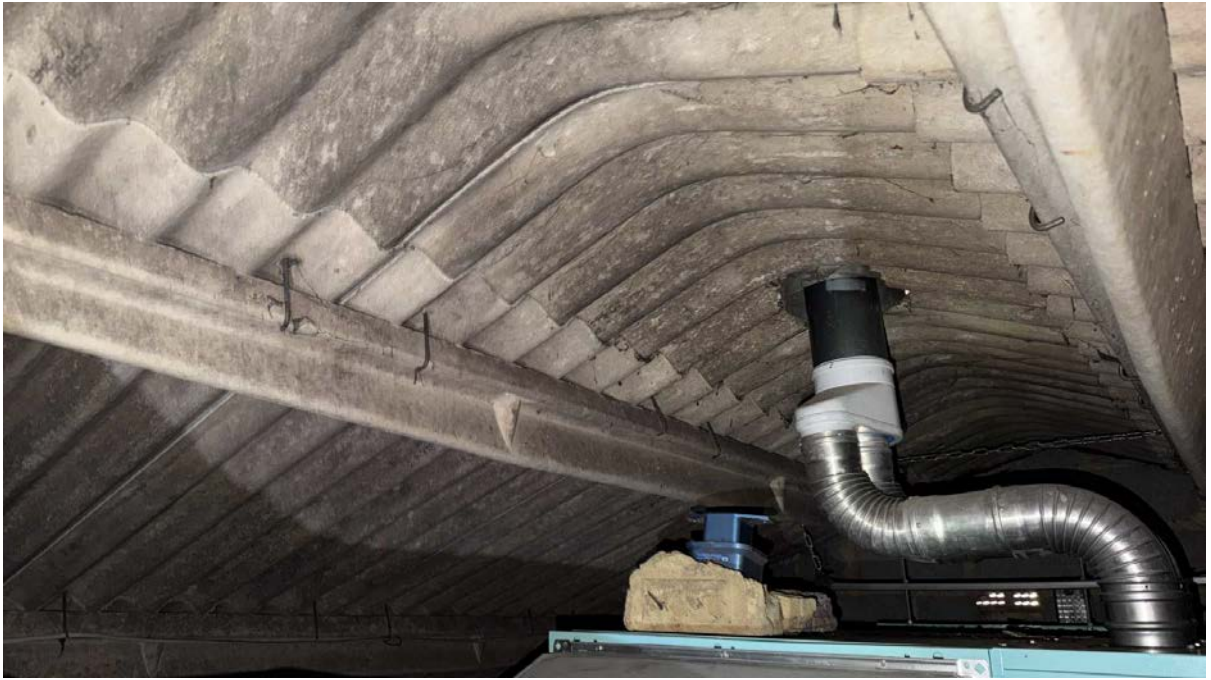
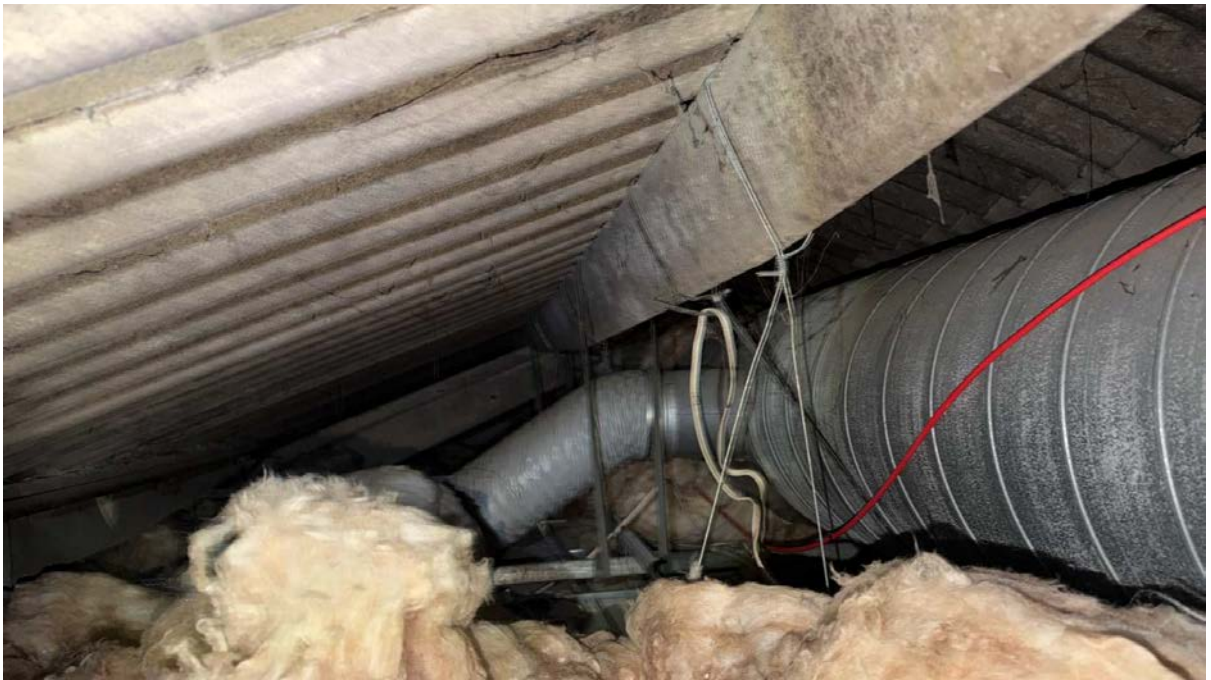
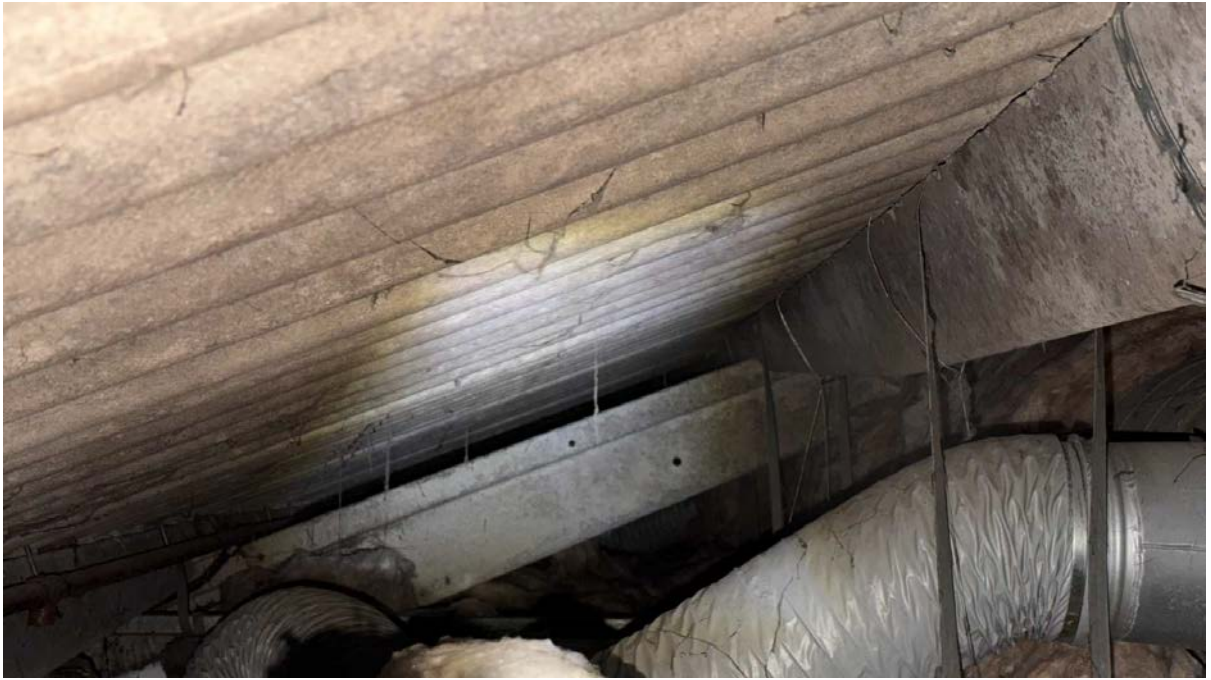
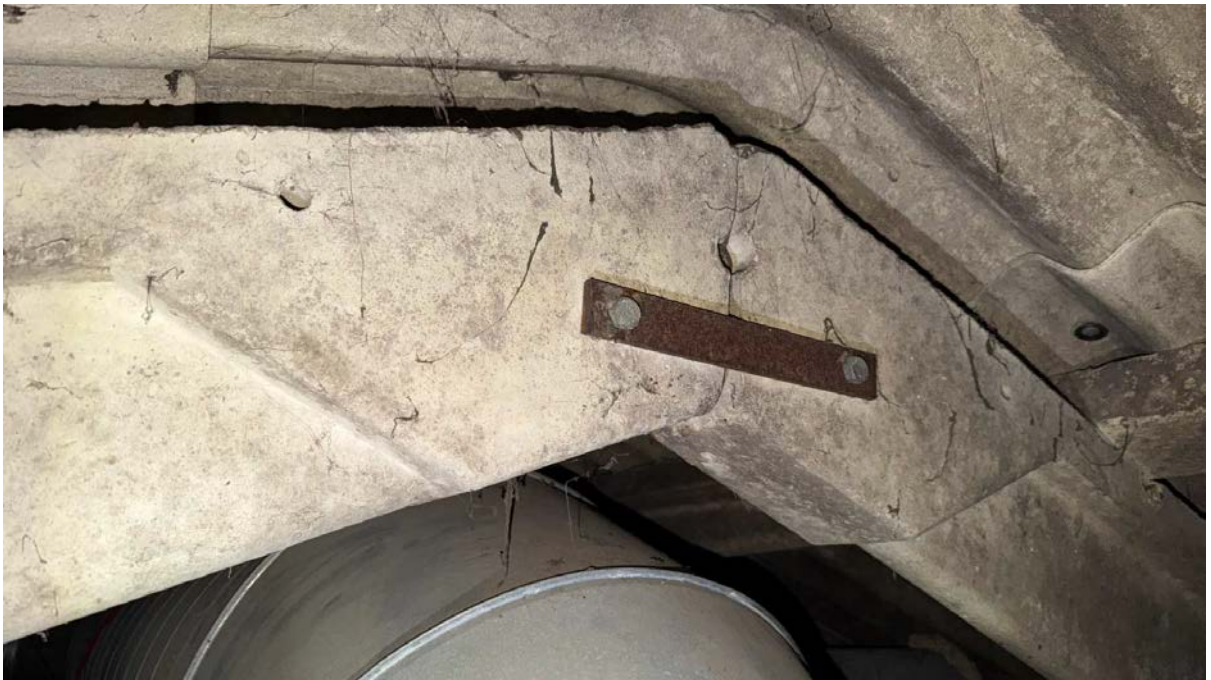
The property has an accessible loft space through the disabled bathroom. There is a ladder installed for access. This does present a small percentage of the roof structure as the main hall ceiling tiles can not be easily lifted and removed due to insulation laying on the top of them.

To the accessible roof space area, no concerning cracking was noted to the brickwork on the gable end. No cracking or damage was noted to the roof supports. Comments have already been made on some damage noted to the asbestos roof panels where daylight could be noted so have not been raised again in this section.
