Your survey report

Teynham Community Hall, 89 Station Road,
Teynham, Kent, United Kingdom, ME9 9DU

Teynham Parish Council

19/03/2026

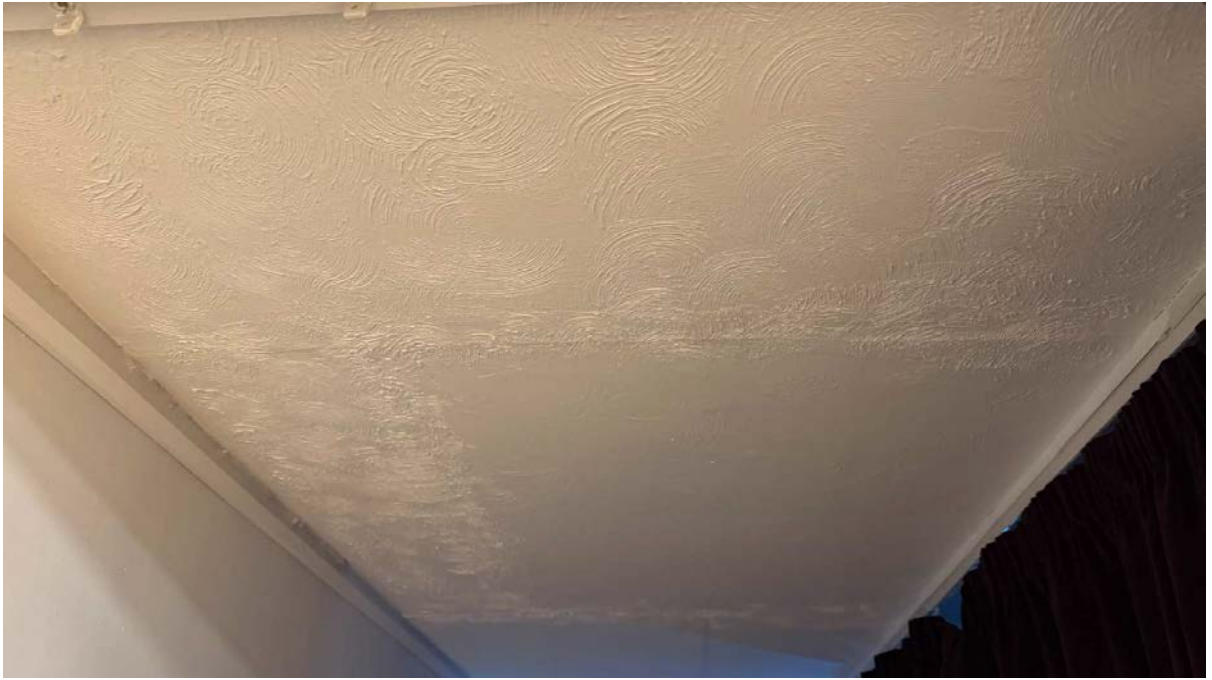
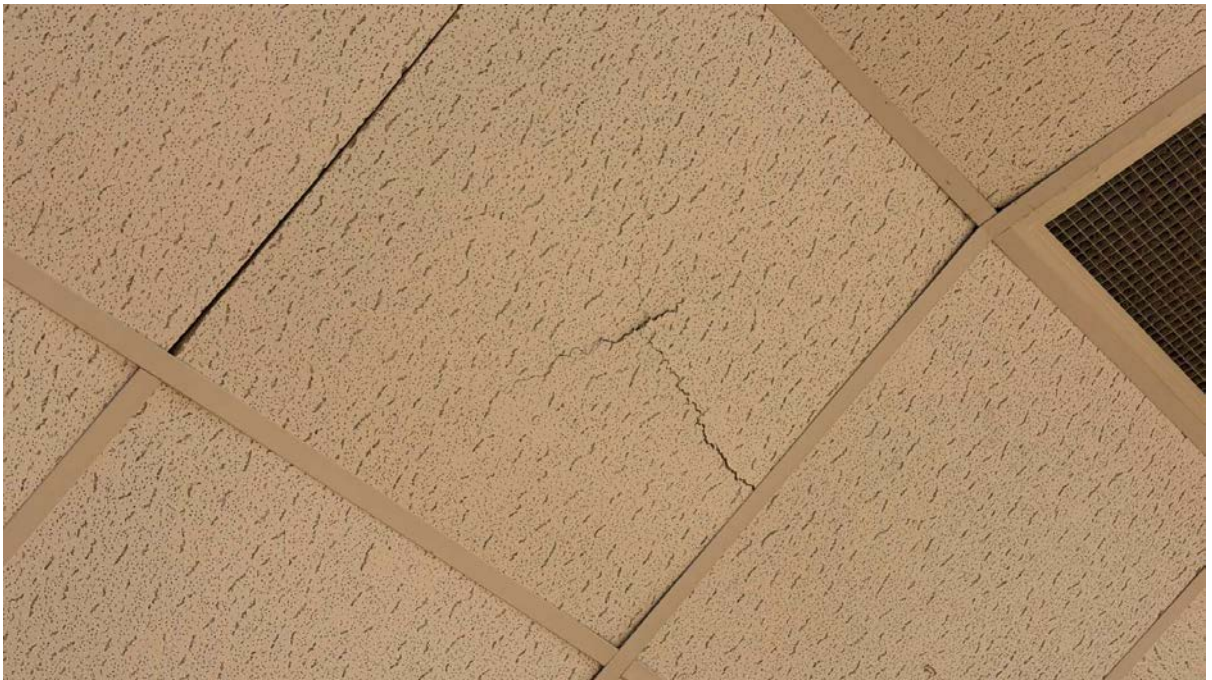
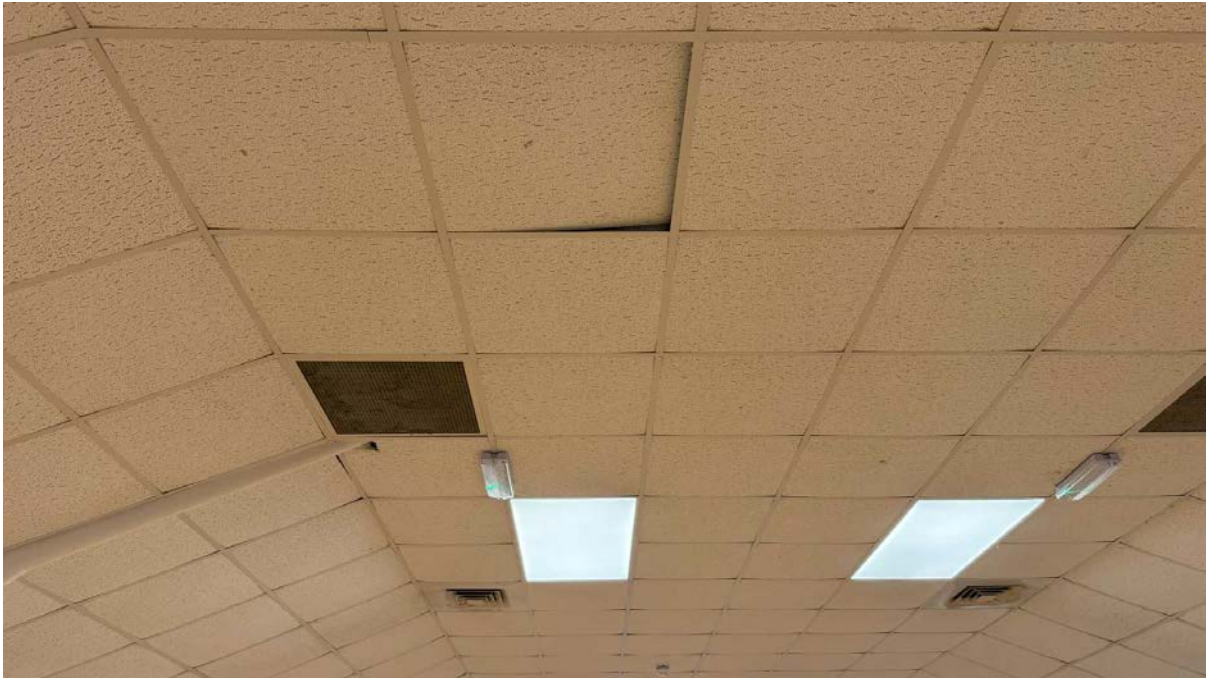
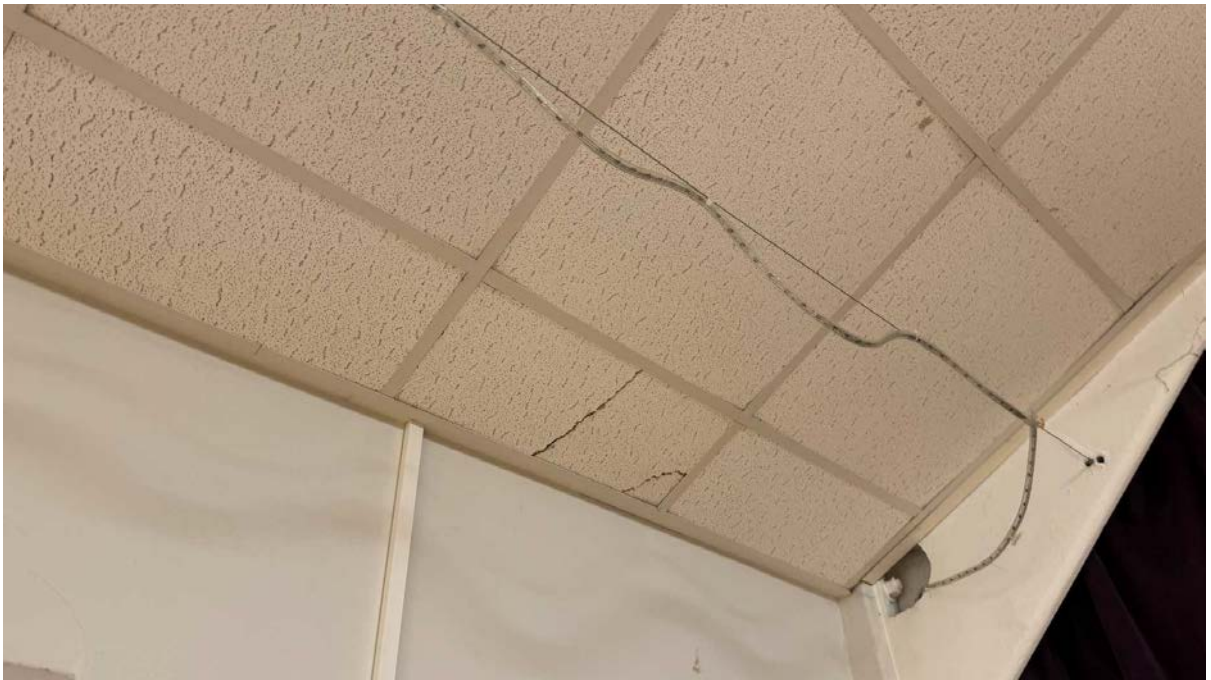
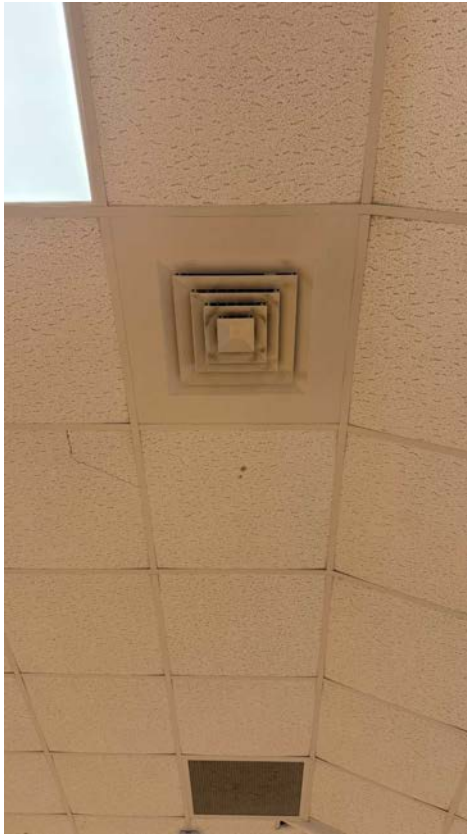
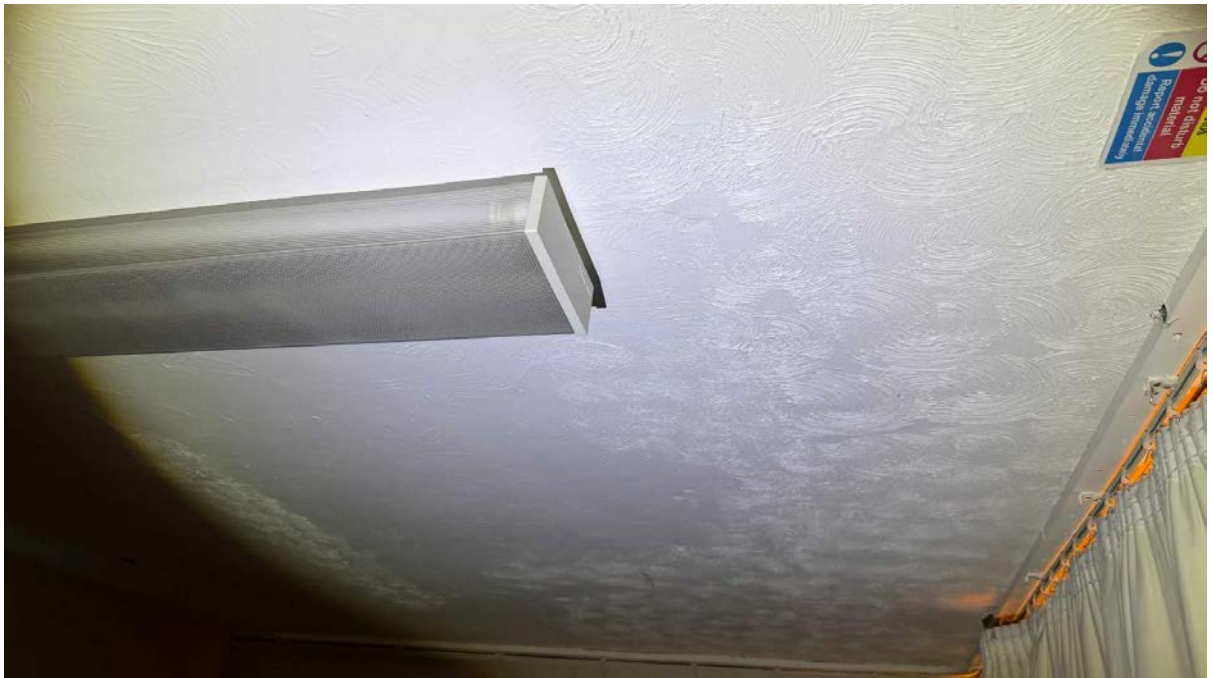
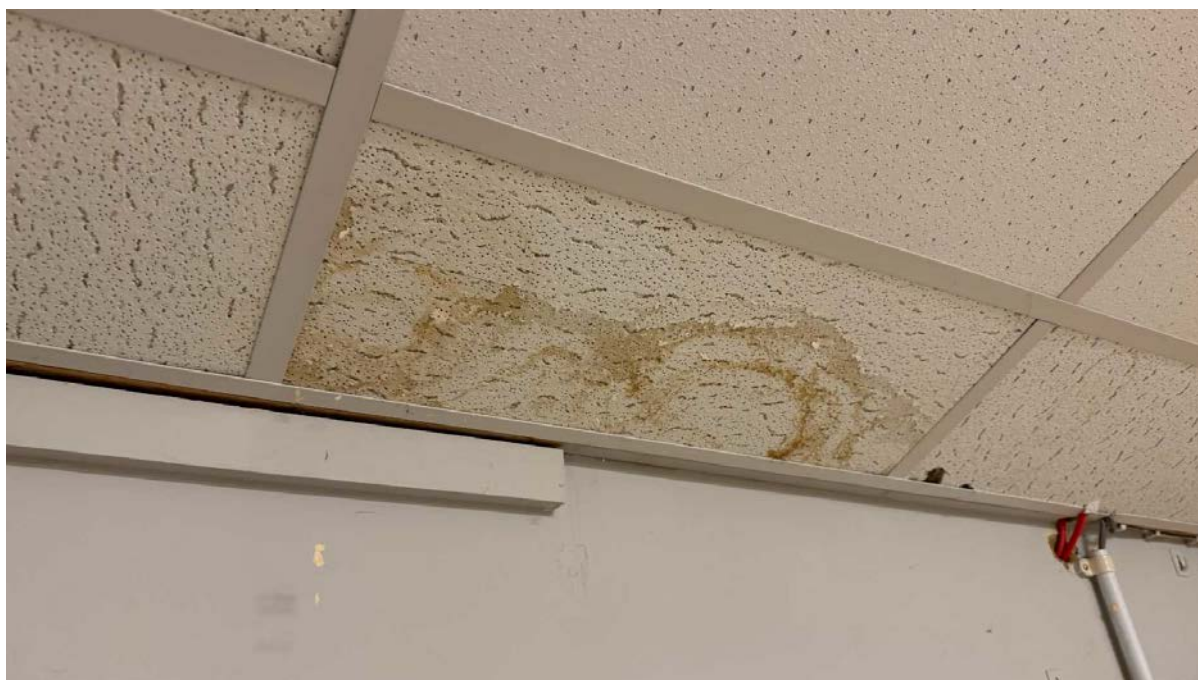
E2 Ceilings

Due to the age of the property, it is common to see hairline cracks between the ceilings and walls. This can also be due to thermal changes inside the property. The ceilings were inspected for any concerning cracks or other damages.

It should be noted that due to the age of the property, some of the ceilings have an Artex surface which may contain traces of Asbestos (some labels were noted to confirm this is the case).

No concerning damages or major cracking was noted to the ceilings overall.

Through the main hall, there are ceiling tiles installed. A number of damaged tiles were found as well as some stained from past water leaks. In the next few years, there will be various tiles requiring replacement.

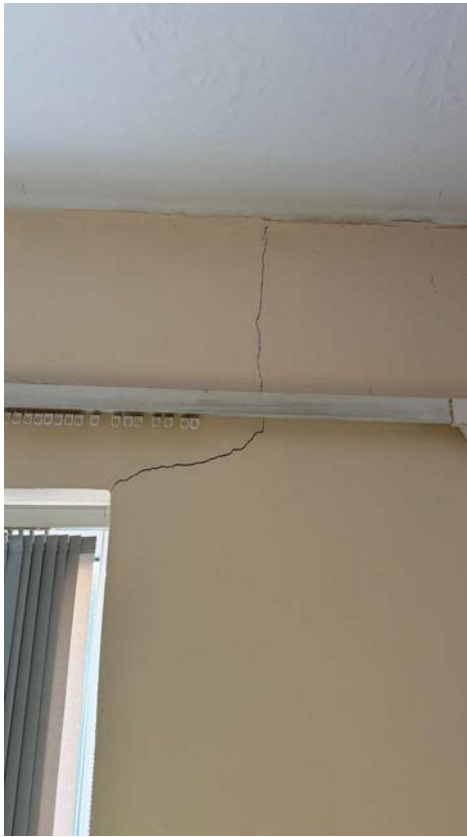
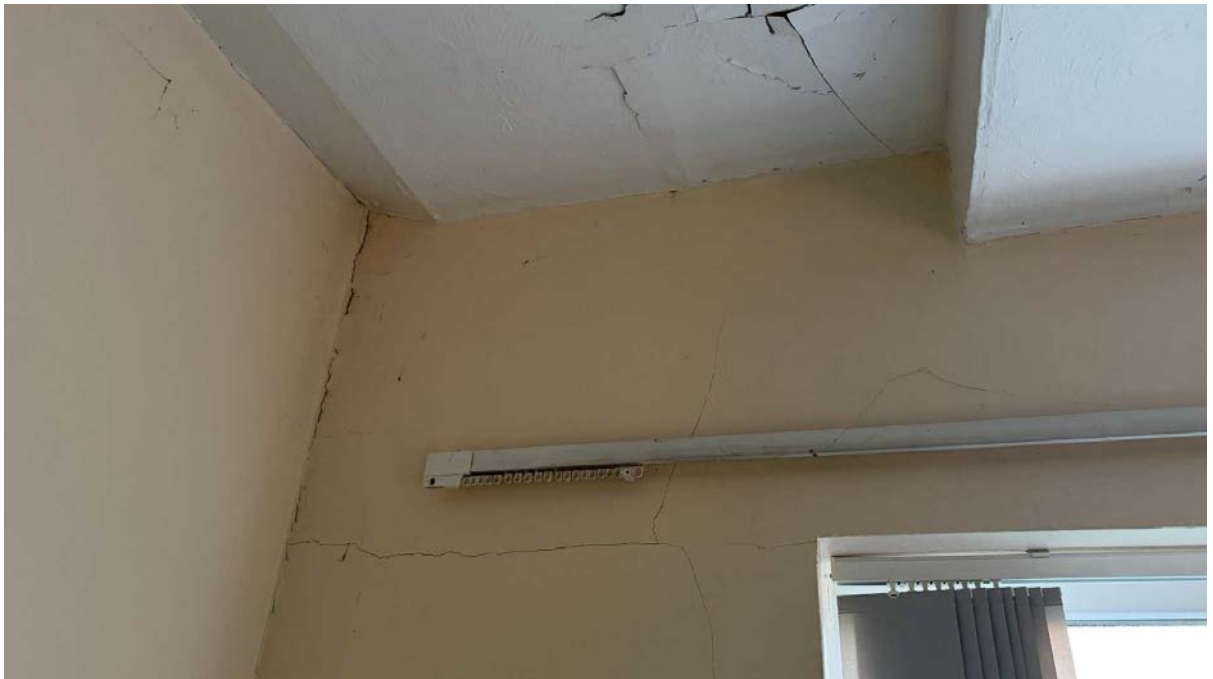
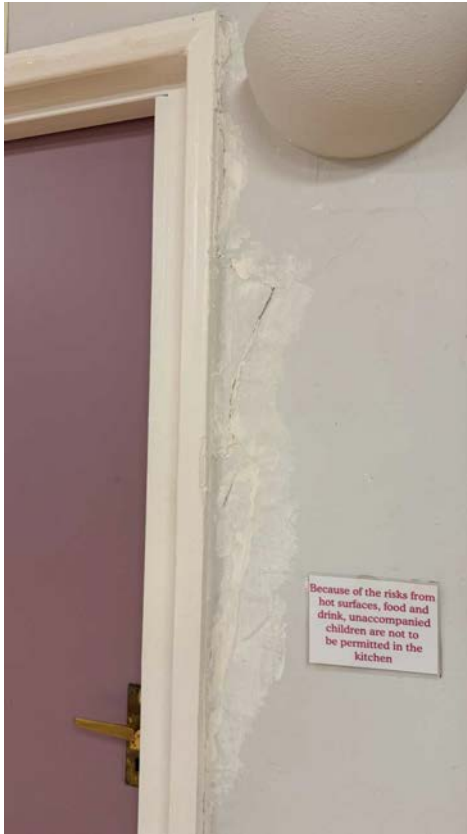
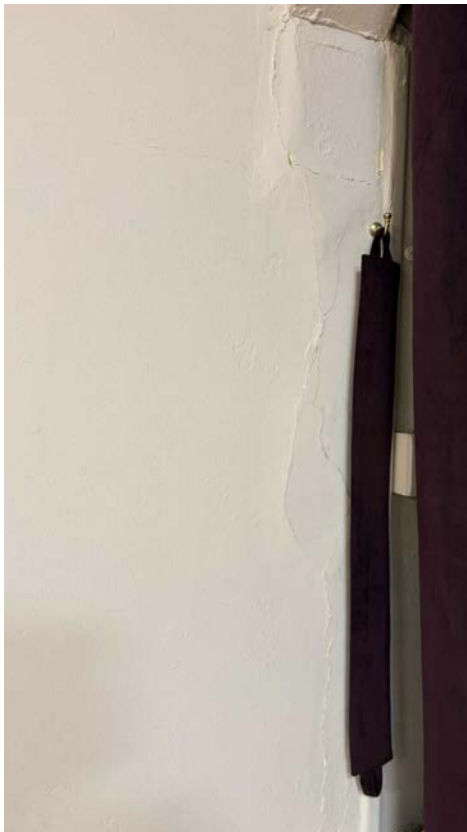
E3 Walls and partitions

The main internal walls to the property were inspected for any concerning structural cracks or other damages. Due to the age of the property and thermal changes, it is common to see hairline cracks which can be attended to during internal decorating. There was some cracking to the rear office, rear wall however no external cracks were noted. This is likely due to general settlement and thermal changes, however it is advised to monitor the cracking over the coming few months for any changes. There are some general cracks and loosening plaster surfaces in the main hall which is to be expected with the age of the property and high usage. Some slight cracks were noted under the roof supports due to these areas being stress points. You should expect to carry out cyclical redecoration through the property however no concerning cracking was noted overall to the accessible wall surfaces.

Because of the risks from hot surfaces, food and drink, unaccompanied children are not to be permitted in the kitchen

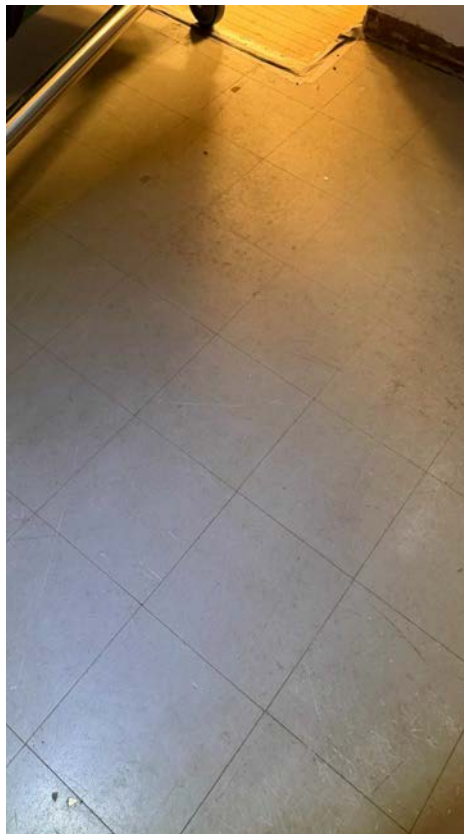
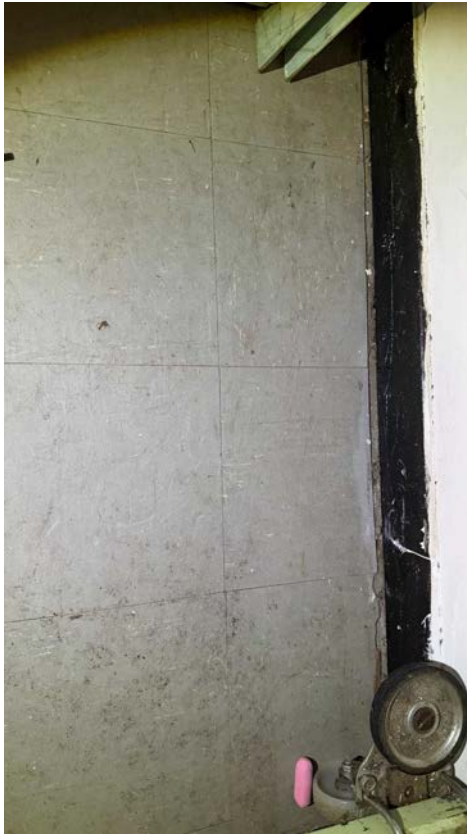
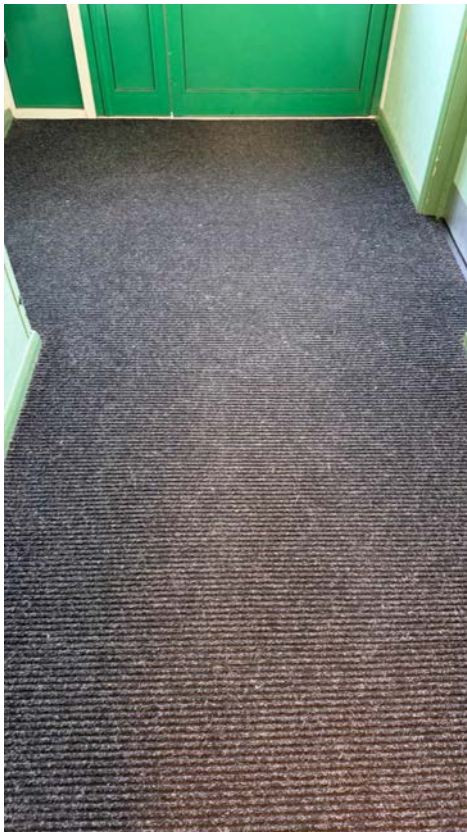
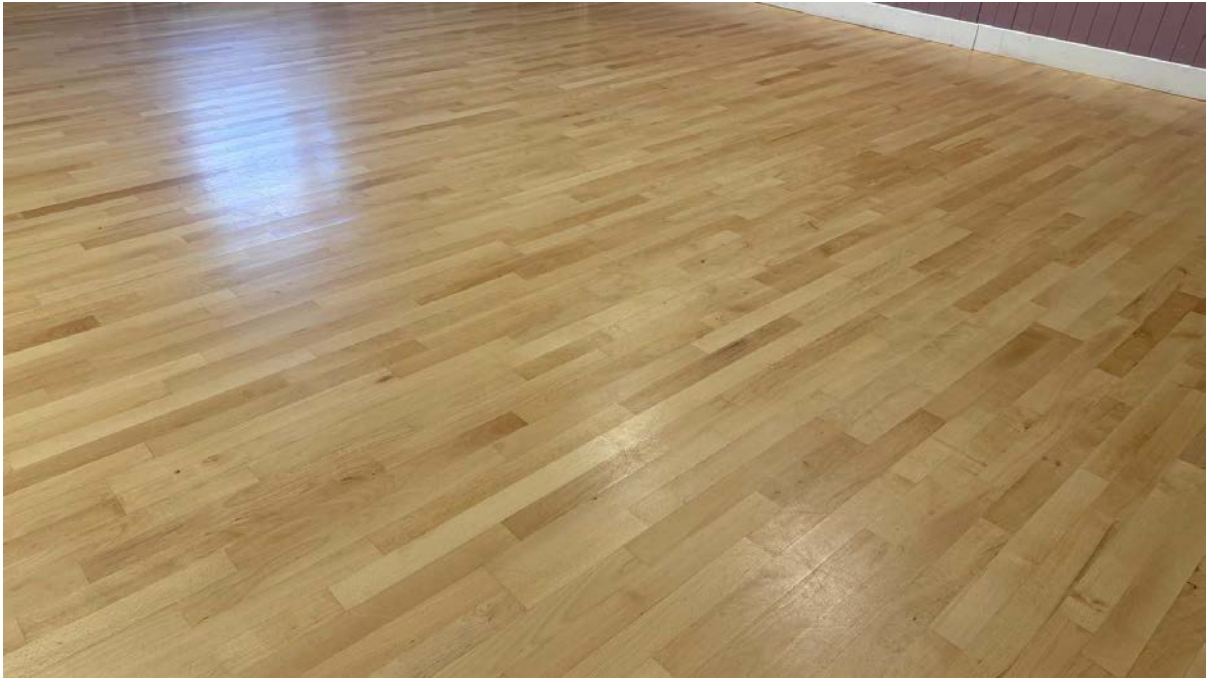
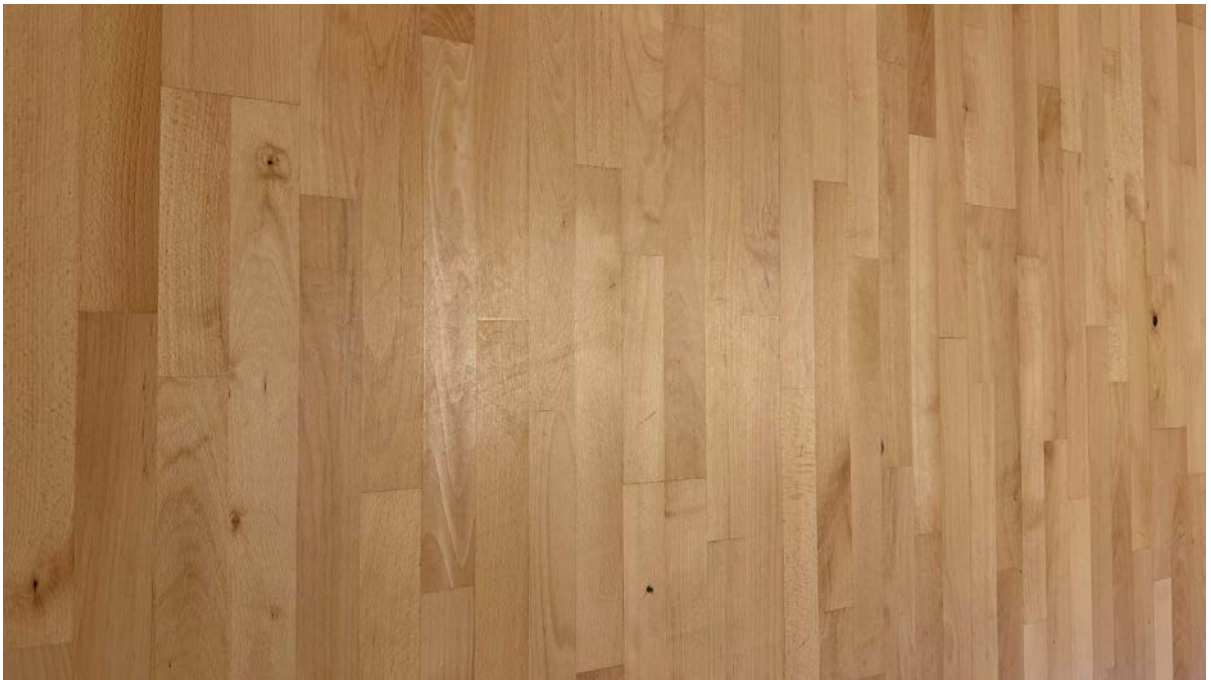
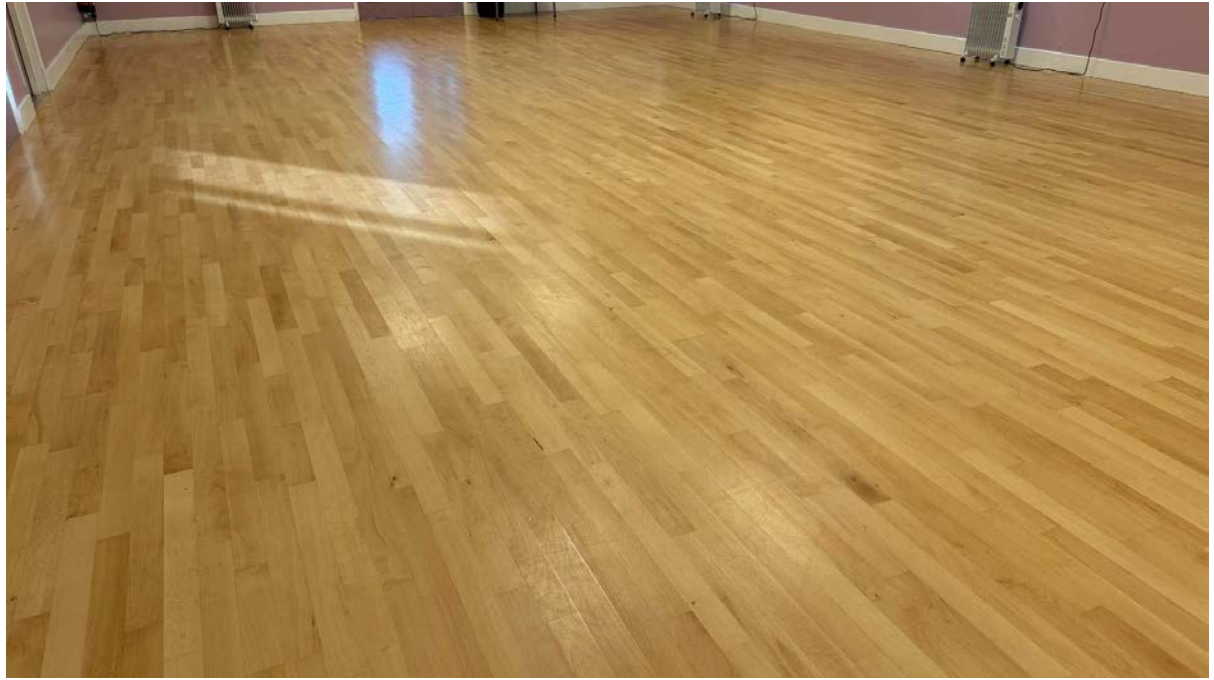
E4 Floors

The main hall has undergone full restoration to the main flooring in the last 5 years or so. No issues were noted such as current damage or excessive wear other than expected marks through regular use.

The carpet to the main entrance is a hard wearing product and was in good condition. It is likely that this will remain in good condition for the next 5 years at least.

There are some tiled floor surfaces to store rooms, which appear to be original and therefore likely contain traces of asbestos. No damaged areas were noted where any health risks would be present. However should any future damage occur and tiles become disturbed and start to crack, then these should be safely removed. You may wish to consider installing a carpet or vinyl overlay to protect the tiles against any future damage.

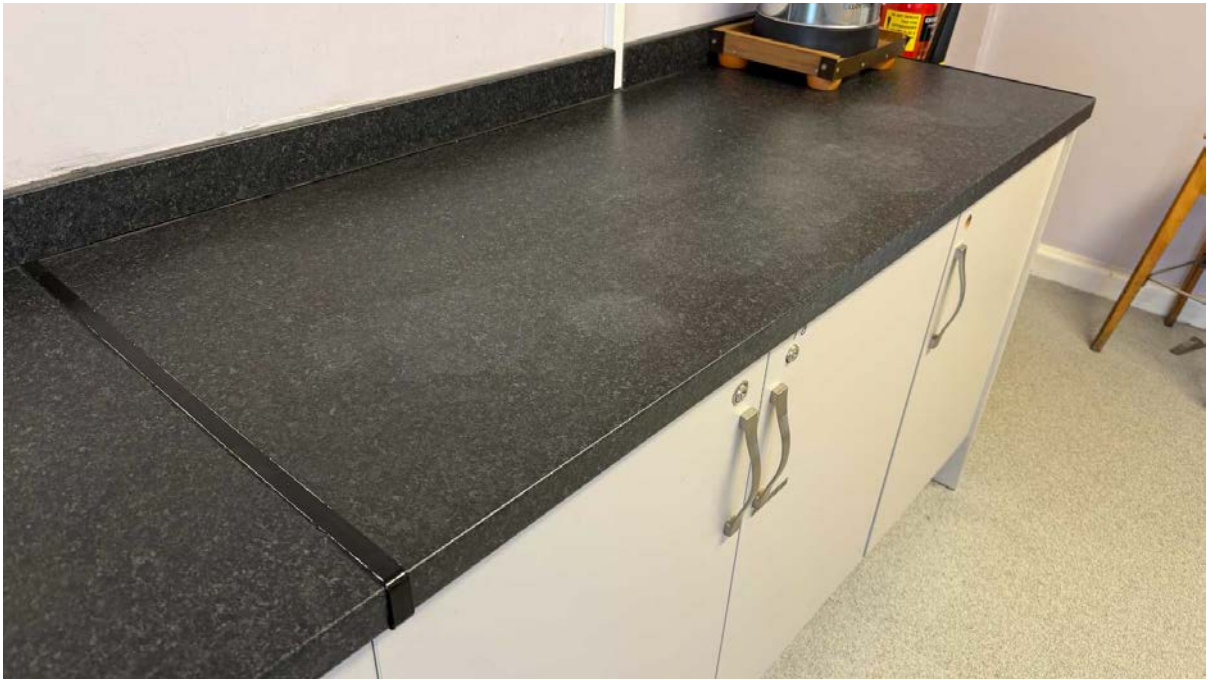
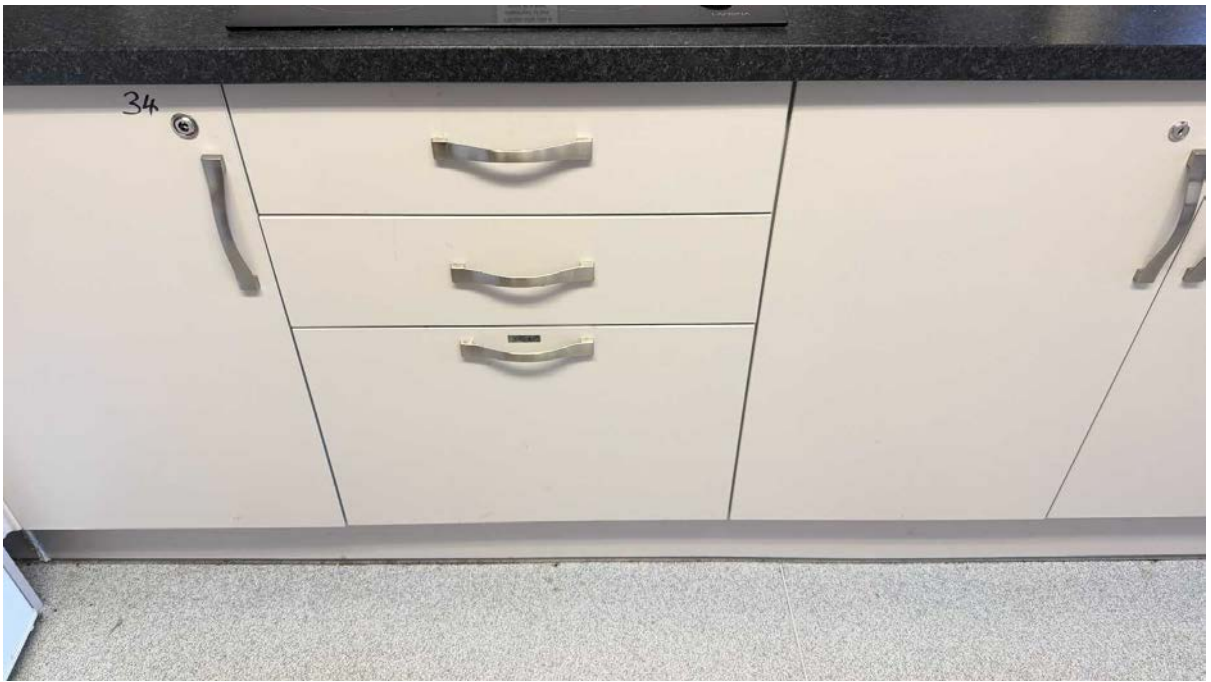
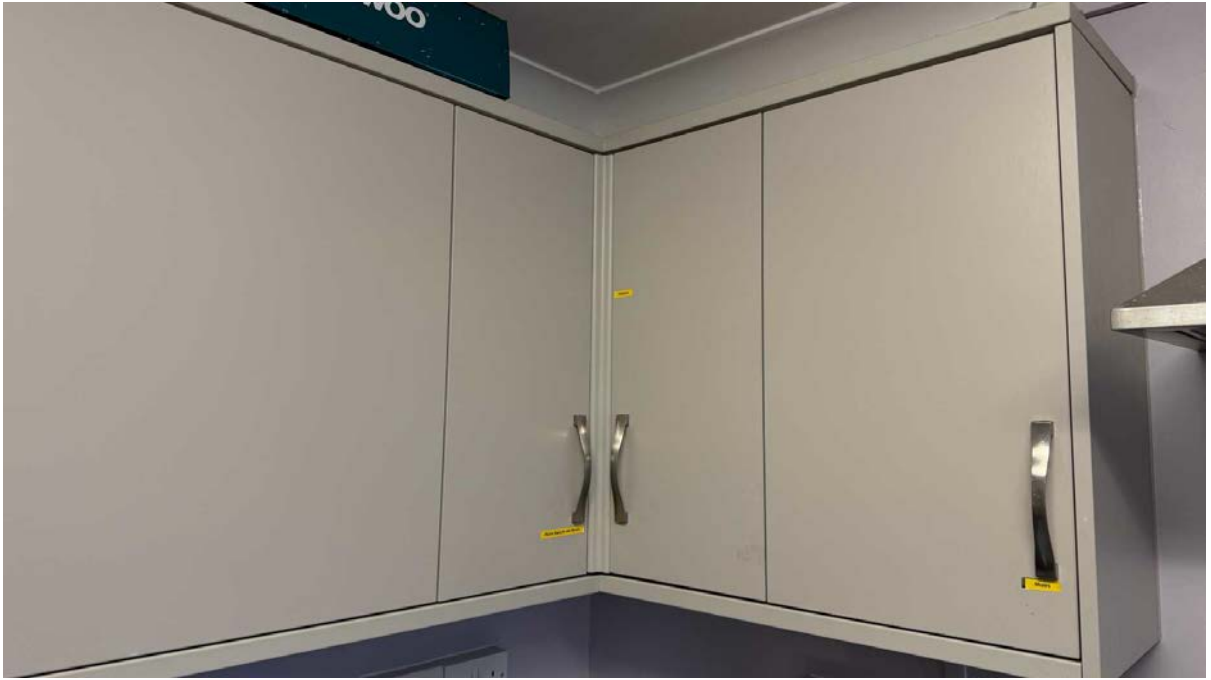
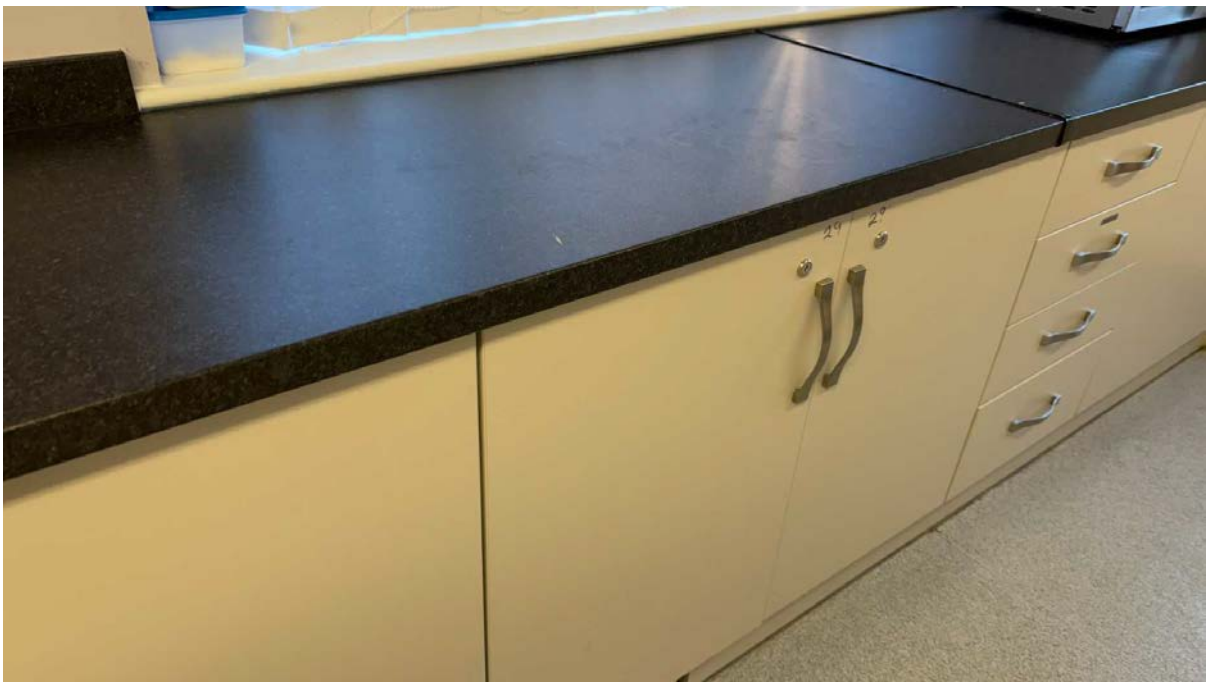
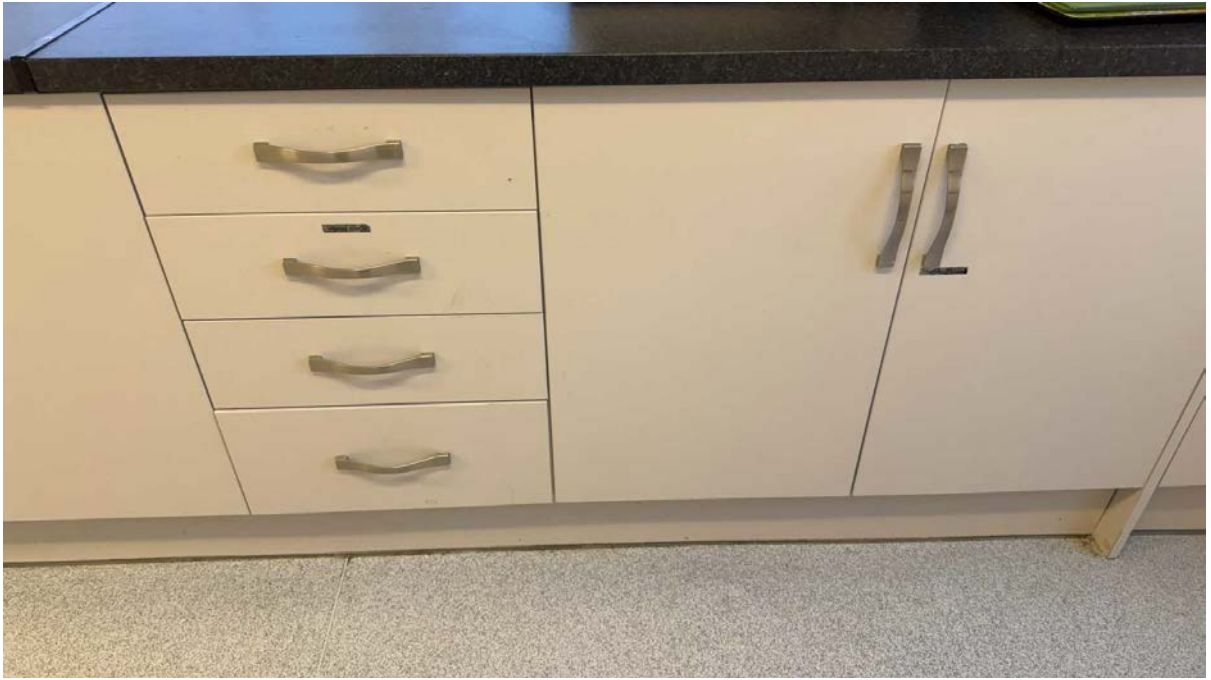
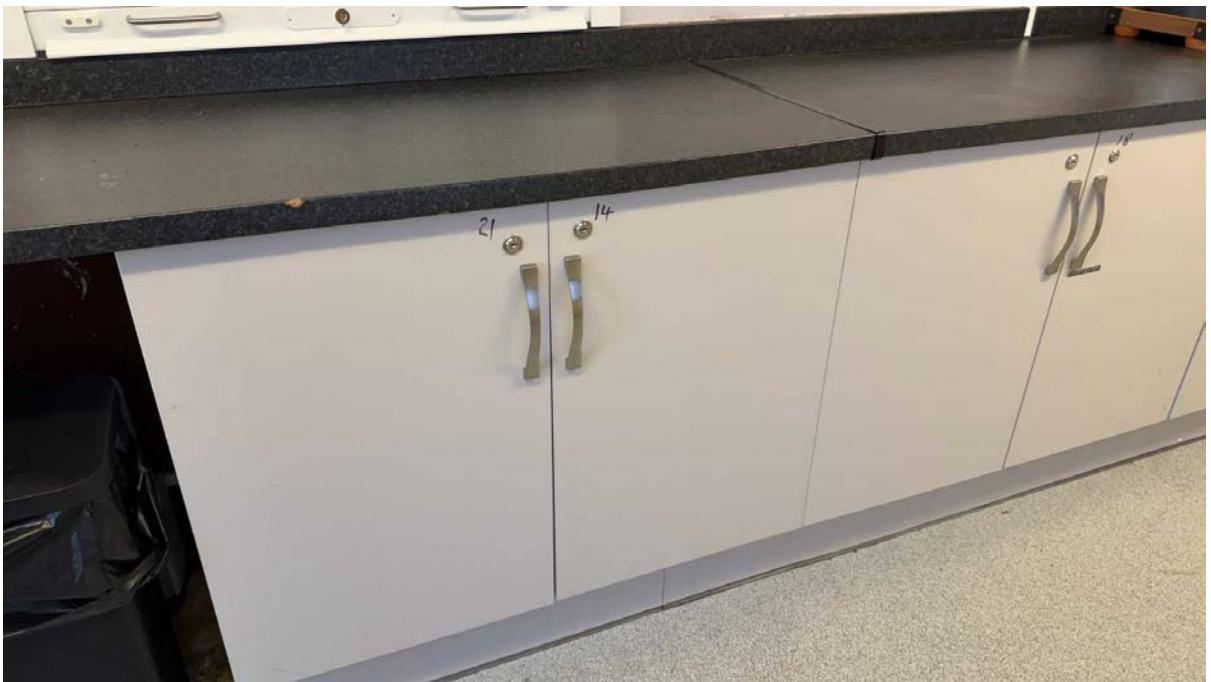
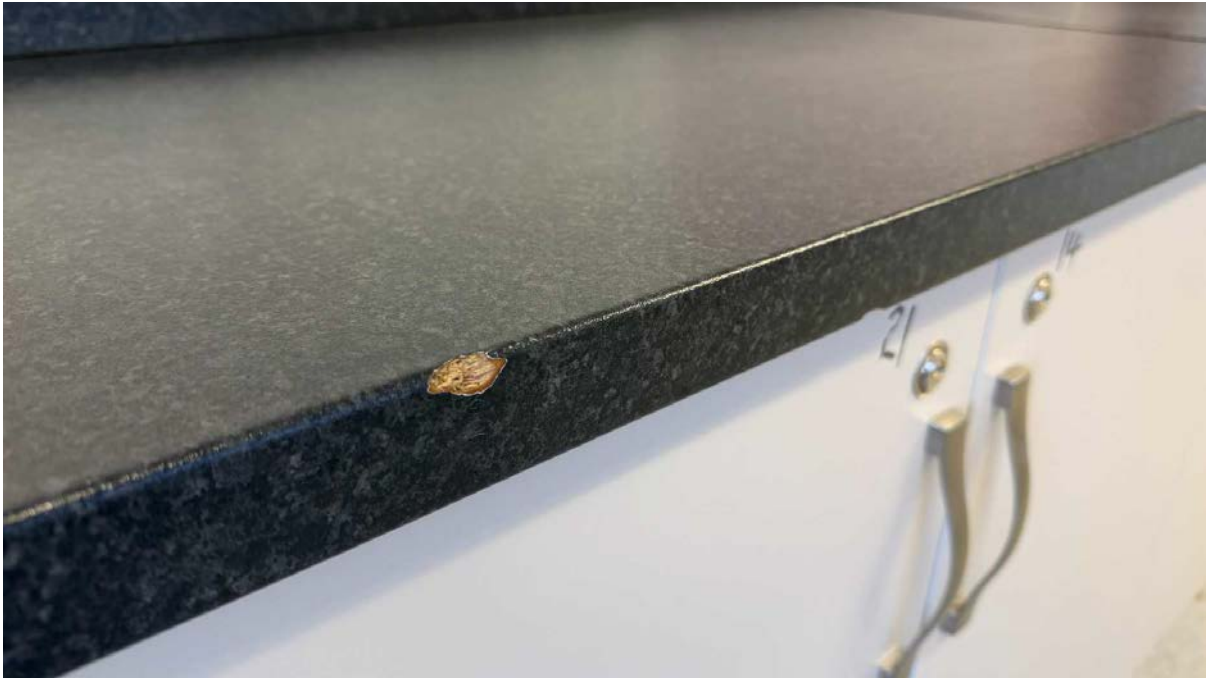
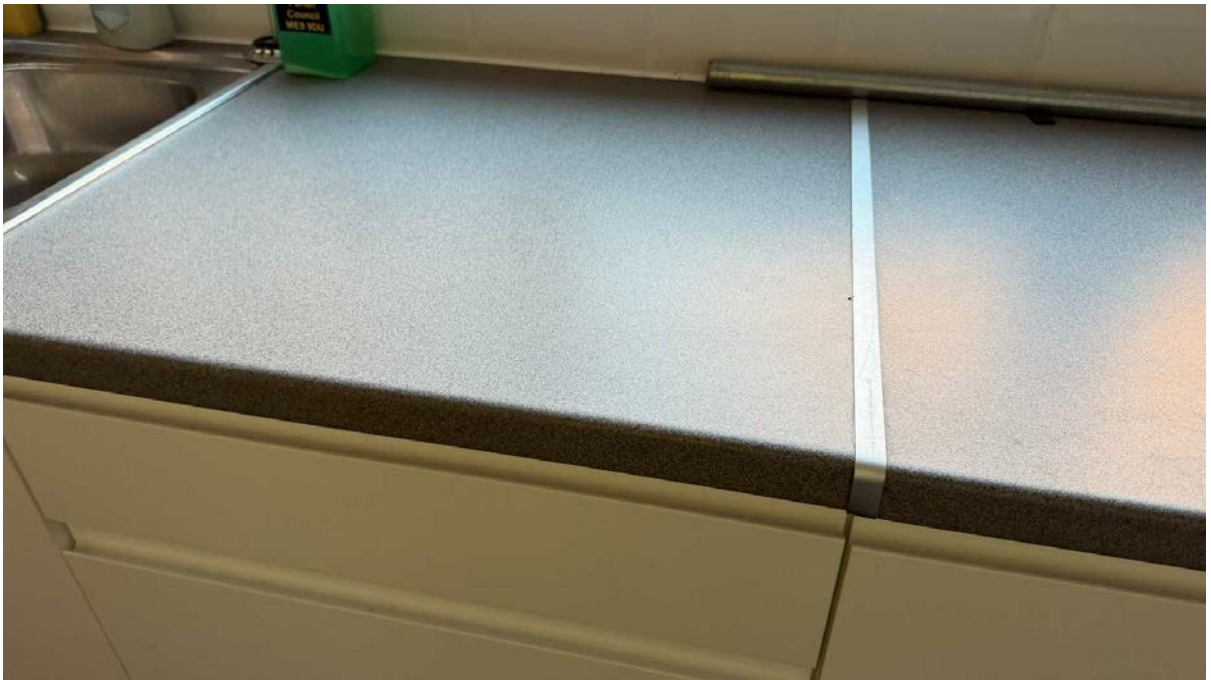
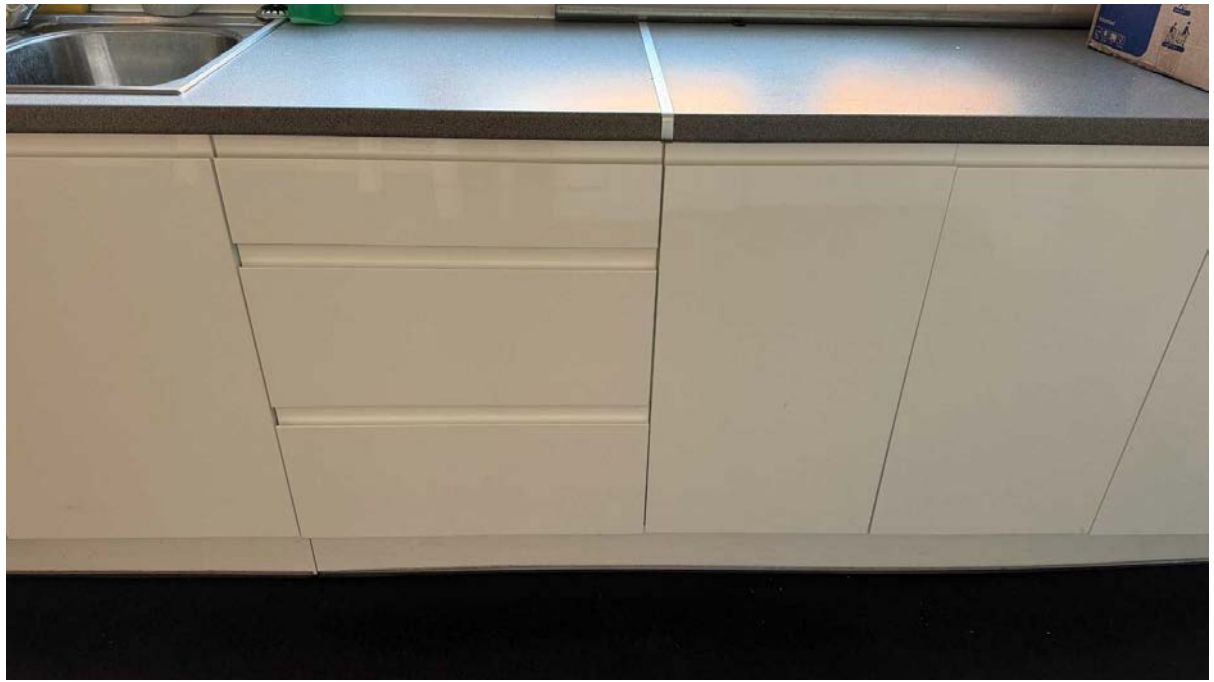
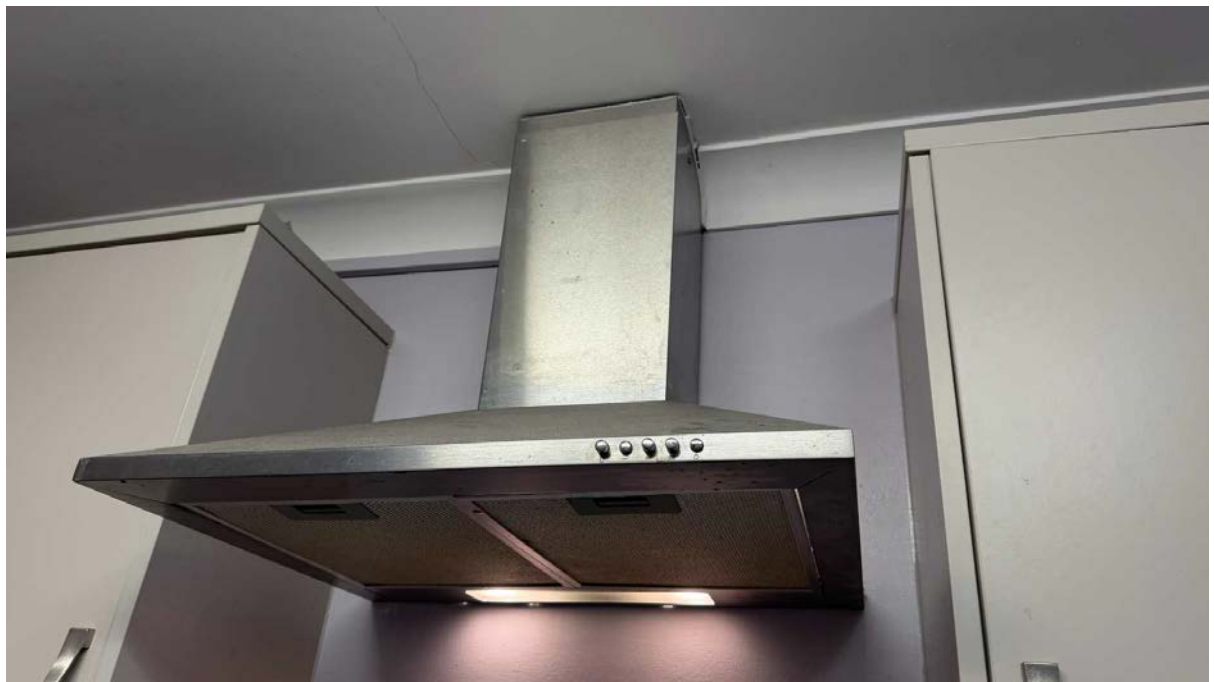
There are two kitchens to the hall (main kitchen and secondary smaller kitchen). The units were in good condition overall with no major wear or damages noted. The worktops were also in good condition with no excessive wear noted to the surfaces overall. The kitchens do not appear to require renovation and should remain in this state for the coming 10 years at least if properly maintained.

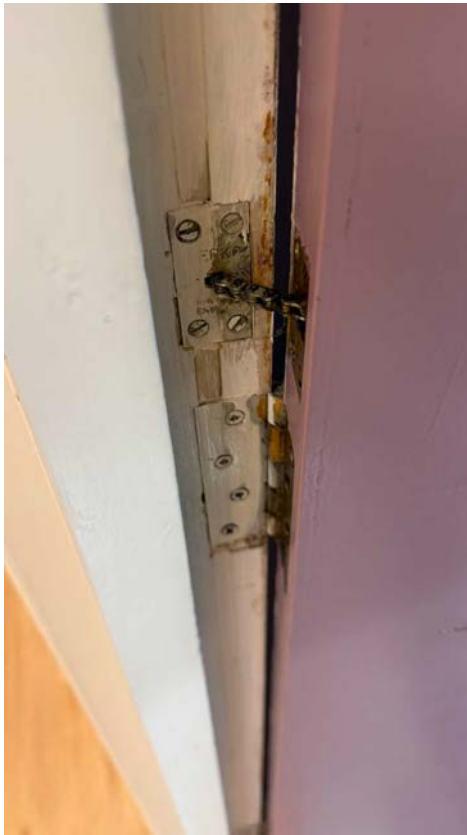
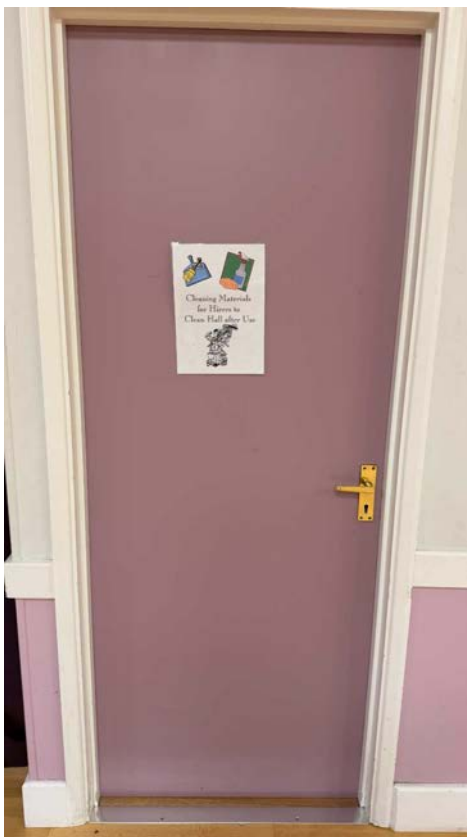
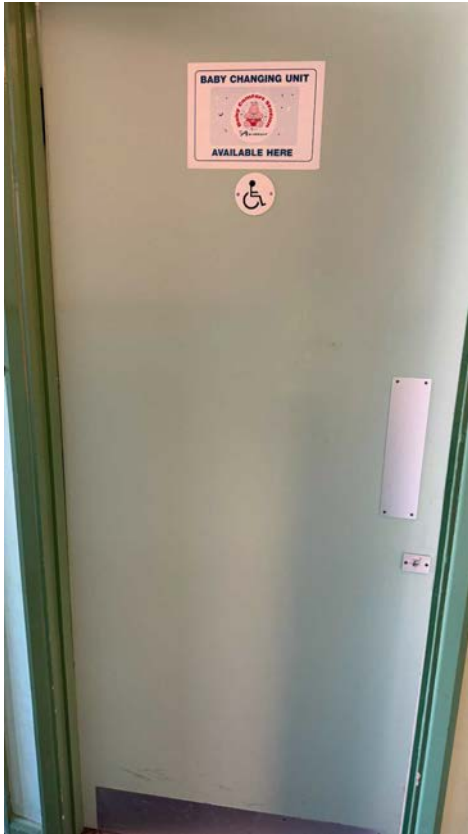
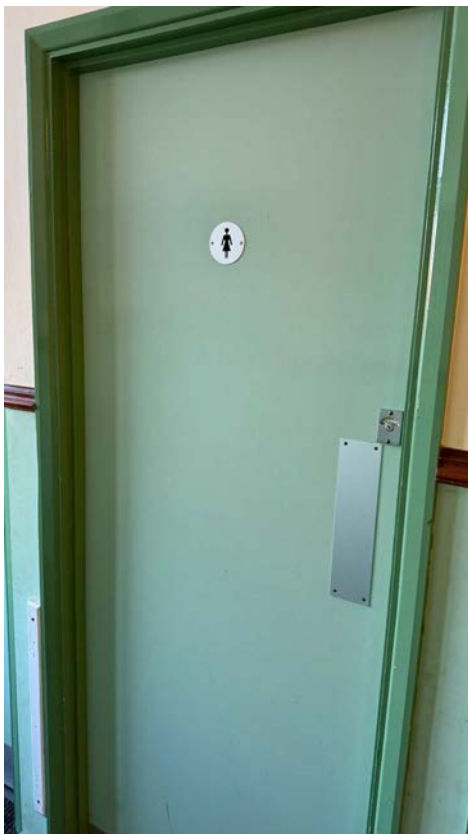
E7 Woodwork (for example, staircase joinery)

The property has timber internal doors to each room. A number of doors were inspected and tested. No major issues were noted where replacement doors would be required. Some doors are fire doors with self closing mechanisms which were found to be operating properly.
