Your survey report

Teynham Community Hall, 89 Station Road,
Teynham, Kent, United Kingdom, ME9 9DU

Teynham Parish Council

19/03/2026

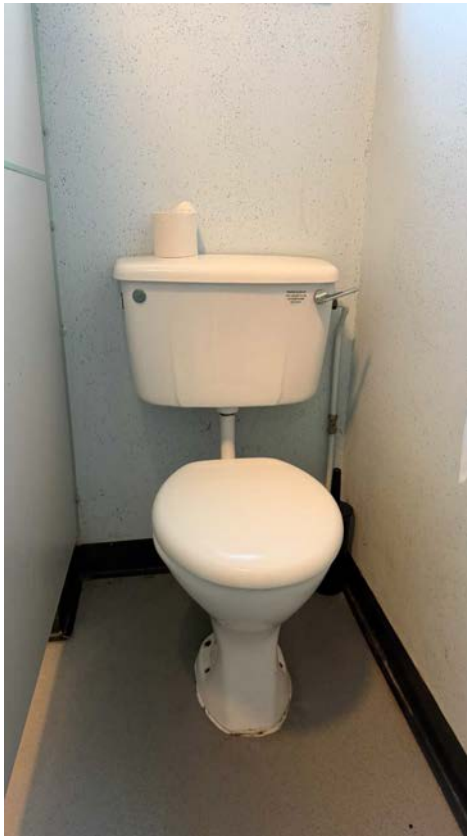
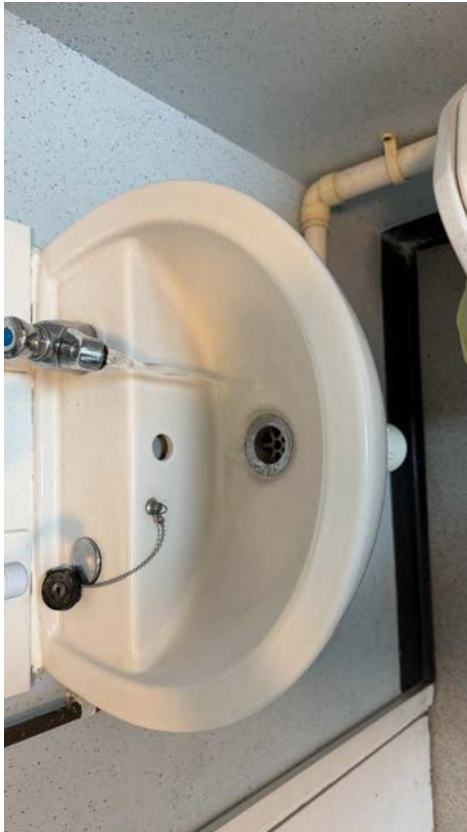
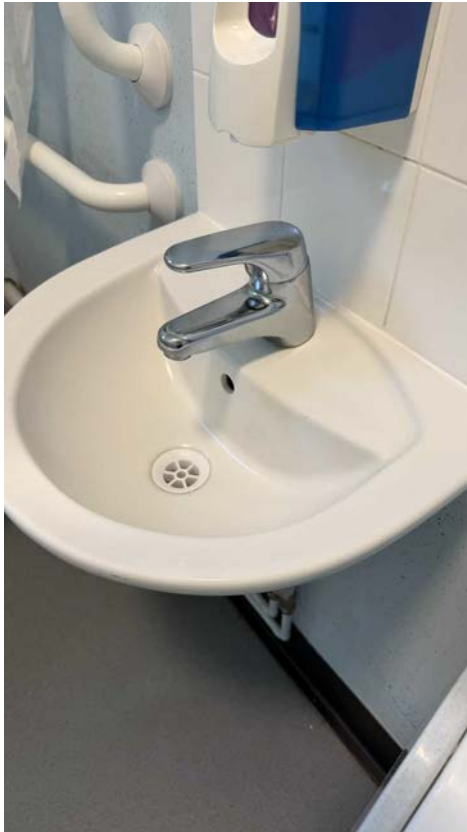
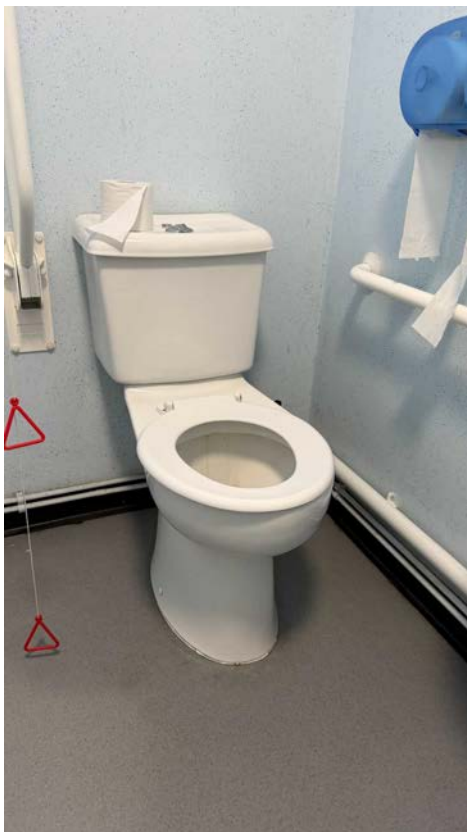
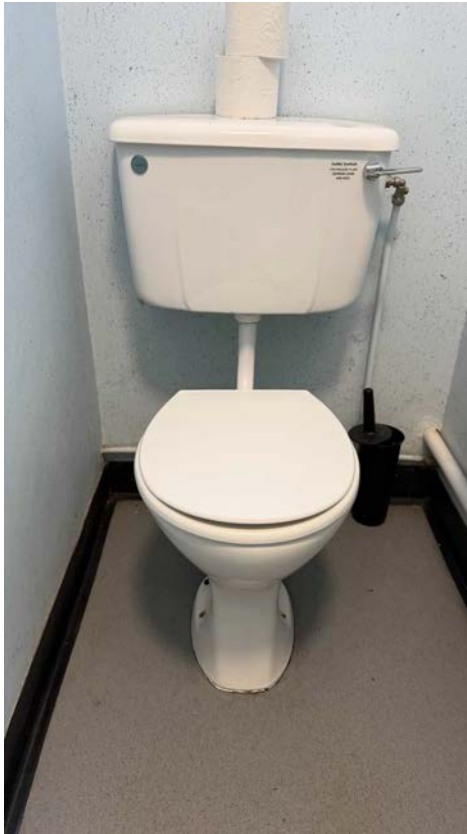
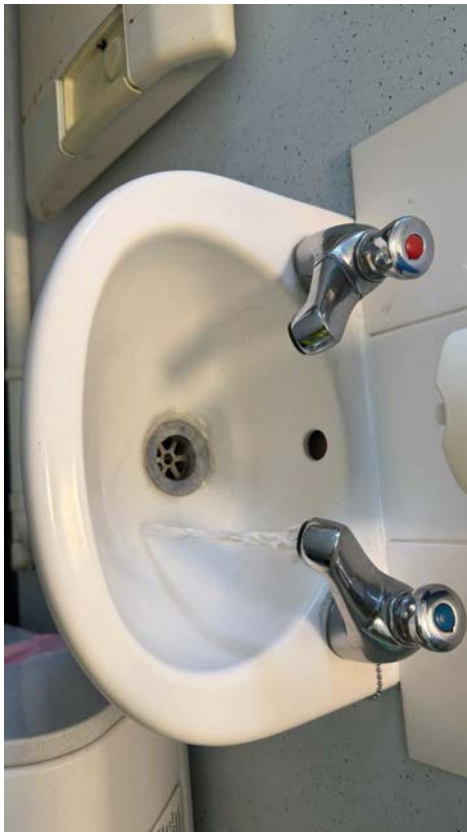
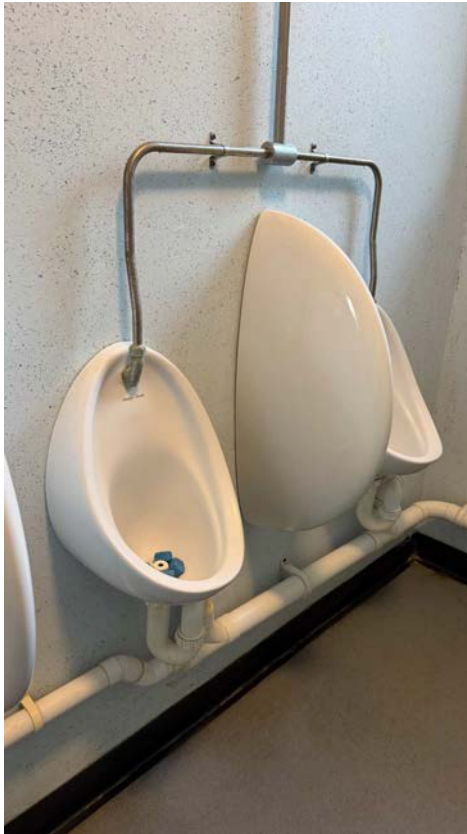
E8 Bathroom fittings

The hall has three bathrooms with a toilet in each bathroom and urinals to the male bathroom. There are sinks installed as well. The units were generally in good condition with no damages noted or evidence of water leaks. No major wear was noted to the taps or loose fixings. The bathrooms do not appear to require renovation and should remain in this state for the coming 10 years at least if properly maintained.

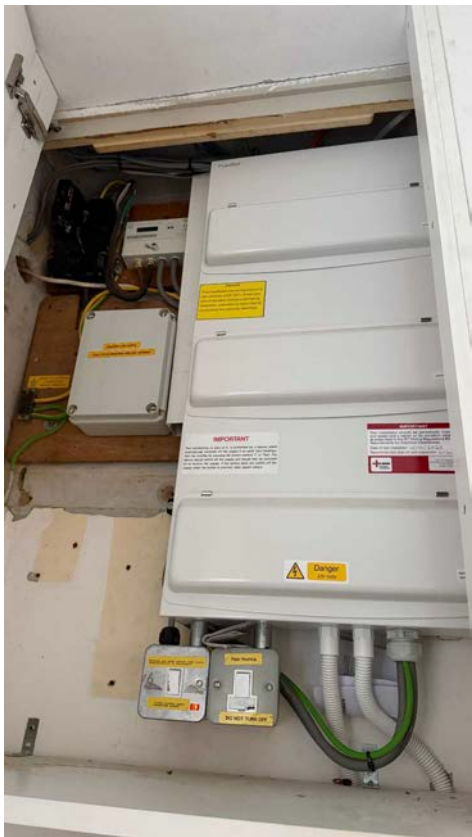
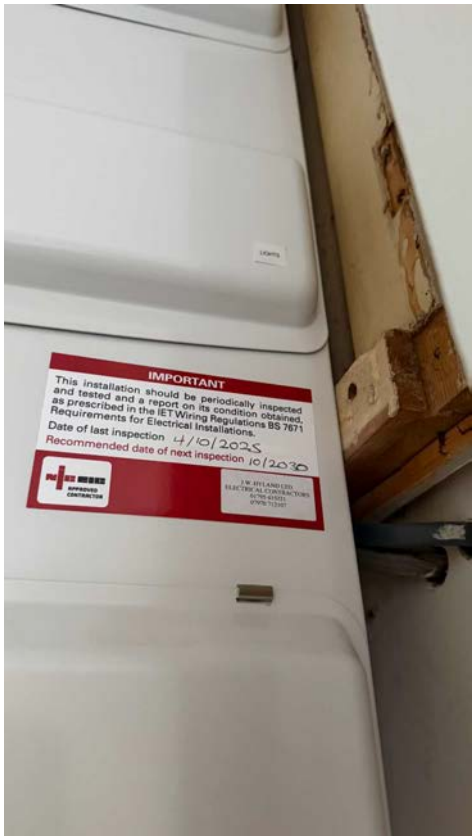
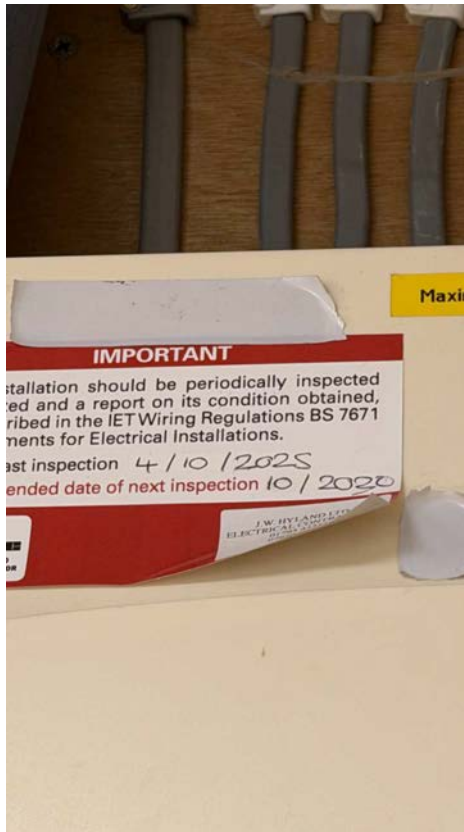
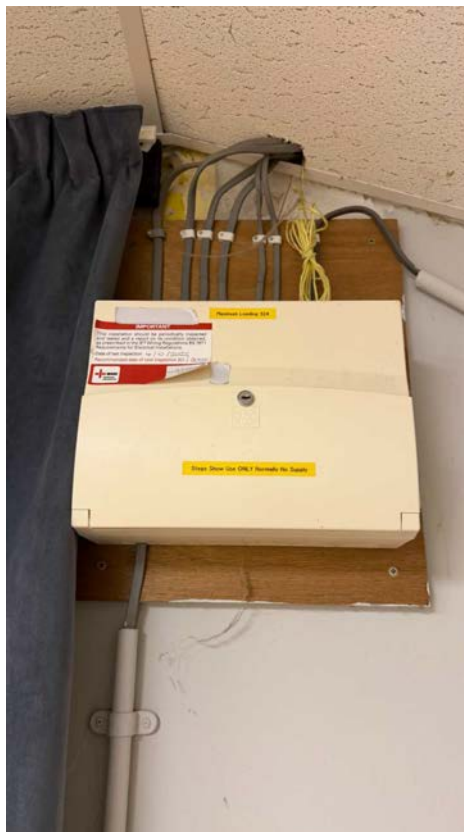
There were multiple fuse boards found inside the property; one to the rear of the stage area and another board inside the smaller kitchen. It is recommended that domestic electrical installations are tested at least once in every 5-10 years. If there is no record of a test certificate within this period then I recommend that the system is tested by a qualified electrician. The label on the boards confirms the last inspections were carried out in 2025 so are currently within date.

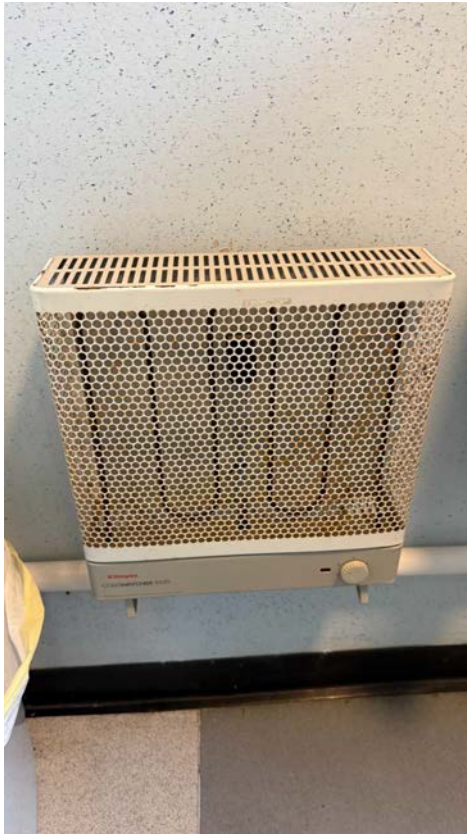
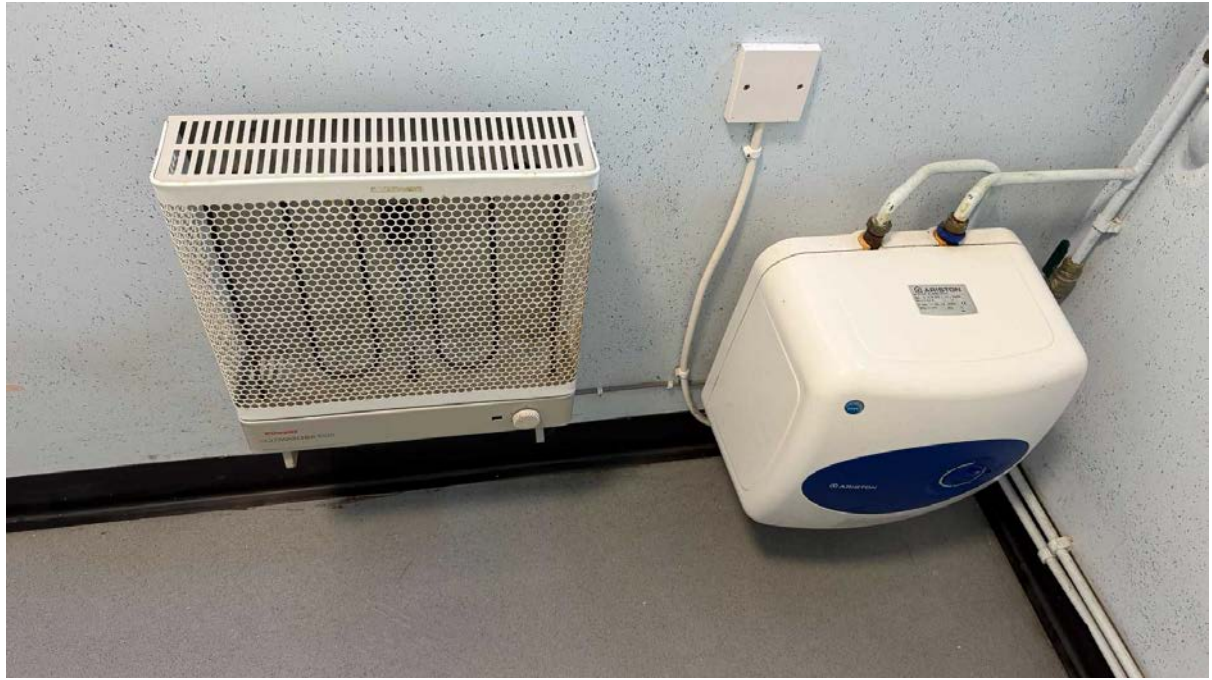
Heating to the property is provided by a Powrmatic warm-air unit located within the roof void. It is understood to currently not be operating due to considerations being given to replacement.

There are also electric wall heaters installed to bathrooms and the rear office area. The bathroom heaters were noted to be very old

The heater in the rear office appears to be a more modern product and does not require replacing.

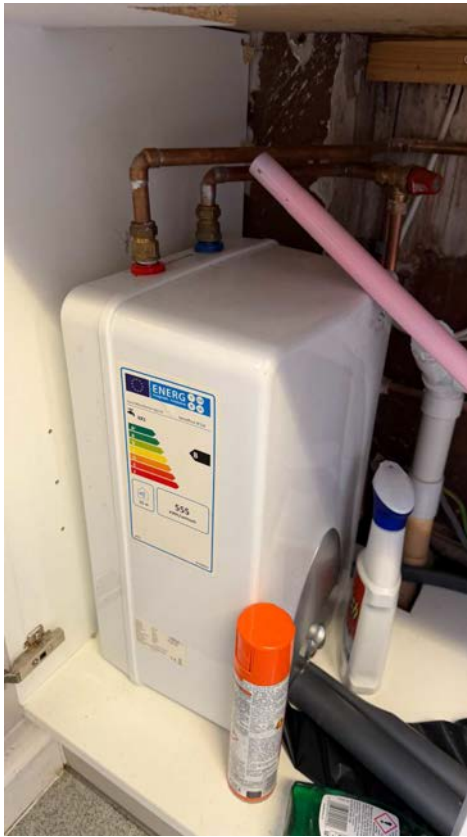
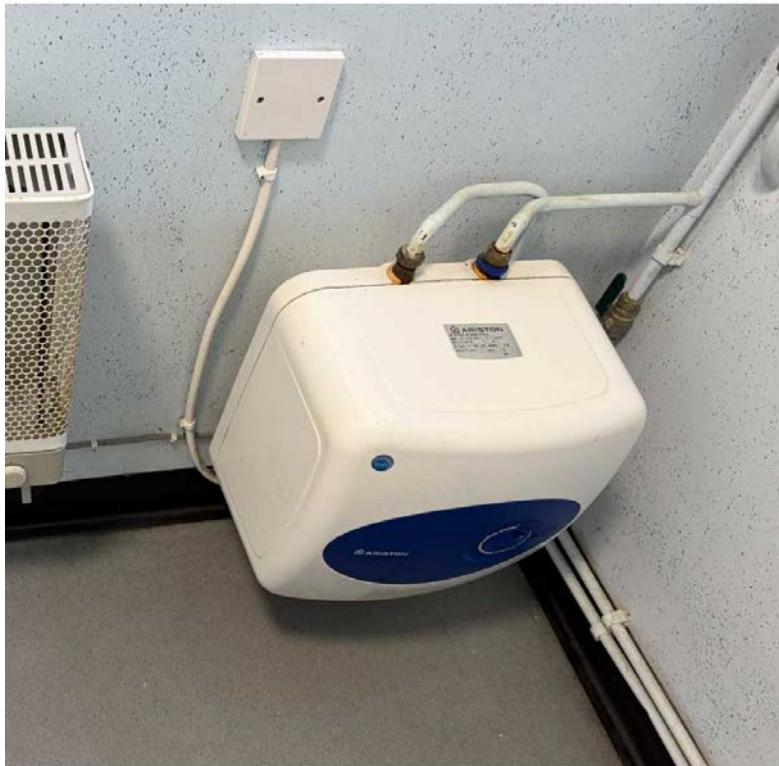
F5 Water Heating

During the inspection, the hot water supply equipment was inspected to the bathrooms and kitchens. These appear to be supplied by electric water heating units (located on walls and under kitchen worktops). No gas powered combi boiler was noted inside the property.

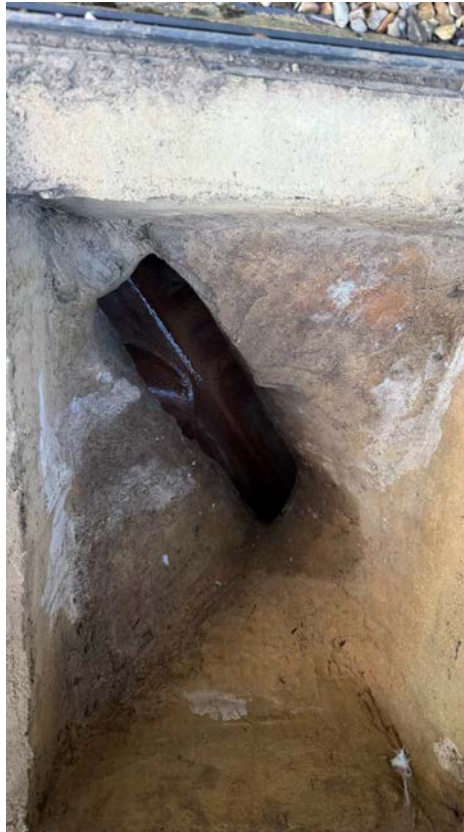
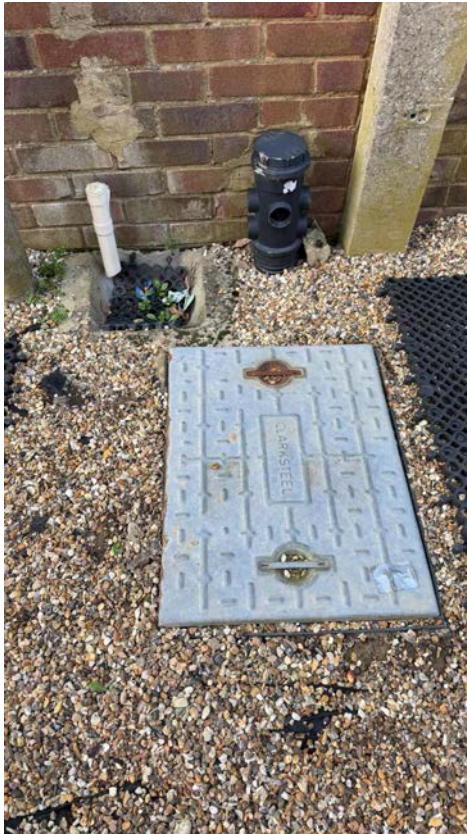
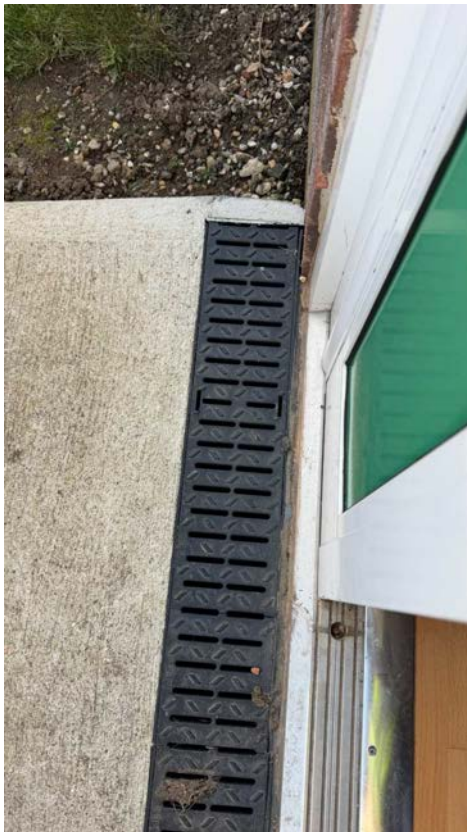
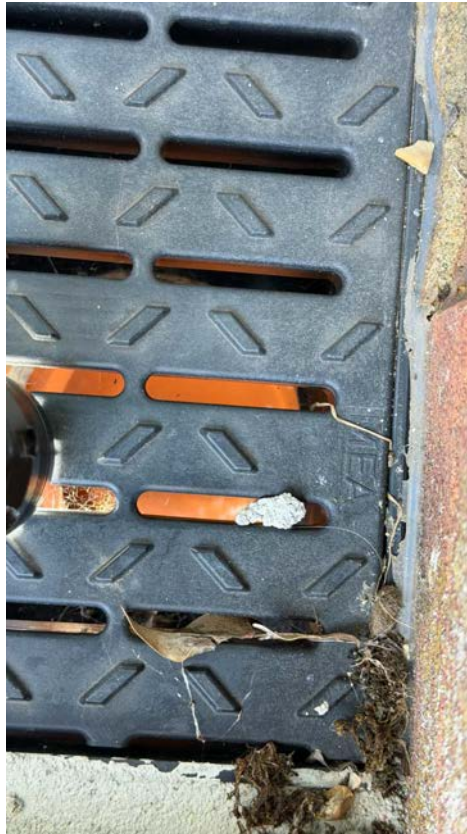
F6 Drainage

There is inspection chamber located to the left side grounds along with rodding points to the soil stack vent section, which can be used to carry out jetting or rodding should any future drainage issues occur. No evidence of blockages or collapse were noted.

There is an ACO surface water drain by the left side door which should be kept clean of debris. This can be carried out by lifting the grating. It is understood to be connected to a fairly recent (last 10 years) surface water drain run out to the front of the property.

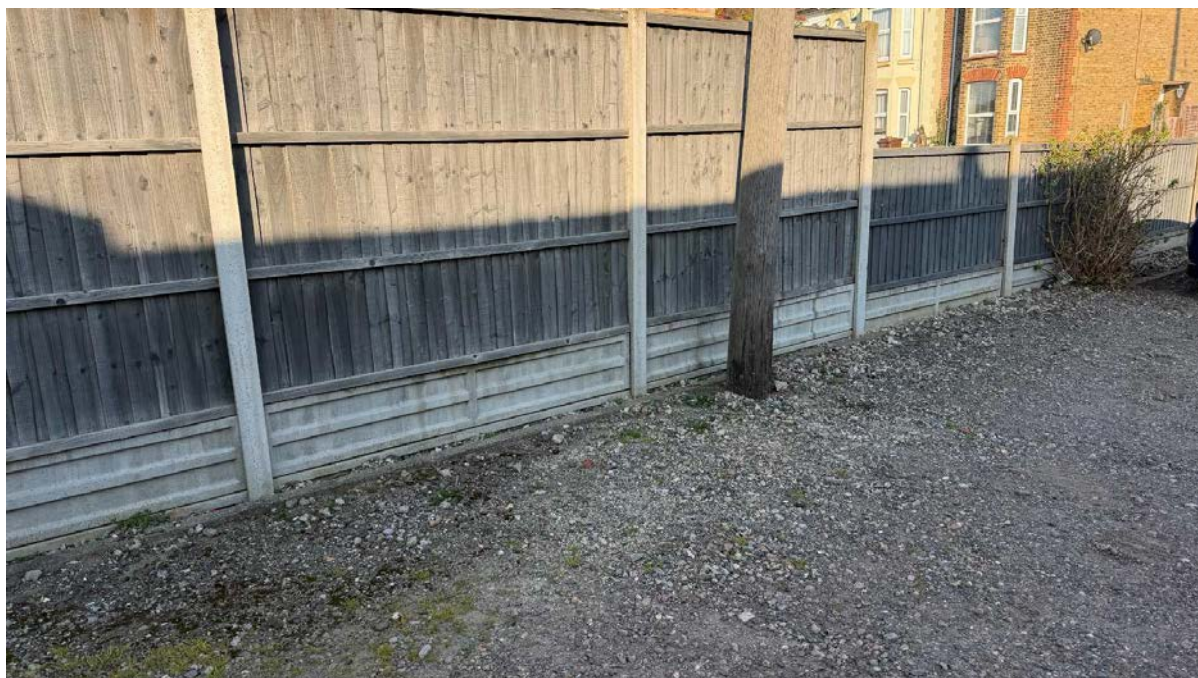
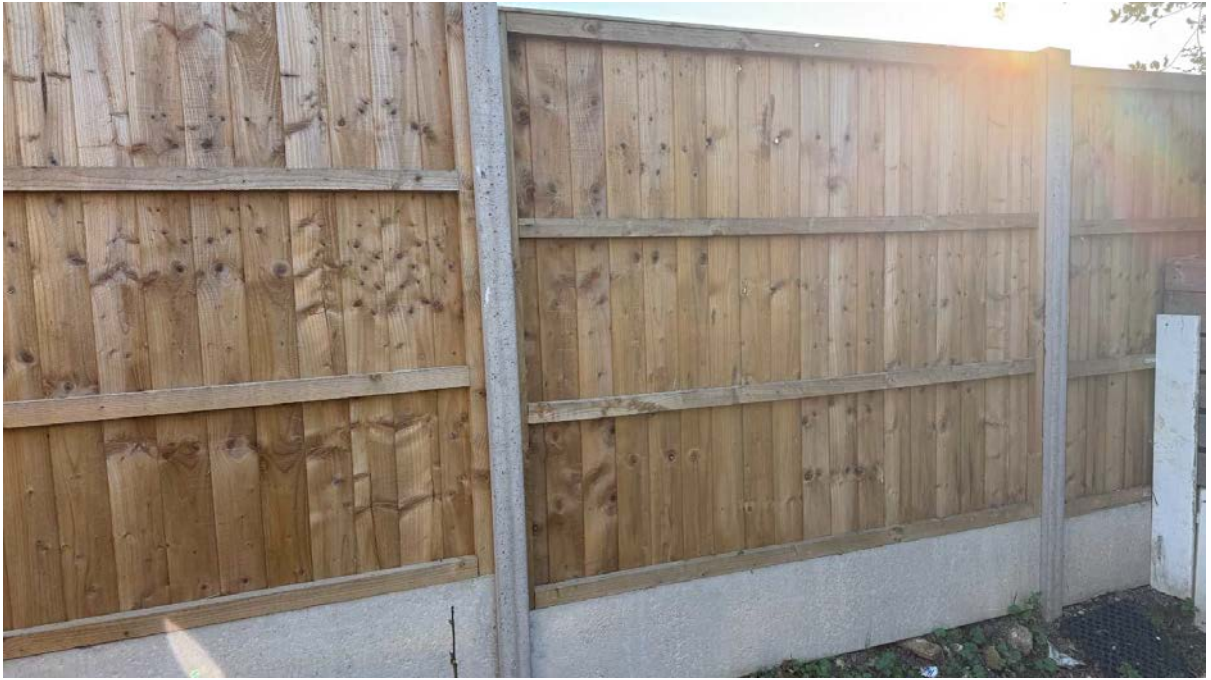
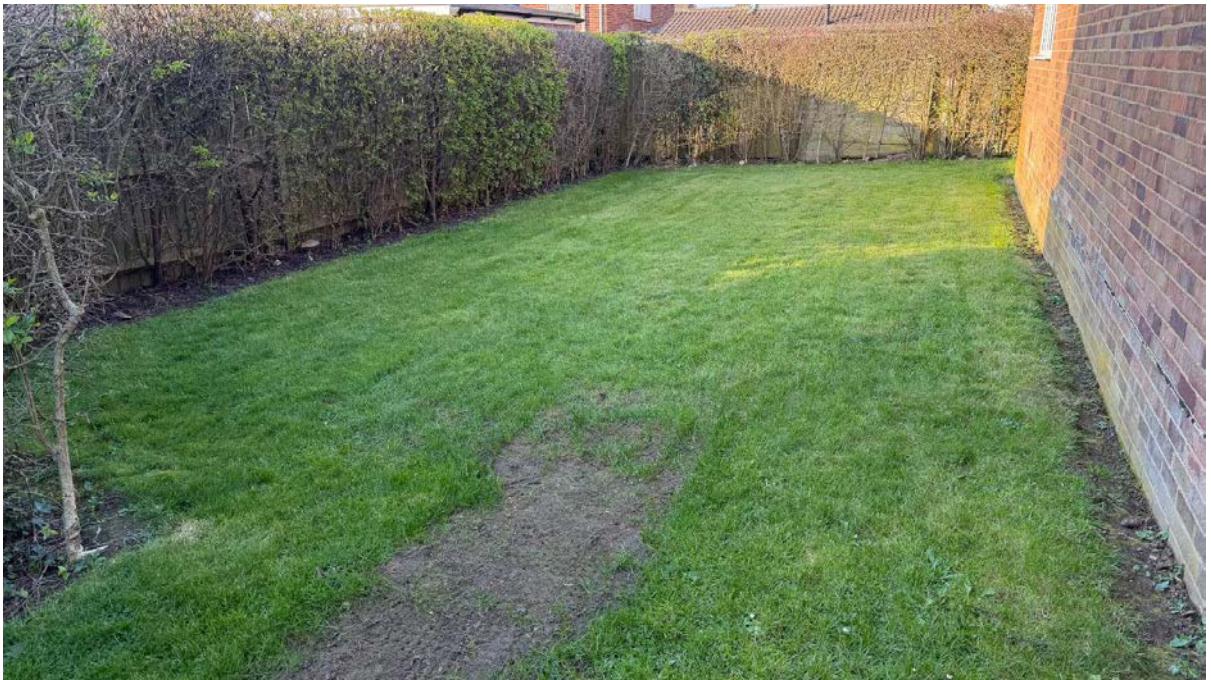
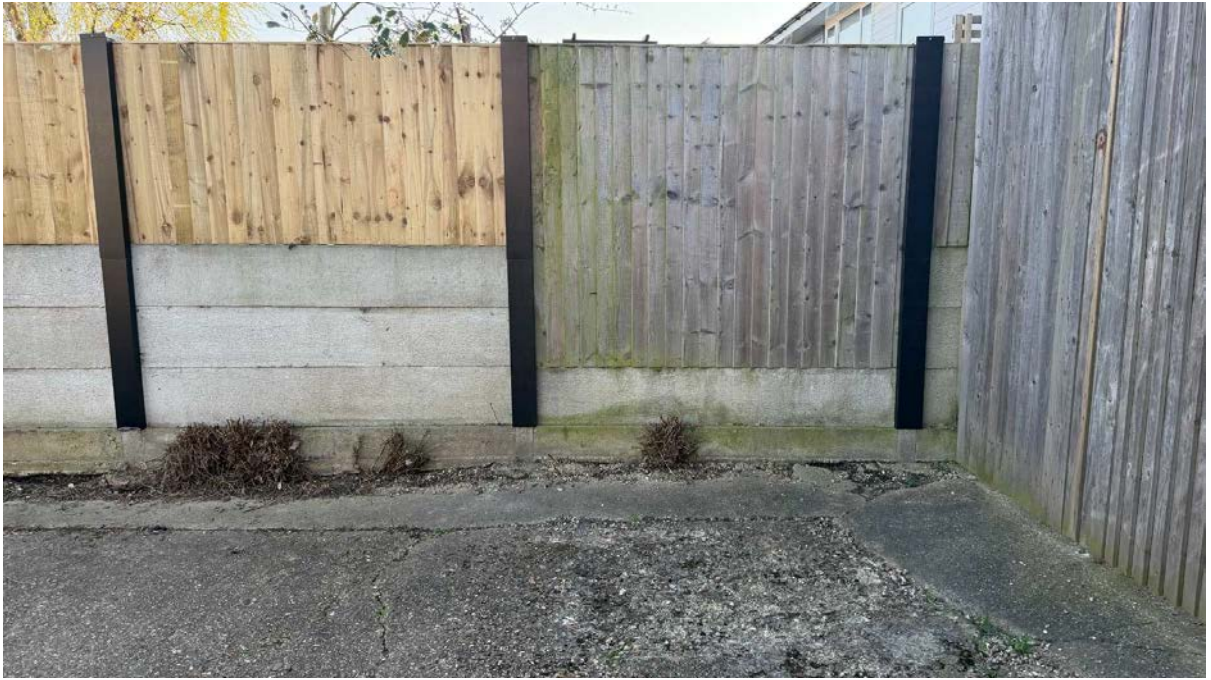
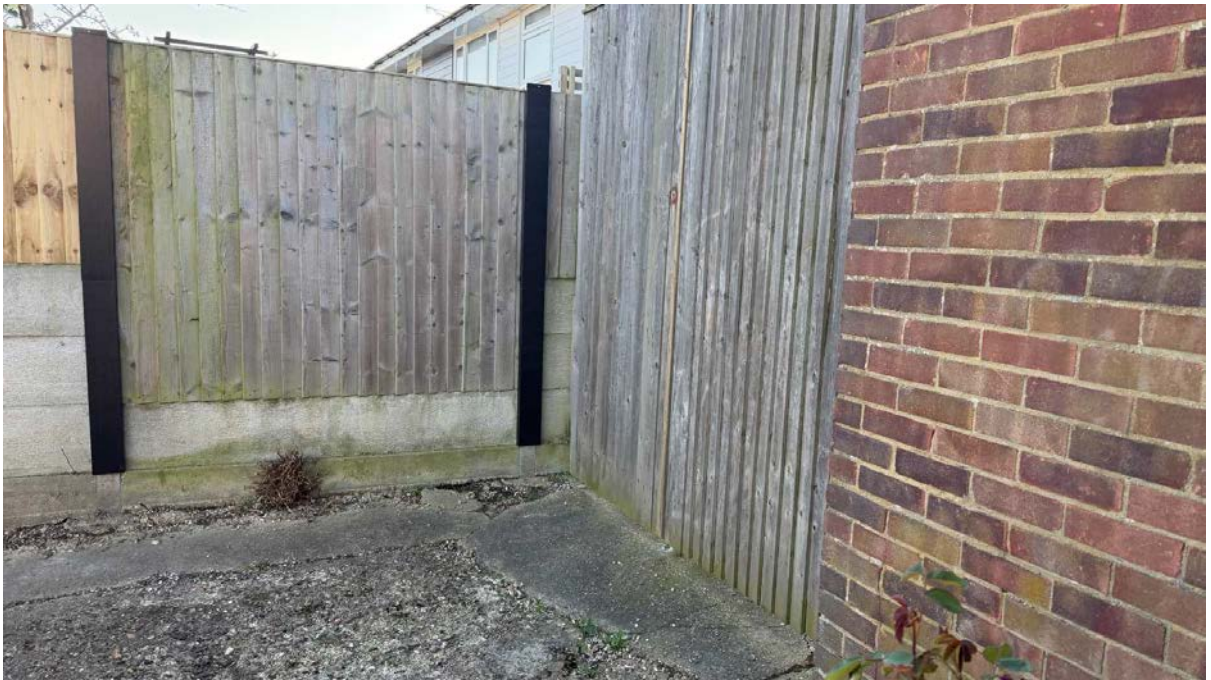
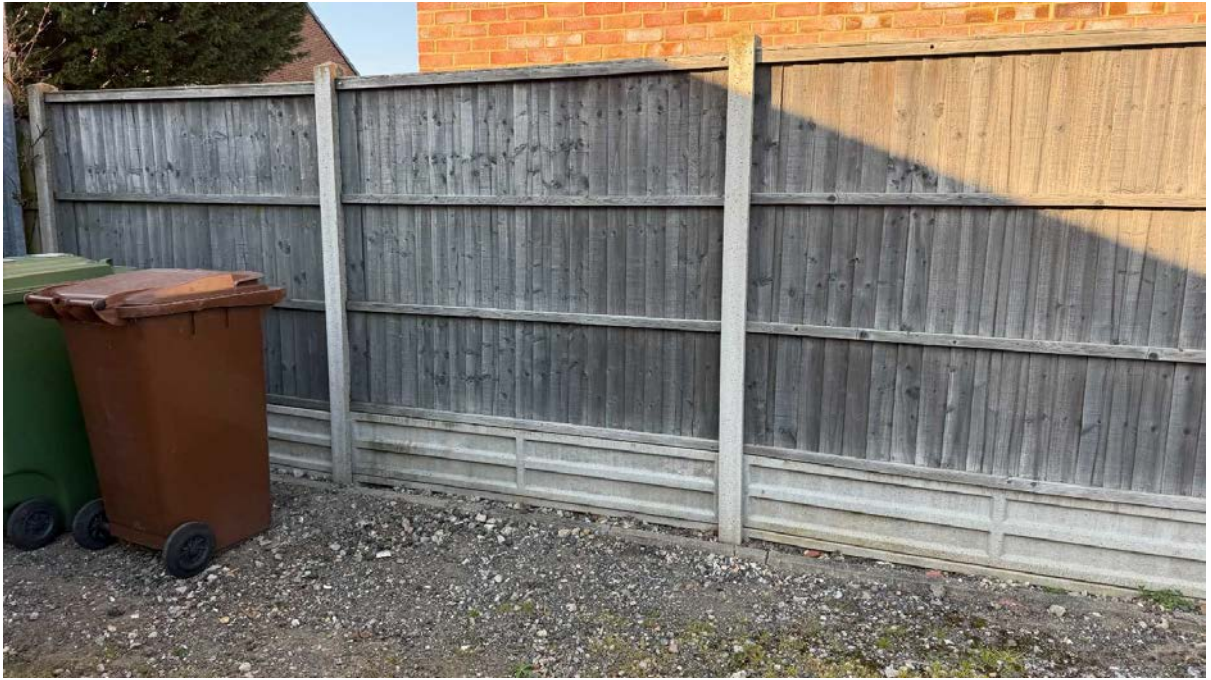
To the front and rear grounds, there are various boundary lines with timber fencing installed. No collapsed panels or loose posts were noted overall. To the front car park, there are front boundary brick walls. There are signs of general weathering and settlement (age related) cracks, however no major damage or loose brickwork was noted where rebuilding the walls would be required.
